Moisture Survey Inspection Report

Date of Inspection:

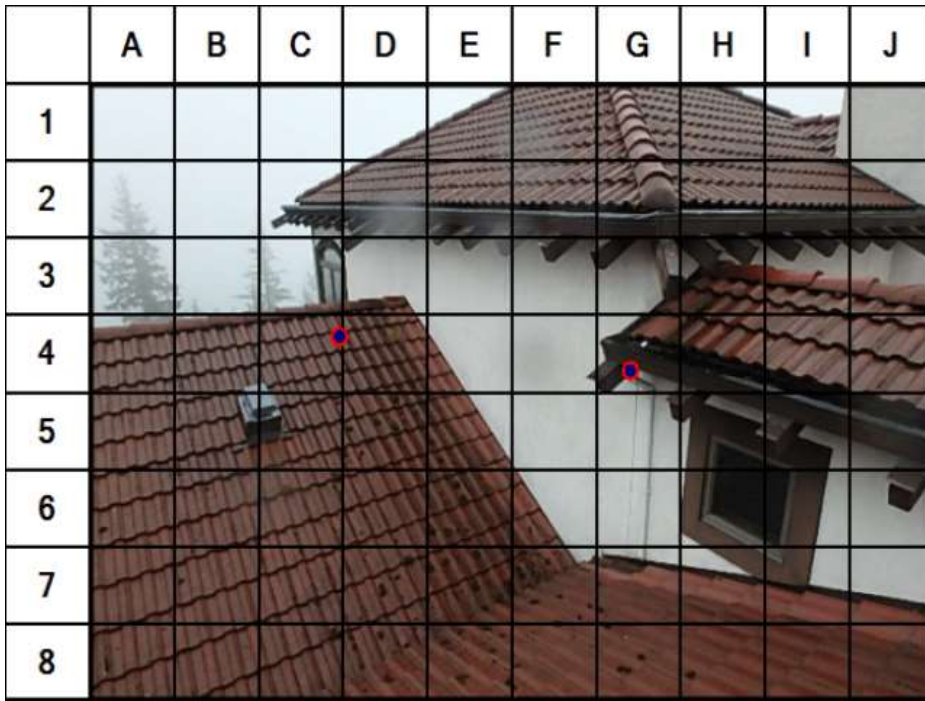
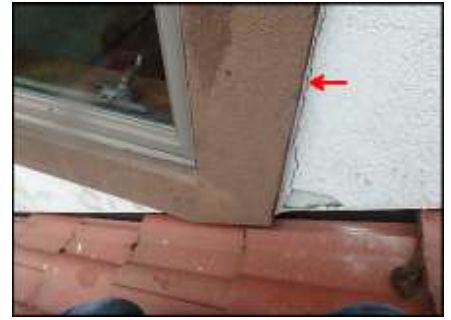
Delamination of EPS planton needs to be re-adhered prior to sealant joint application at planton perimeter; typical

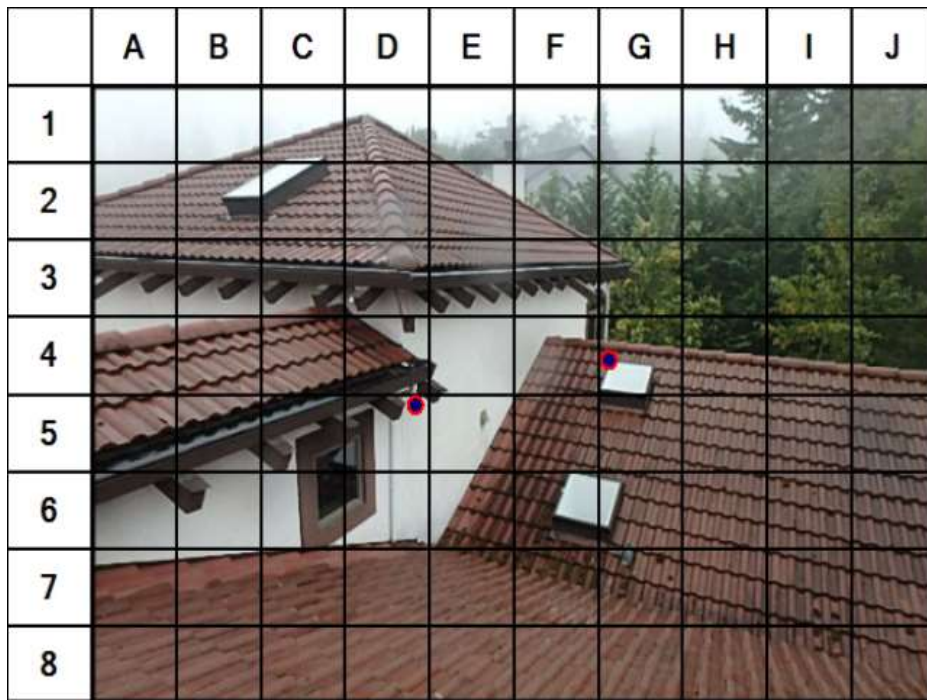
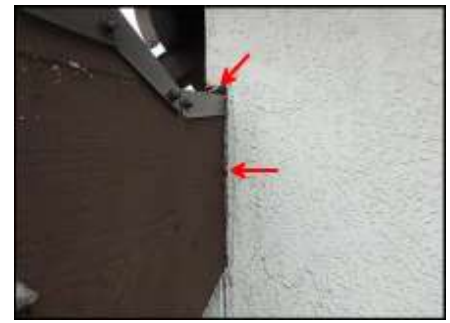
Roof and fascia terminations need sealant joint application; typical

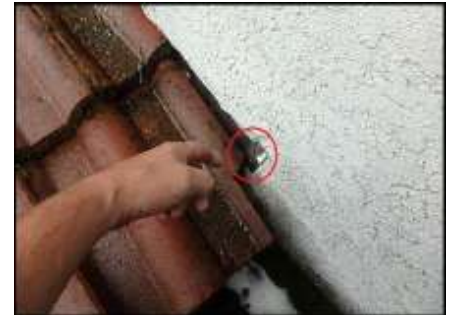
Torch down adequately extends behind stucco to protect against moisture intrusion at cut & turned kickout flashing installed at roof termination; typical

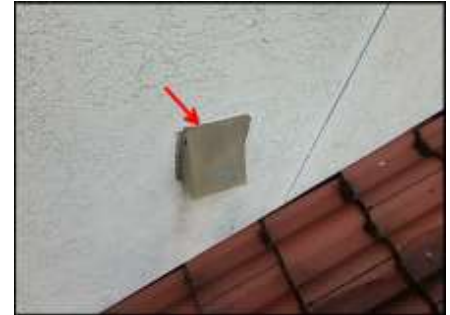
Vent penetration needs sealant joint application; typical

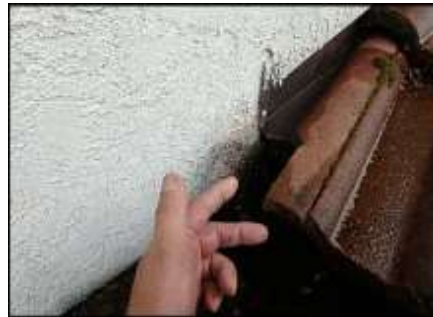
Torch down adequately extends behind stucco to protect against moisture intrusion at cut & turned kickout flashing installed at roof termination; typical

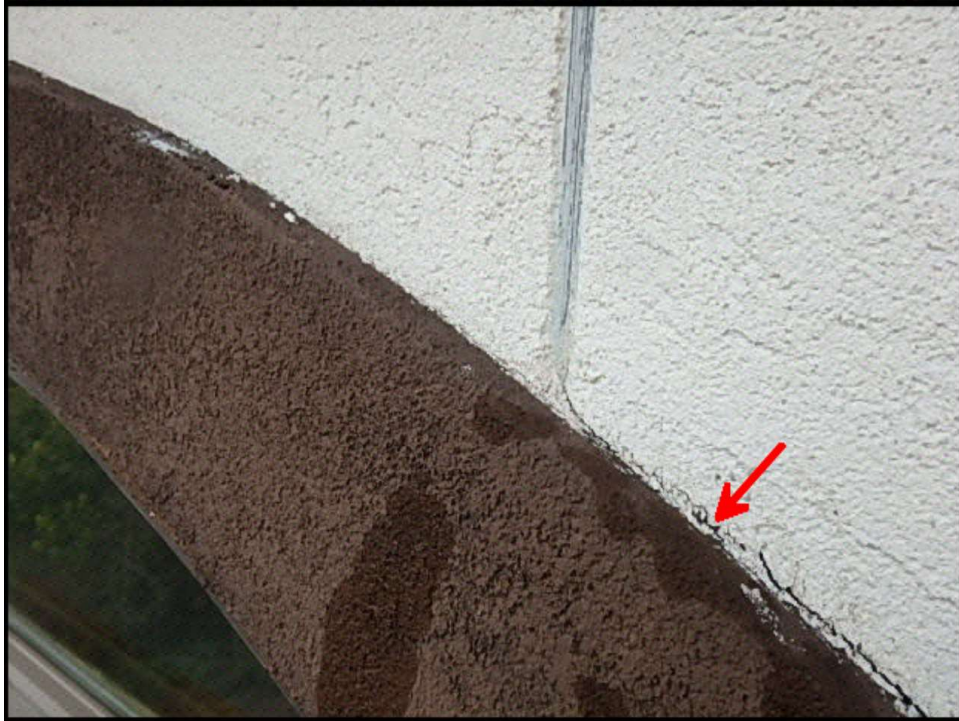
Delamination of EPS planton needs to be re-adhered prior to sealant joint application at planton perimeter; typical

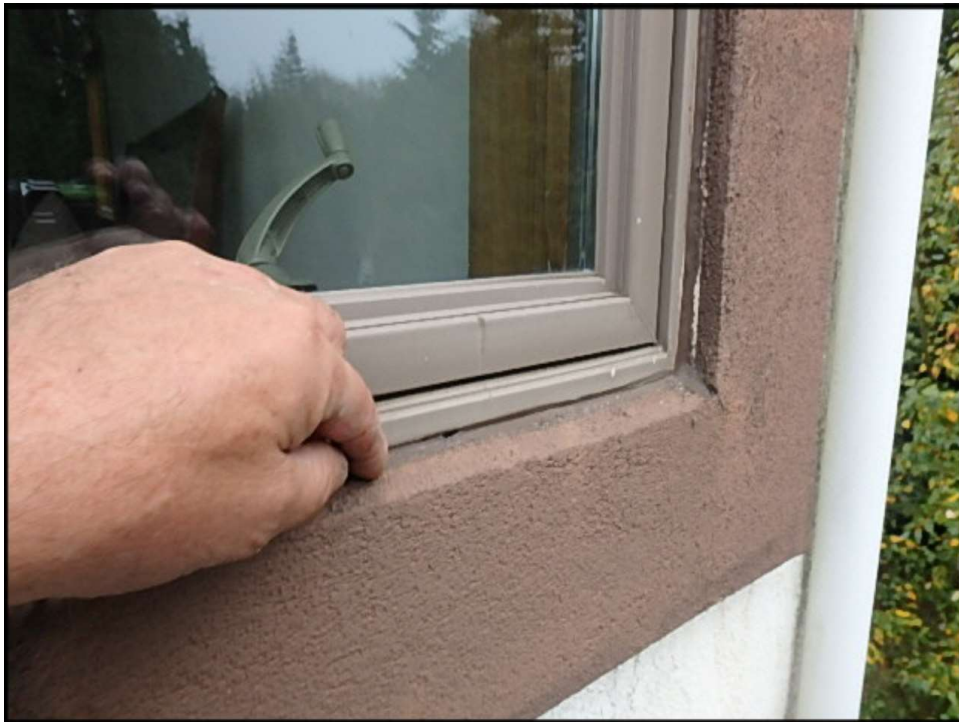
UV damaged sealant joint failing at window perimeter needs to be removed and replaced; typical

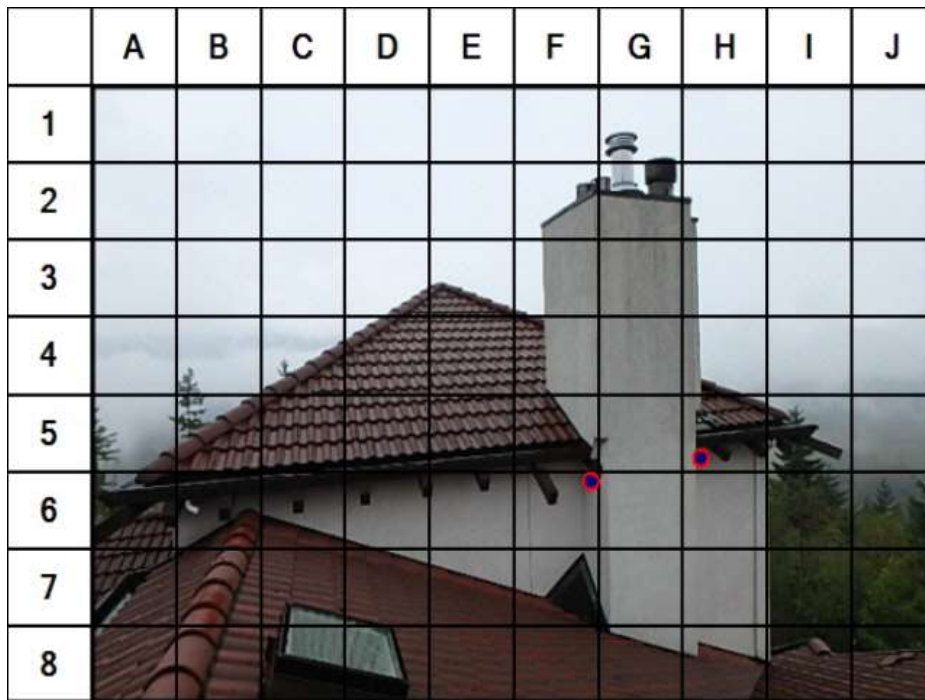
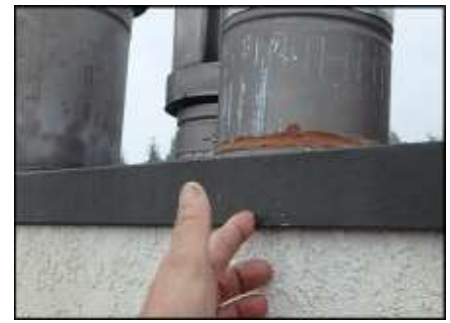
Chimney cap adequately extends over stucco to protect against moisture intrusion; typical

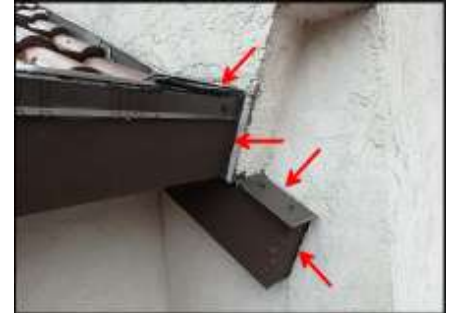
Roof and fascia terminations need sealant joint application; typical

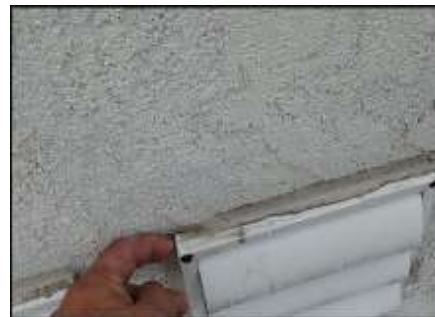
Sealant joint failure at vent penetration needs to be removed and replaced; typical

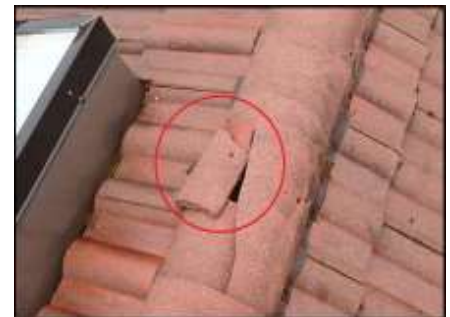
Broken roof tile needs to be replaced; typical

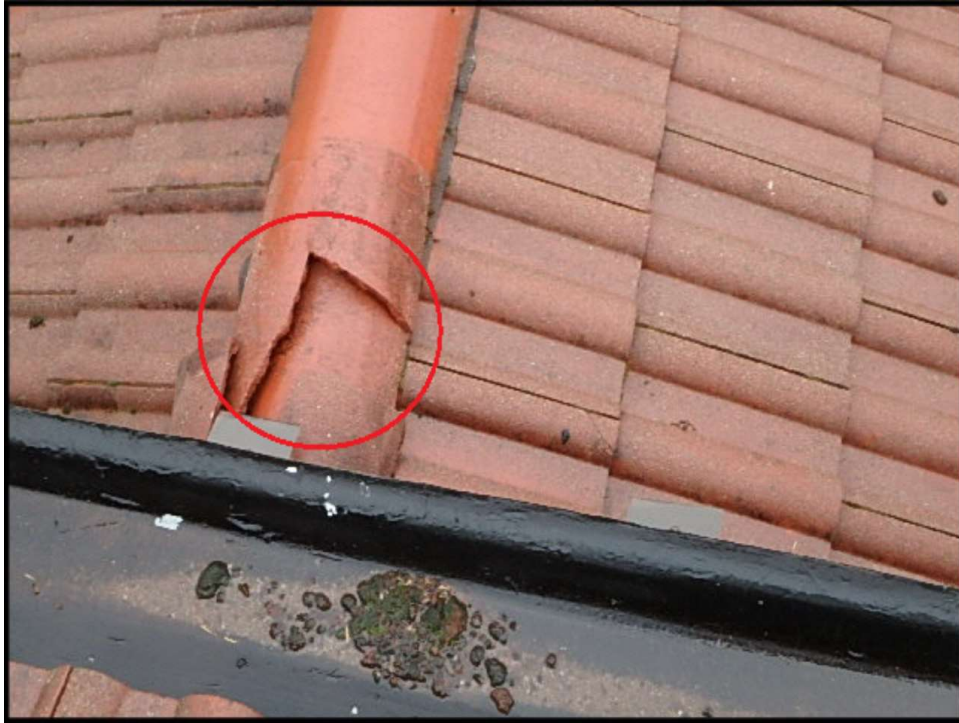
Broken roof tile needs to be replaced; typical

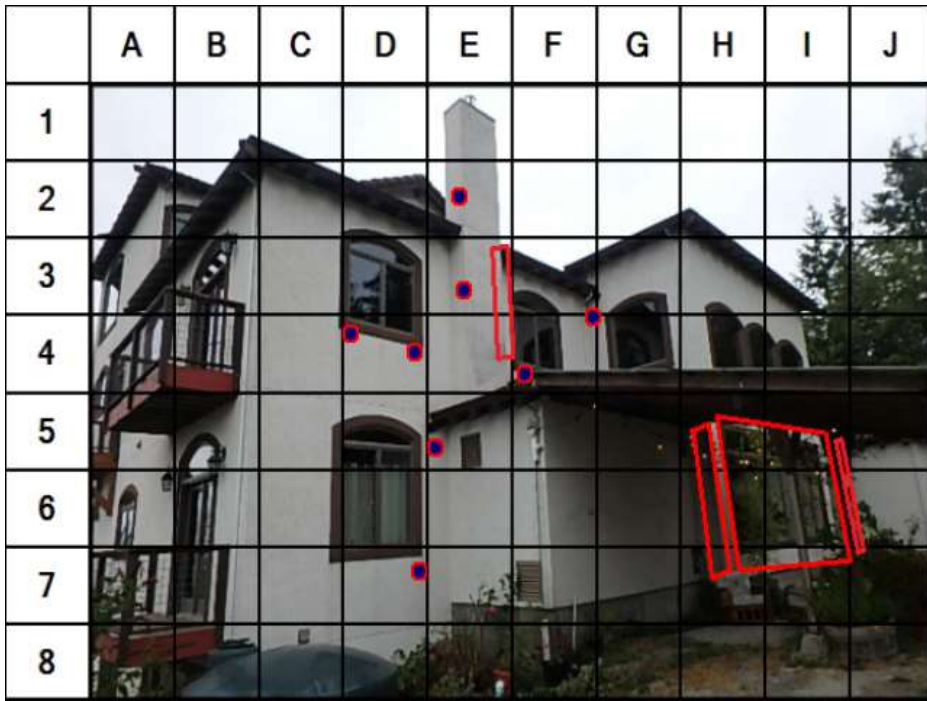
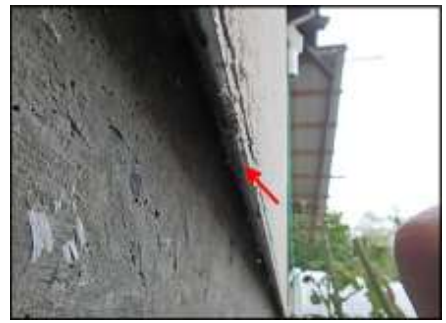
Weep screed installed at base of stucco; typical

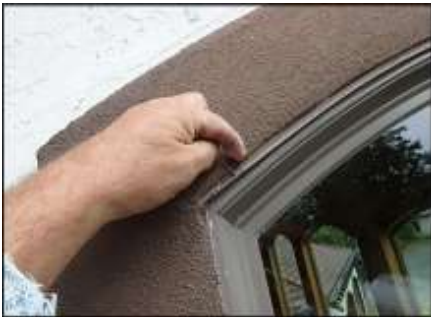
Sealant joint failure at window perimeter needs to be removed and replaced; typical

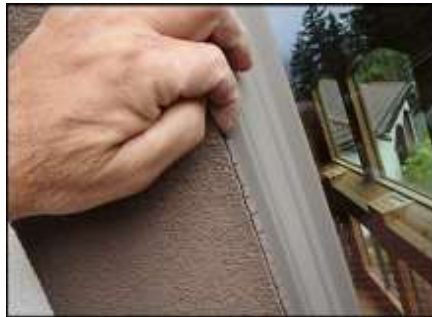
Sealant joint failure at window perimeter needs to be removed and replaced; typical

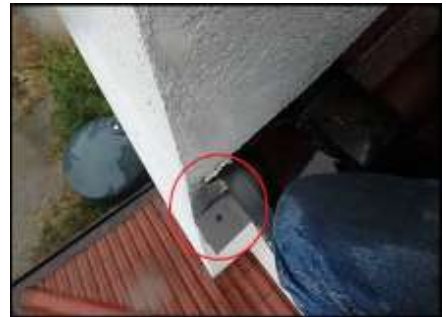
Roof termination needs further evaluation to determine necessary remediation upon remediation of soft substrate below (E3)

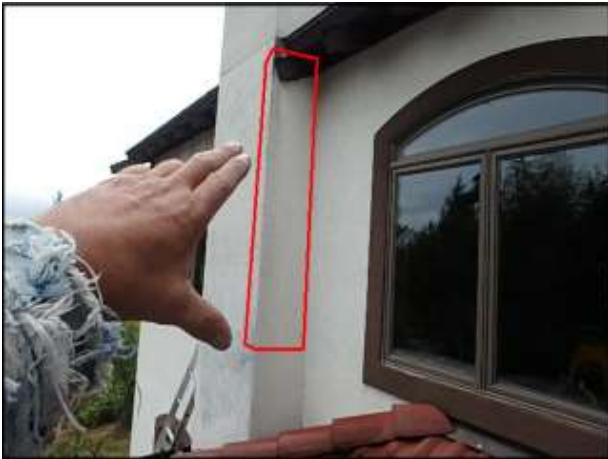
Approximate area of soft substrate below roof termination needs to be removed and replaced (E3-E4)

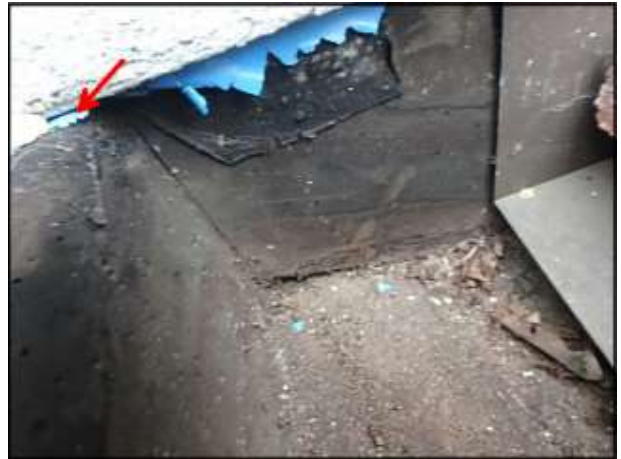
Torch down roofing to stucco needs sealant joint application; typical

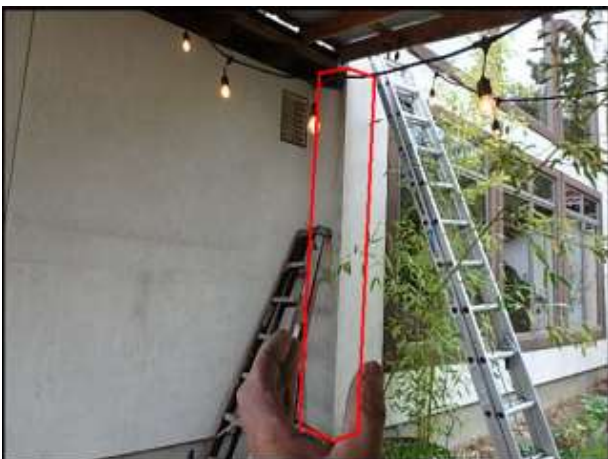
Approximate area of soft substrate below roof termination needs to be removed and replaced (H5-H7)

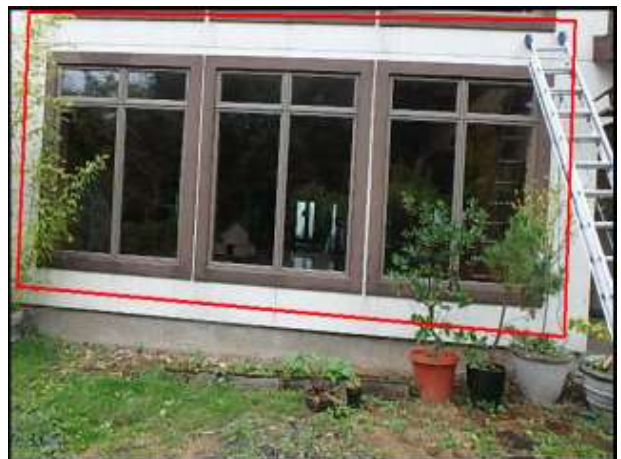
Approximate area of soft substrate at window perimeter needs to be removed and replaced (H5-I7)

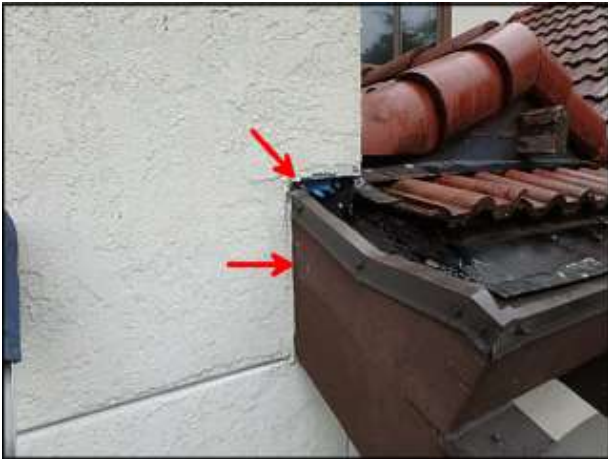
Roof and fascia terminations need sealant joint application; typical

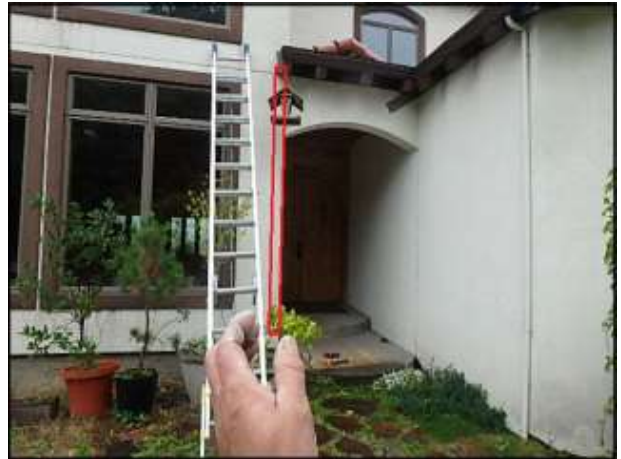
Approximate area of soft substrate below roof termination needs to be removed and replaced (I5-J7)

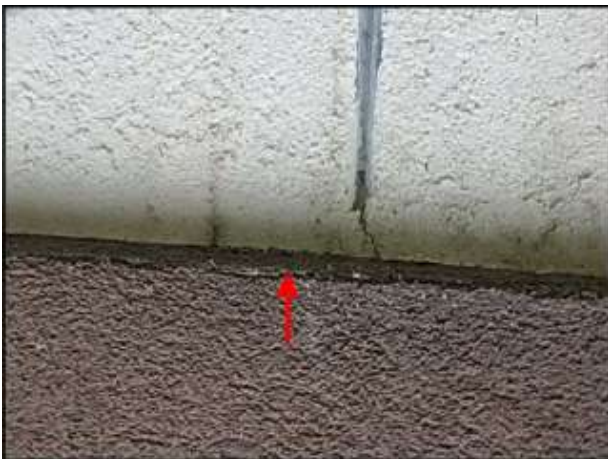
Delamination of EPS planton needs to be re-adhered prior to sealant joint application at planton perimeter; typical

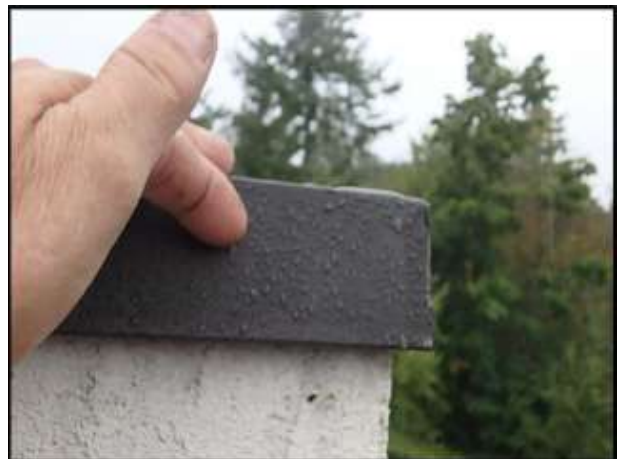
Chimney cap adequately extends over stucco to protect against moisture intrusion; typical

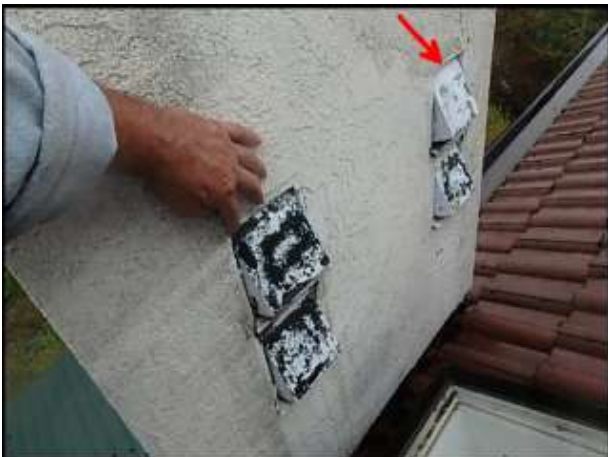
Vent penetrations need sealant joint application (E2)

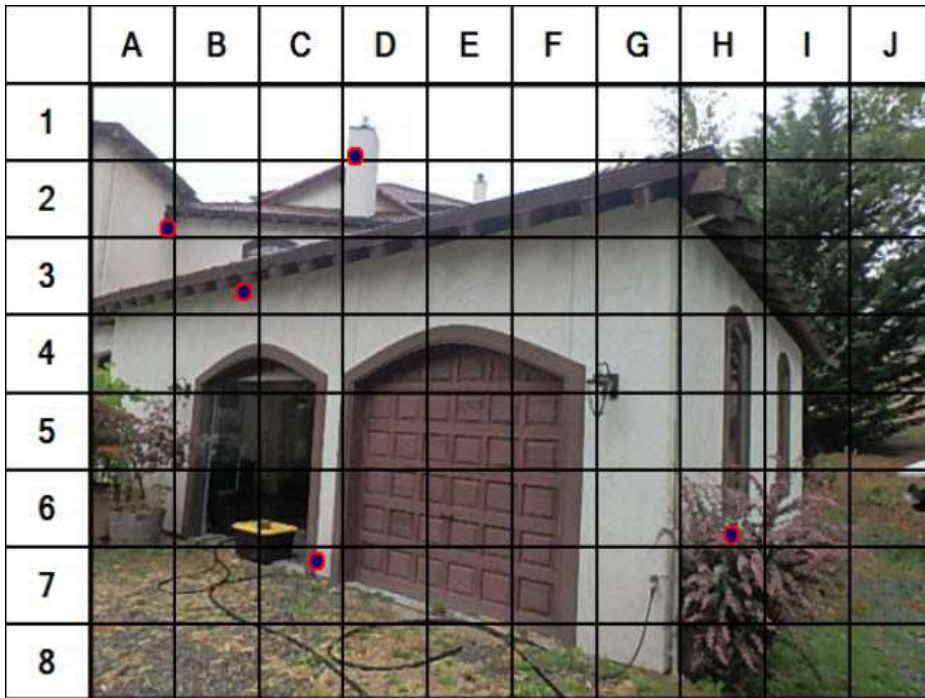
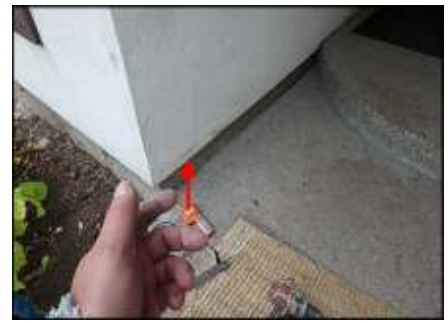
Stucco properly terminated above concrete at entry to protect against moisture intrusion (A6)

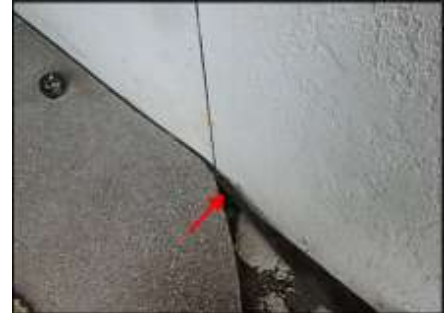
No remediation necessary at concrete poured to base of stucco at entry due installation of rubber flashing to protect against moisture intrusion (A6)

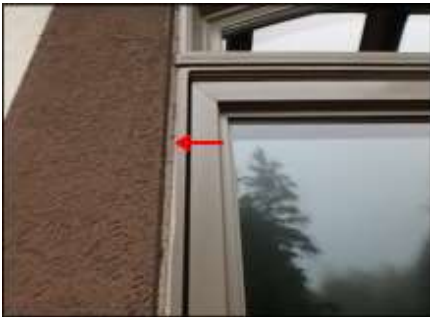
Sealant joint failure at window perimeter needs to be removed and replaced; typical

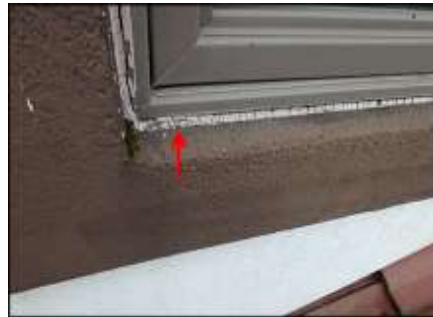
Sealant joint failure at window perimeter needs to be removed and replaced; typical

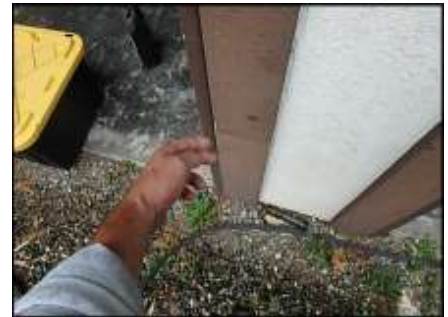
Recommend remediation of area of impact damage for aesthetic purposes (C7)

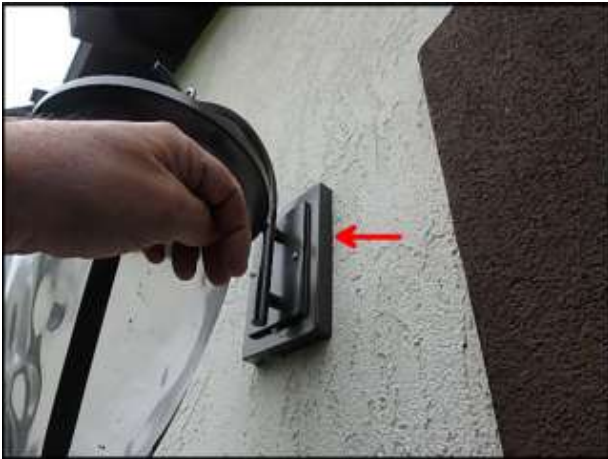
Light penetration needs sealant joint application; typical

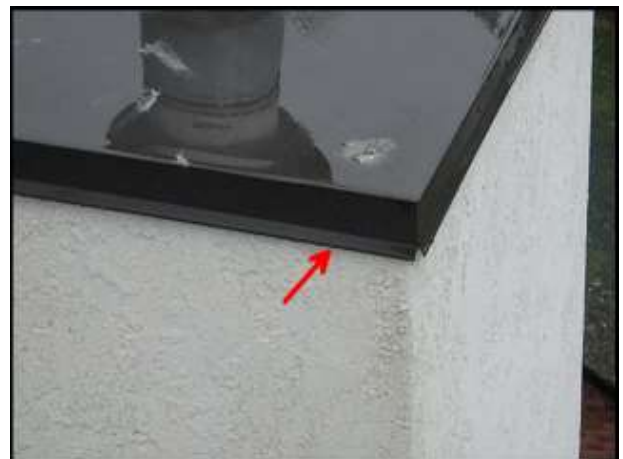
Chimney cap adequately extends over stucco to protect against moisture intrusion; typical

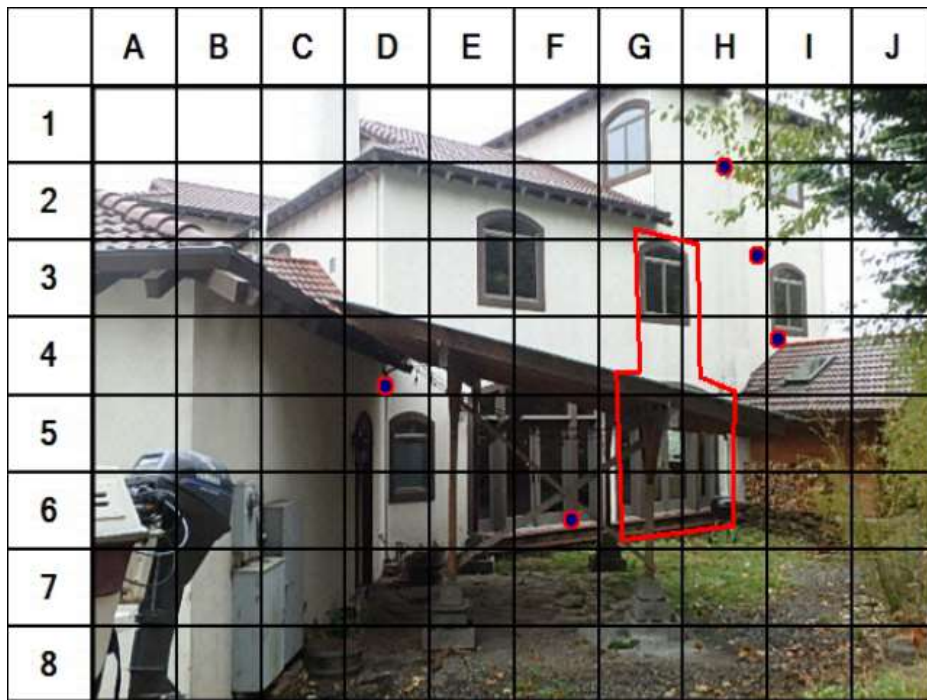
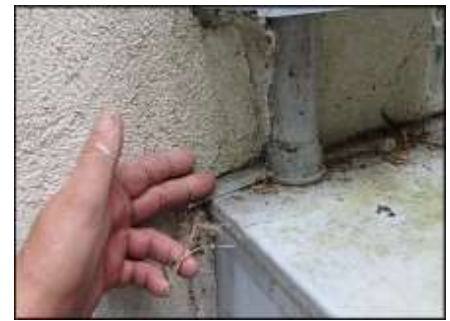
Flashing installed at utility penetration head (B7)

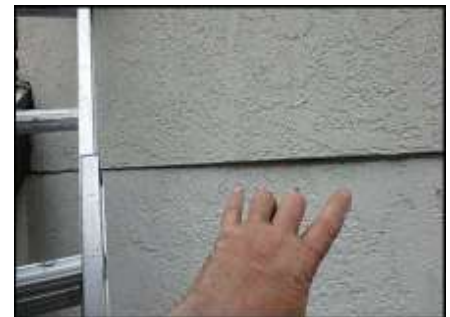
Deflection observed at floor line appears to be due to stucco installation over earthquake strap (D4)

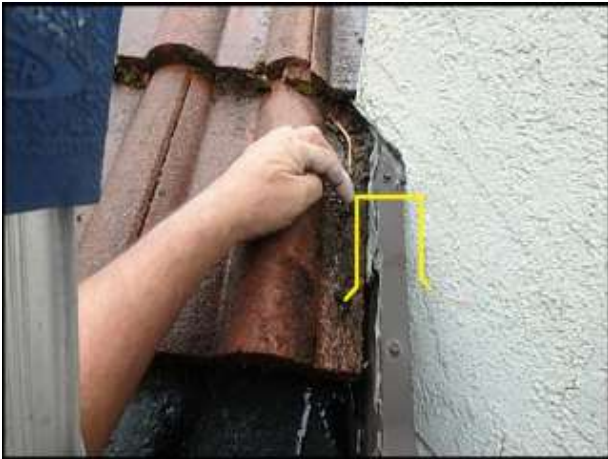
Flashing at roof termination needs counter cap flashing installed; typical

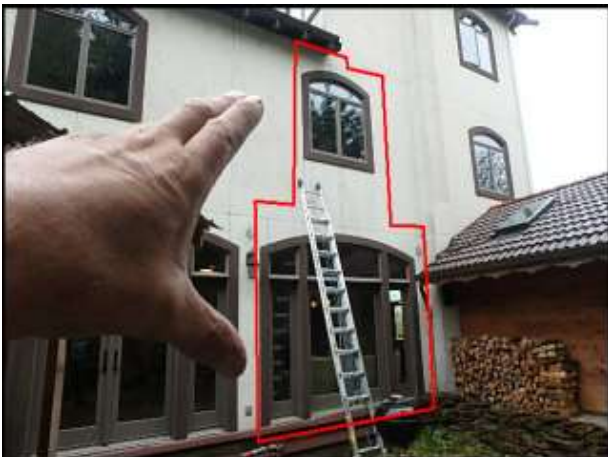
Approximate area of soft substrate below roof termination needs to be removed and replaced (G2-H6)

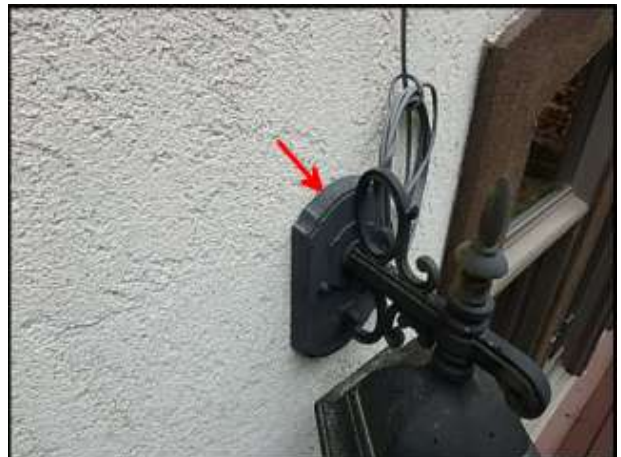
Light penetration needs sealant joint application; typical

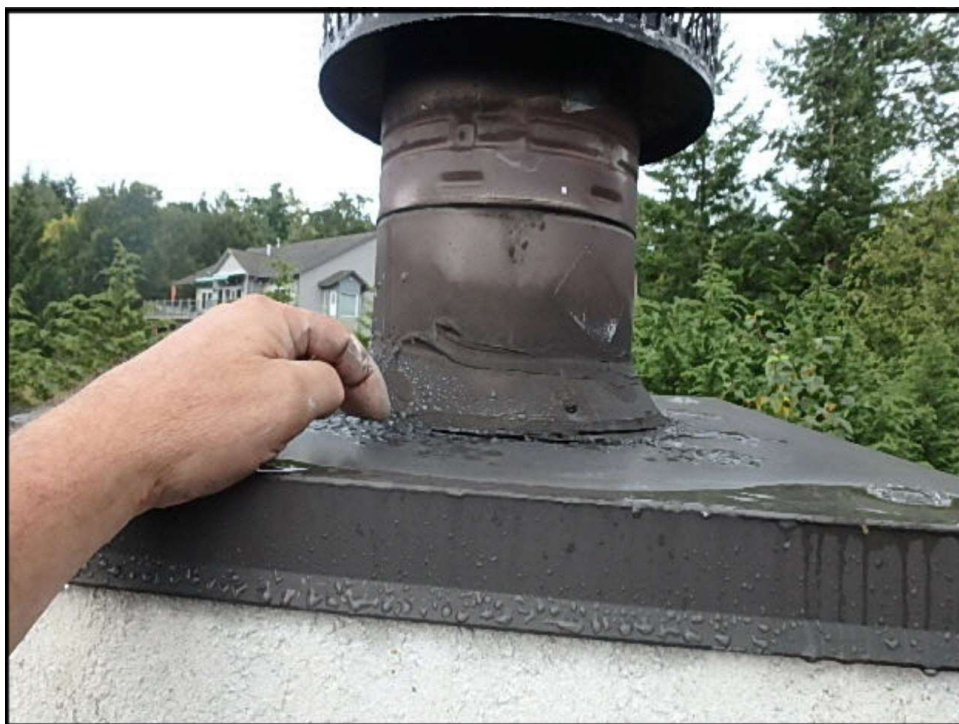
Chimney cap adequately extends over stucco to protect against moisture intrusion; typical

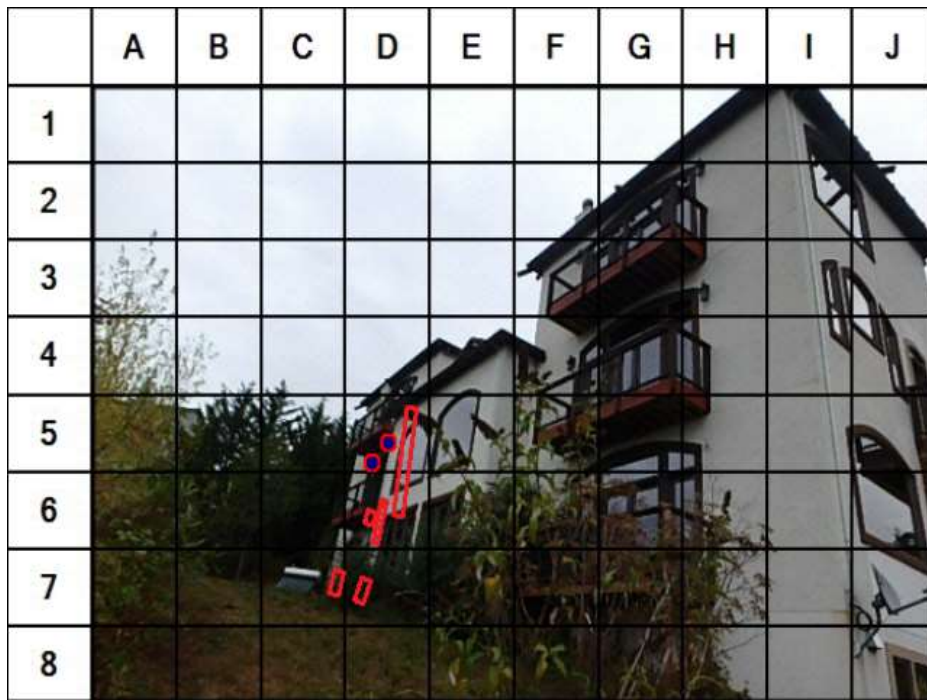
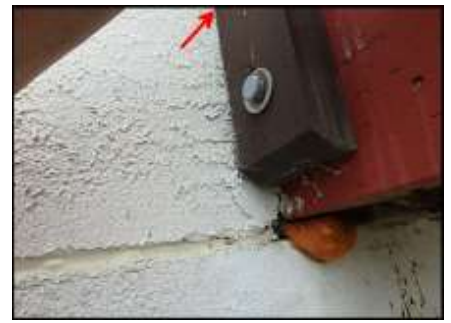
Deck termination needs end dam flashing installed; typical

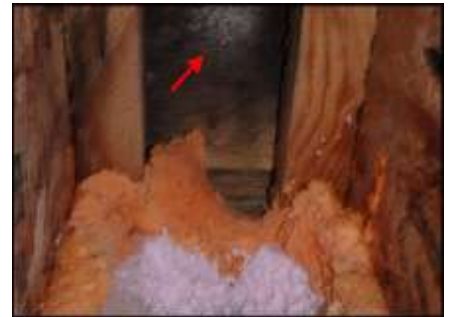
Visible water damaged plywood sheathing at deck needs to be removed and replaced; typical

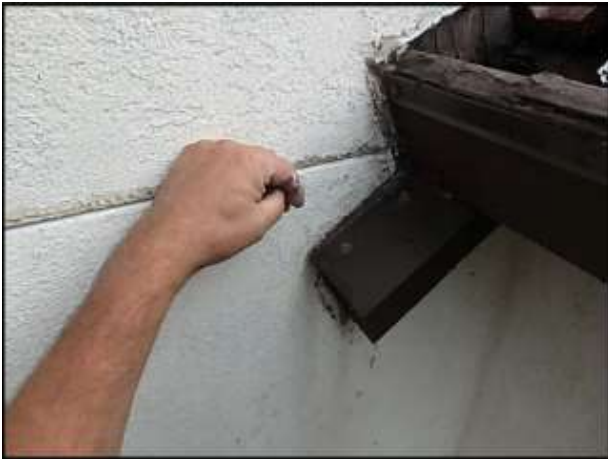
Roof and fascia terminations need sealant joint application; typical

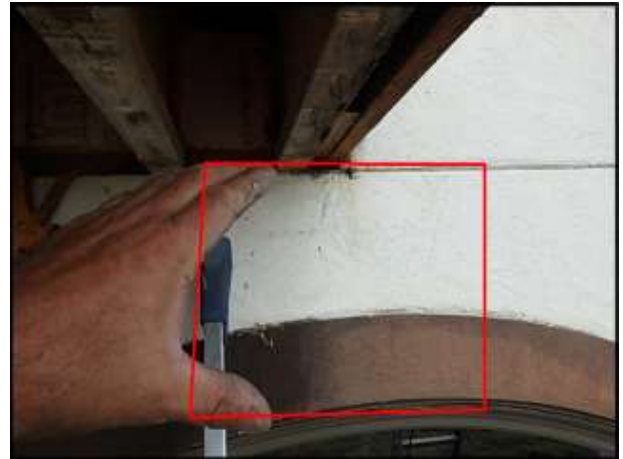
Approximate area of soft substrate below deck needs to be removed and replaced (D6)

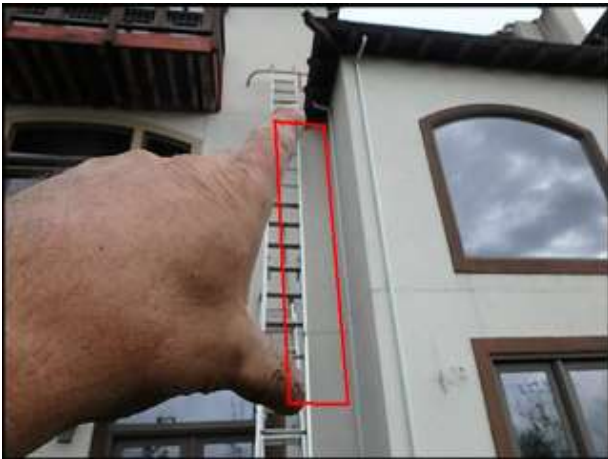
Approximate area of soft substrate below roof termination needs to be removed and replaced (D5-D6)

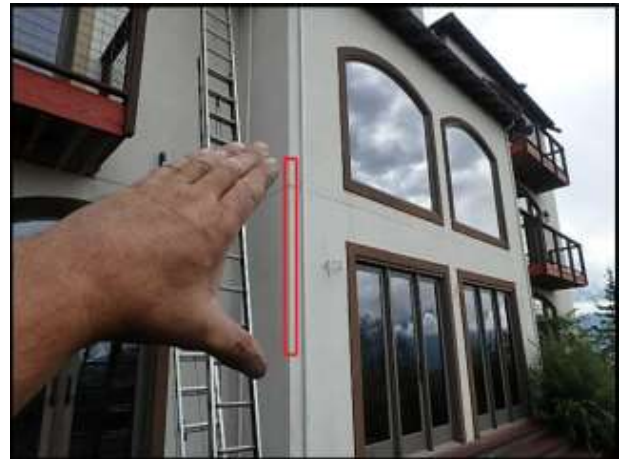
Approximate area of soft substrate at corner needs to be removed and replaced (D6)

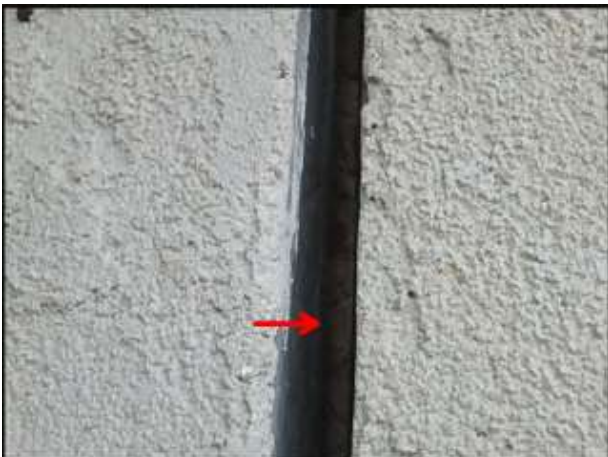
Visible oriented strand board at joint; joint needs sealant joint installed (D6)

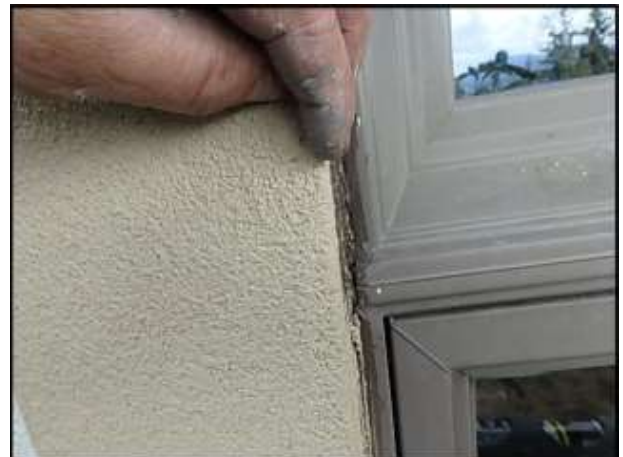
Sealant joint failure at window perimeter needs to be removed and replaced; typical

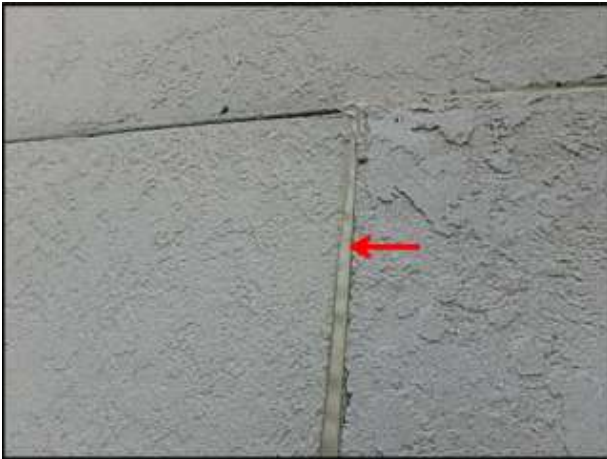
Aged sealant joint needs to be removed and replaced (D6)

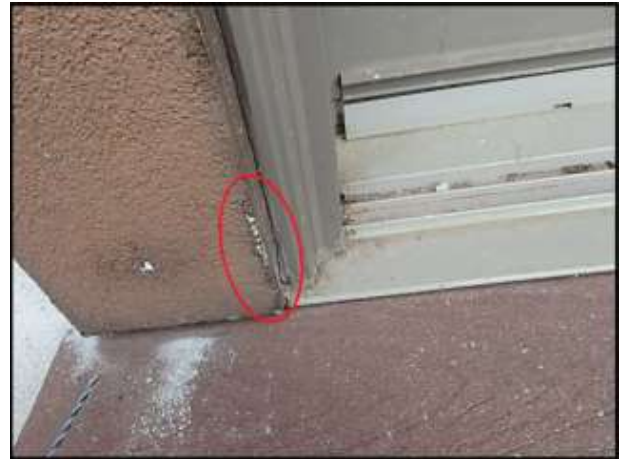
Area of impact damage needs remediation (D6)

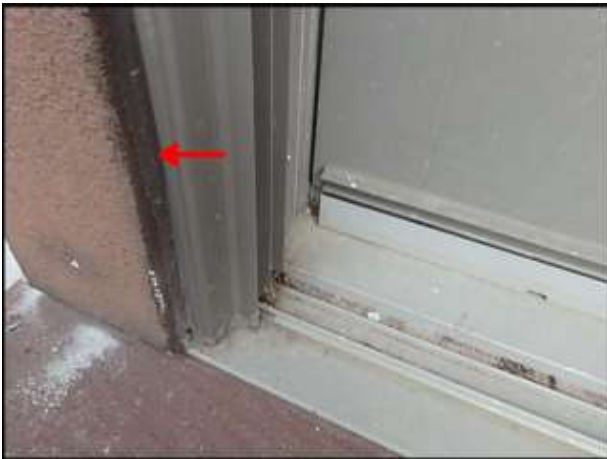
Sealant joint failure at door head and jambs needs to be removed and replaced; typical

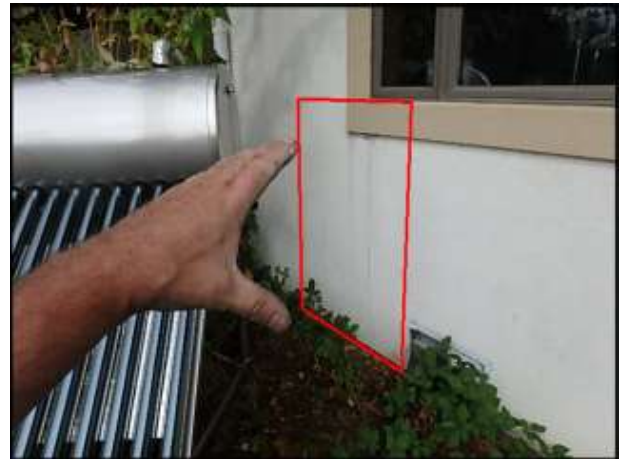
Approximate area of soft substrate below window needs to be removed and replaced (C7)

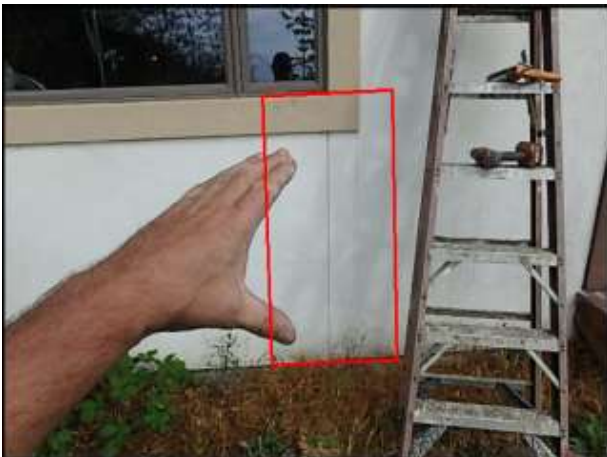
Approximate area of soft substrate below window needs to be removed and replaced (D7)

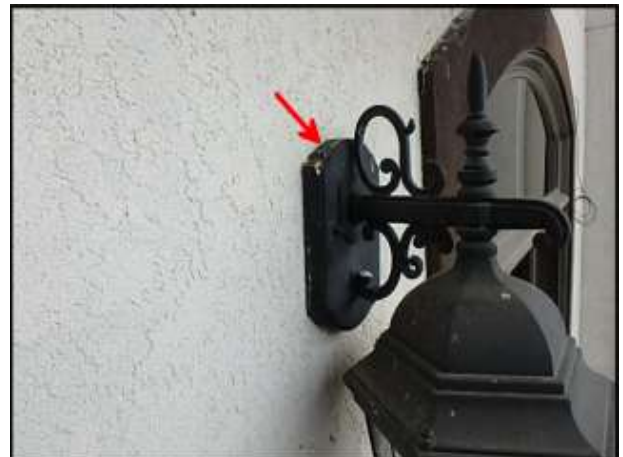
Light penetration needs sealant joint application; typical

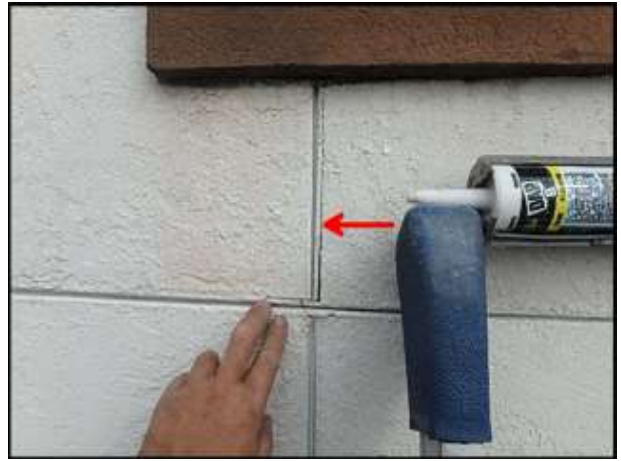
Cracks at expansion and control joints need to be sealed; typical

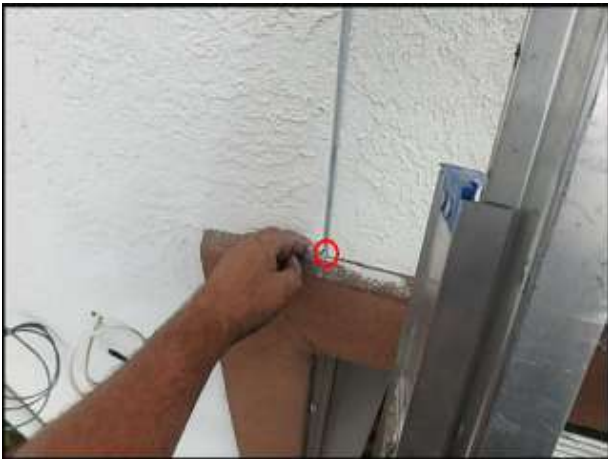
Control joint termination needs to be sealed; typical

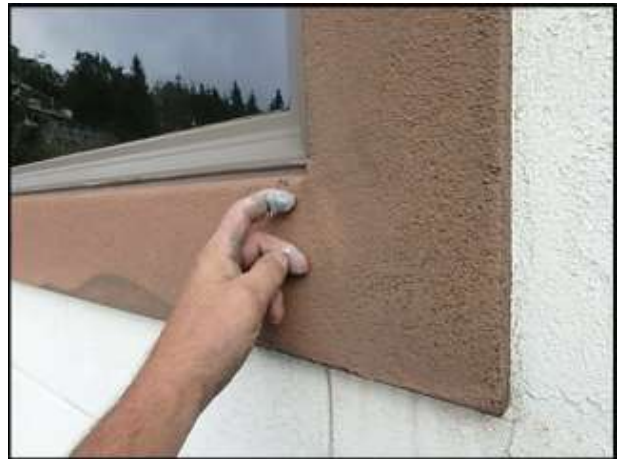
Hairline crack at EPS planton needs elastomeric coating application; typical

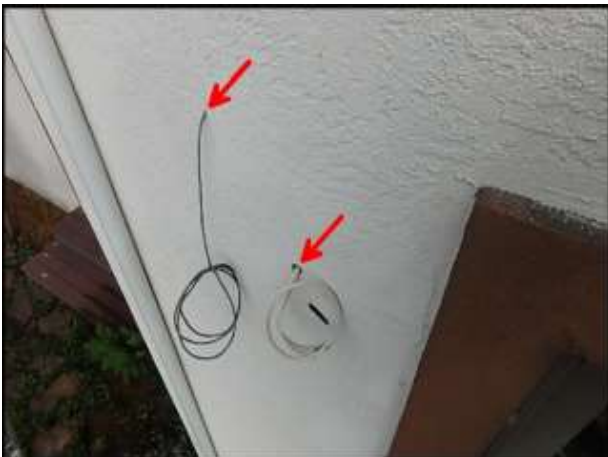
Penetrations need to be sealed; typical

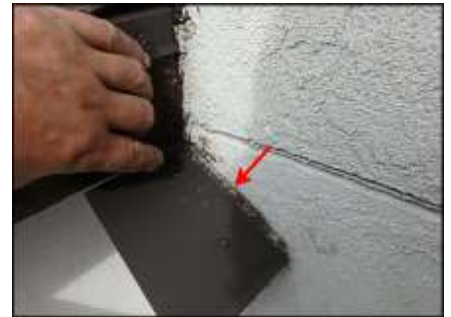
Roof and fascia terminations need sealant joint application; typical

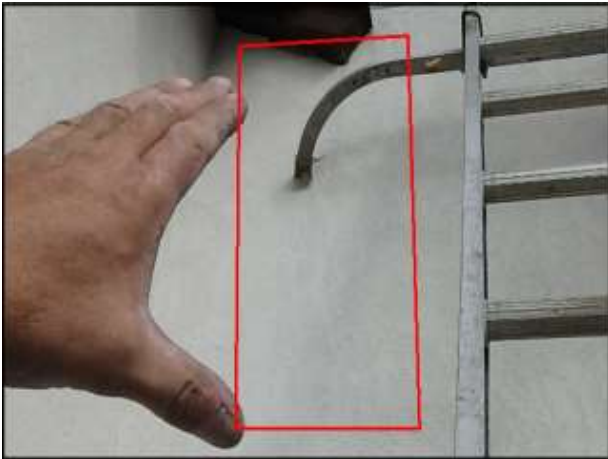
Approximate area of soft substrate below roof termination needs to be removed and replaced (D4-E4)

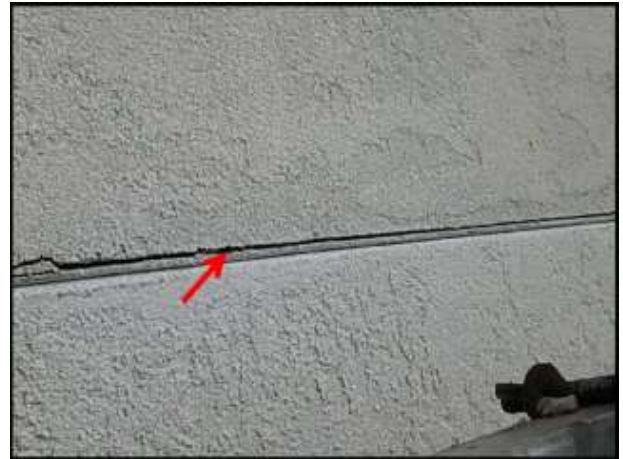
Crack at expansion joint needs to be sealed; typical

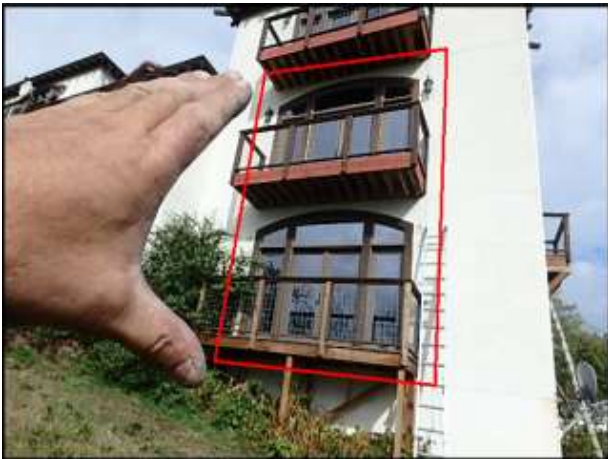
Approximate area of soft substrate at decks needs to be removed and replaced (E3-G7)

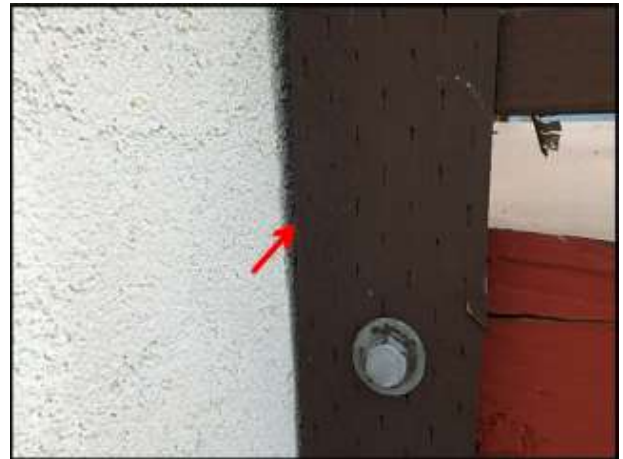
Deck termination needs end dam flashing installed; typical

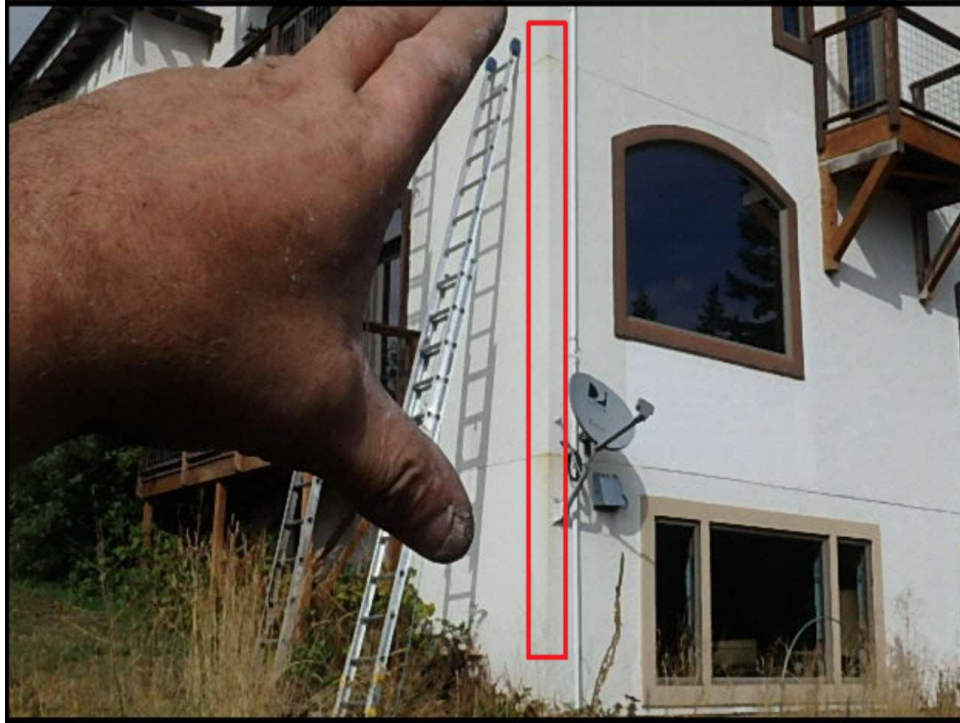
Approximate area of soft substrate at corner needs to be removed and replaced (H3-H7)

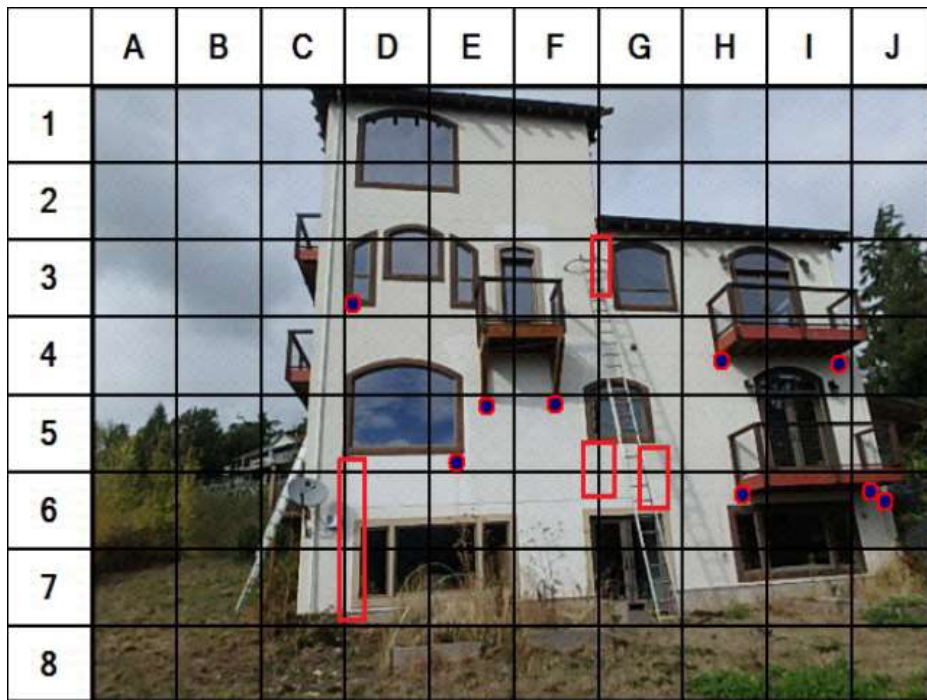
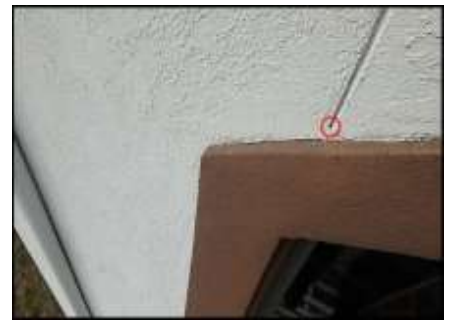
Control joint termination needs to be sealed; typical

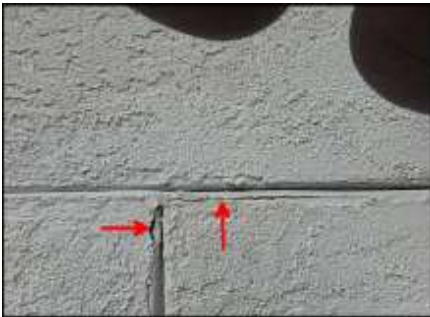
Cracks at expansion and control joints need to be sealed; typical
