Moisture Survey Inspection Report

Date of Inspection:

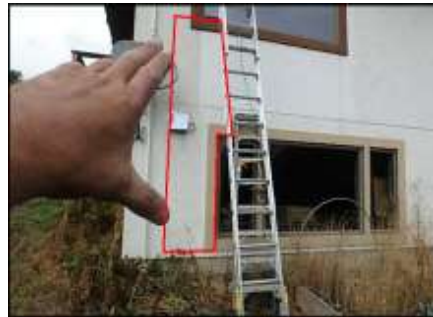
Approximate area of soft substrate at windows needs to be removed and replaced (C5-D7)

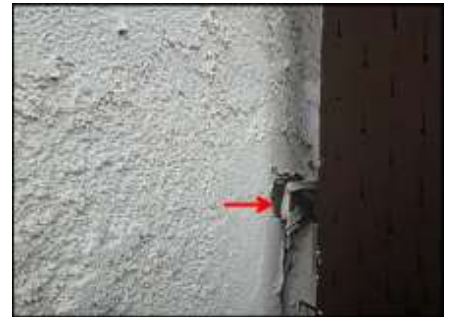
Deck terminations need end dam flashings installed (E4, F4)

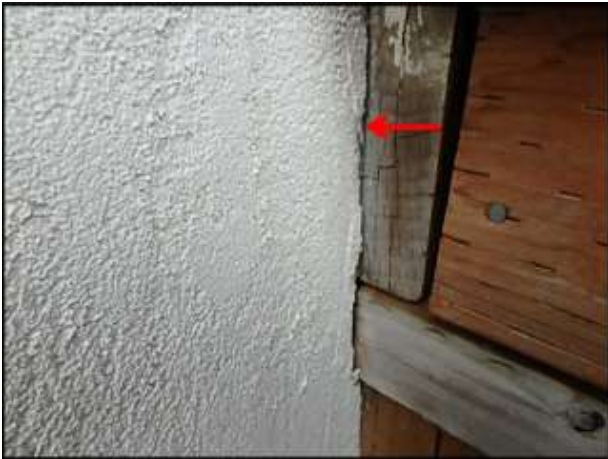
Deck fascia termination needs sealant joint application (E4, F4)

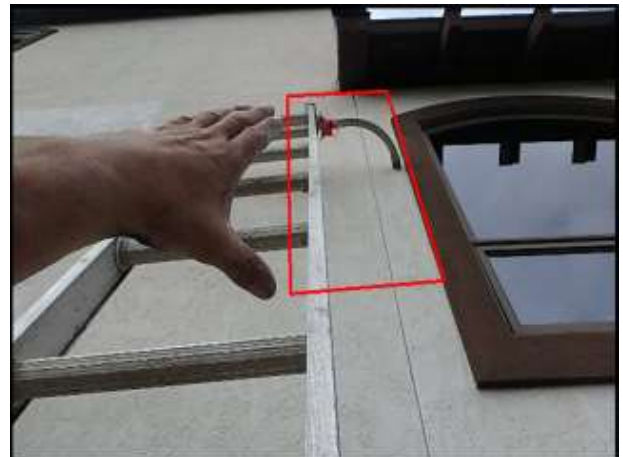
Approximate area of soft substrate below roof termination needs to be removed and replaced (F2-F3)

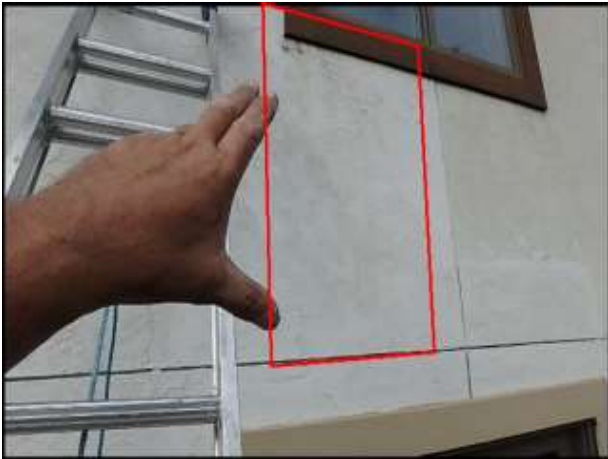
Approximate area of soft substrate below window needs to be removed and replaced (F5-G6)

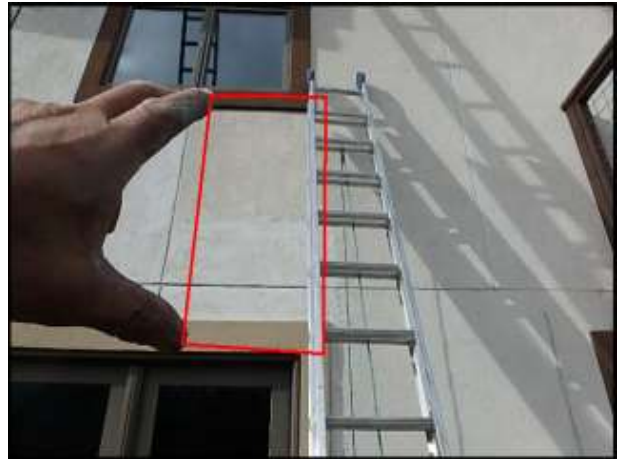
Approximate area of soft substrate below window needs to be removed and replaced (G5-G6)

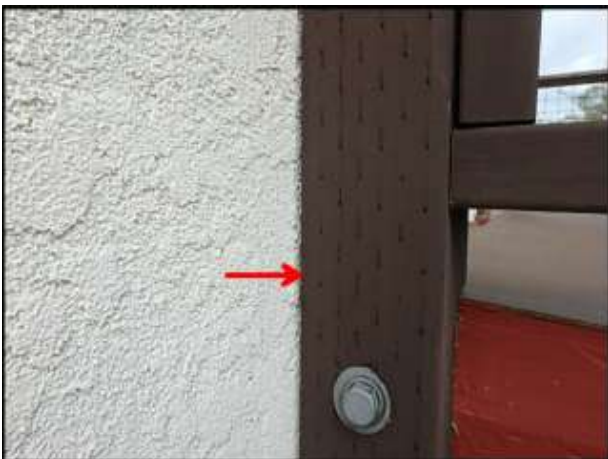
Deck termination needs end dam flashing installed; typical
