# Moisture Survey Inspection

January 1, 2019

123 Pleasant Lane  
Pleasantville, WA 98000

Sound Exterior Inspections, LLC performed a moisture survey inspection on January 1, 2019 of the EIFS Sprint Barrier System installed on the building located at 123 Pleasantville Lane, Pleasantville, Washington at the request of John Doe, LLC.

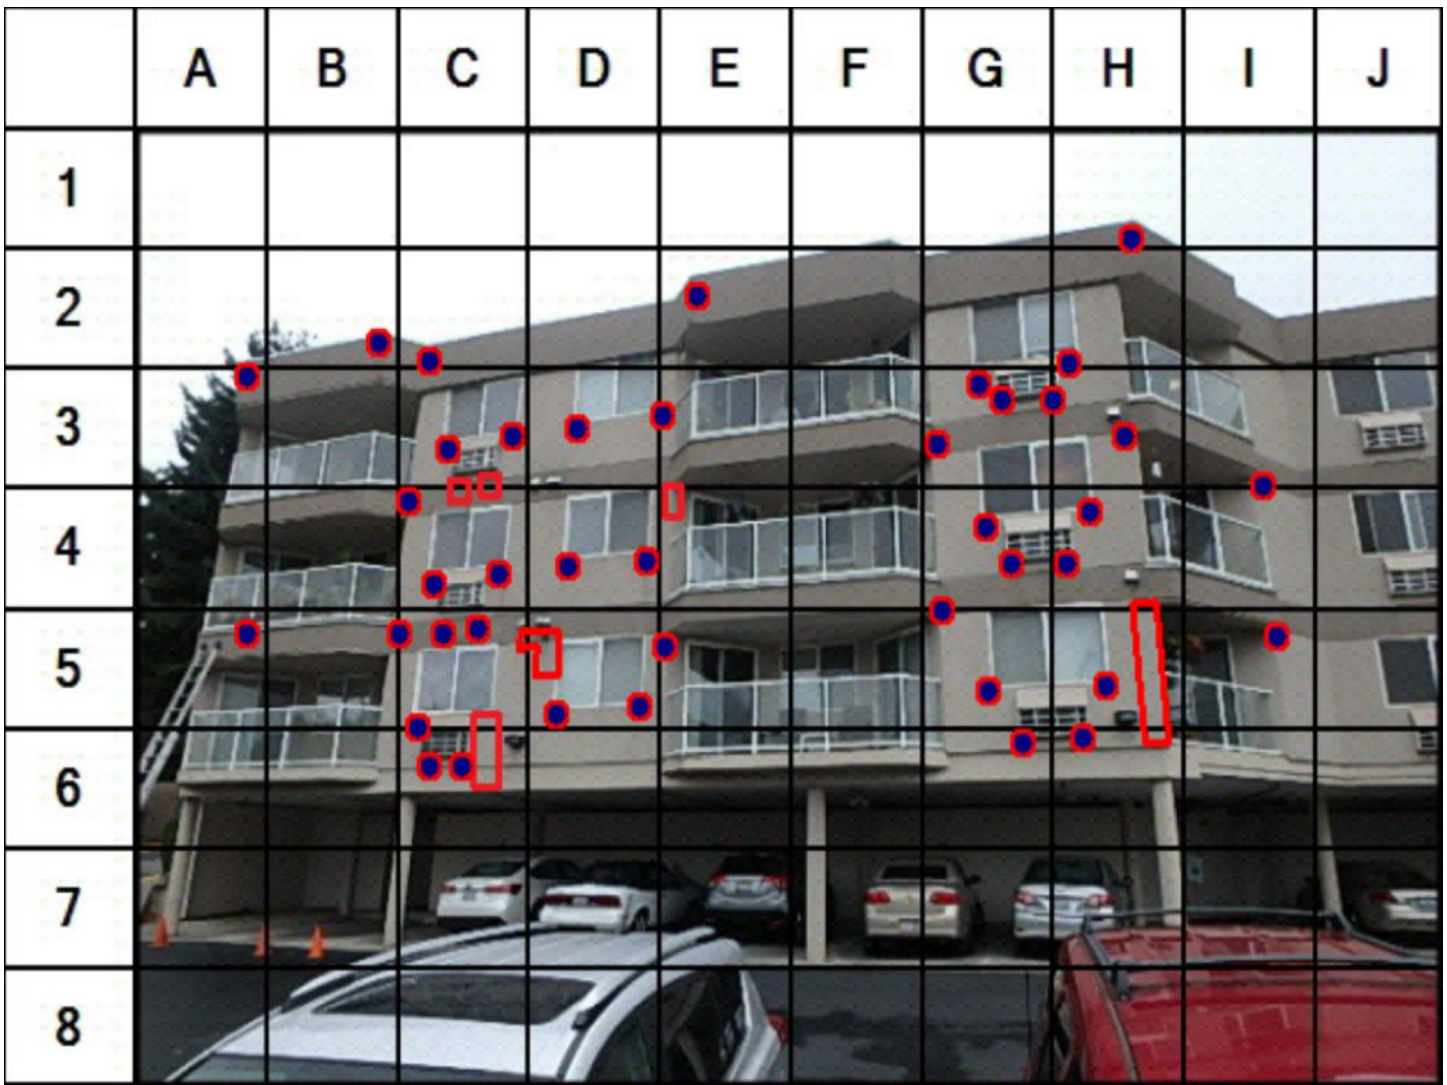
# Front Left Elevation

Grid Location	Item Description	Moisture Readings	Substrate Condition	Observations
A3-H1	Roof cap flashings	8% - 14%	Firm	Roof cap flashings probed within low moisture range.
C3-H5	Windows	8% - 16%	Firm	Windows probed within low to medium moisture range.
C3-G6	PTAC	7% - 10%	Firm	PTACs probed within low moisture range.
A5	Railing attachment	9%	Firm	Railing attachment probed within low moisture range.
C4-I5	Deck terminations	7% - 11%	Firm	Deck terminations probed within low moisture range.
C3-C4	Soft substrate	14%	Soft	Approximate area of soft substrate needs to be removed and replaced.
C3-C5	Soft substrate	15%	Soft	Approximate area of soft substrate needs to be removed and replaced.
C5-D6	Soft substrate	14%	Soft	Approximate area of soft substrate needs to be removed and replaced.
C5-C6	Soft substrate	12%	Soft	Approximate area of soft substrate needs to be removed and replaced.
E4	Soft substrate	14%	Soft	Approximate area of soft substrate needs to be removed and replaced.

H4-H6	Soft substrate	15%	Soft	Approximate area of soft substrate needs to be removed and replaced.

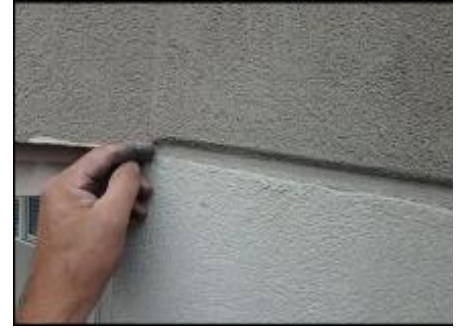
7/8" Sprint board application does not allow for minimum 3/4" foam at base of v-groove; hairline cracks observed; detail needs bond breaker tape and silicone sealant joint application; typical

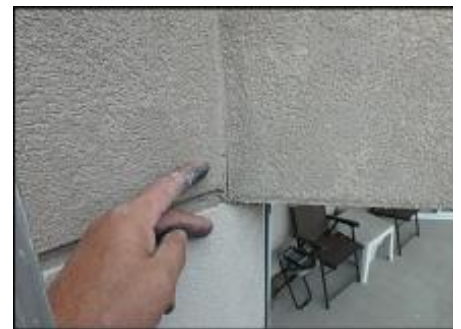
Crack needs to be gouged and slivered with EPS prior to base coat, mesh and finish coat application; typical

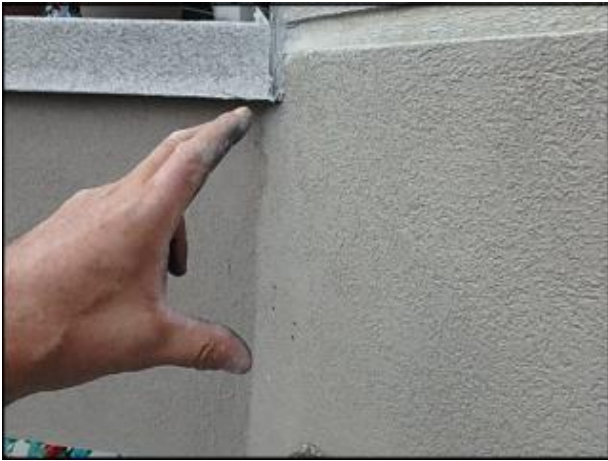
Inconclusive probing results below deck due to OSB substrate cut out to accommodate steel bracket installation; recommend random intrusive evaluation upon system remediation to determine framing condition; typical

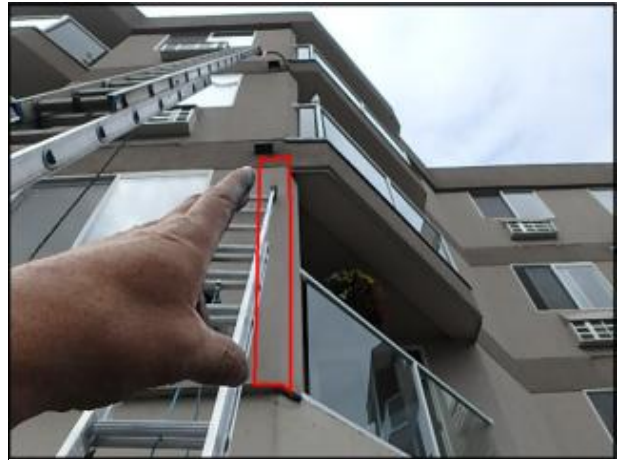
Approximate area of soft substrate needs to be removed and replaced (H4-H6)

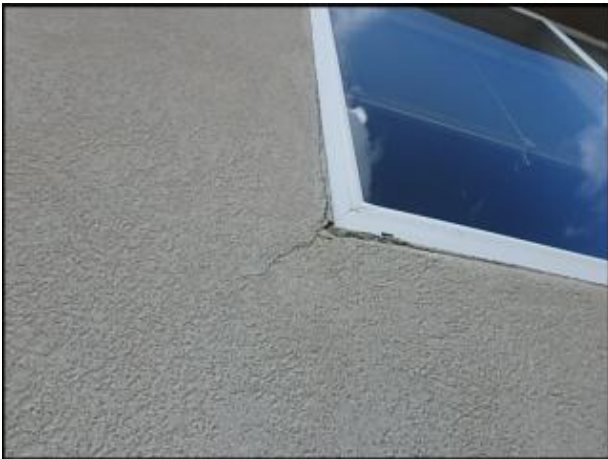
Area of insufficiently attached EIFS needs fasteners installed prior to base coat, mesh and finish coat application over entire system; typical

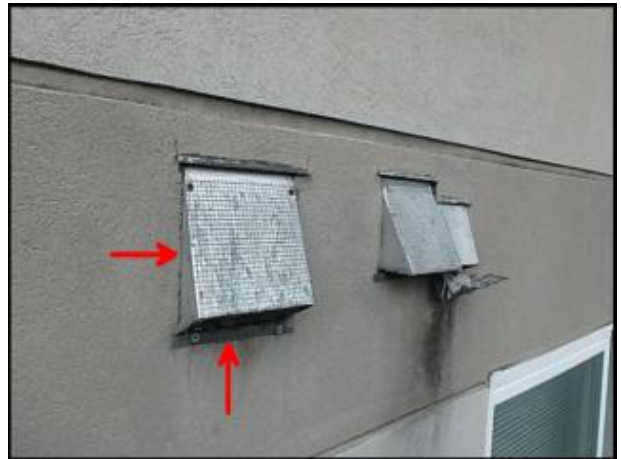
7/8" EIFS needs to be removed at vents prior to base coat and mesh application to accommodate 3/4" silicone sealant joint application; recommend replacing vents upon system remediation; typical

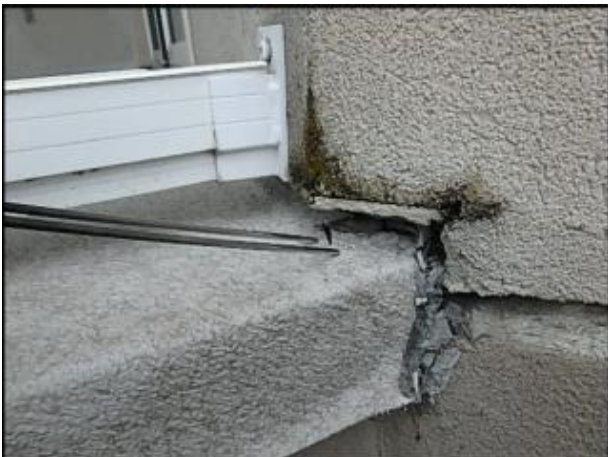
Recommend replacement of deck membrane due to installation defects and failure observed; typical

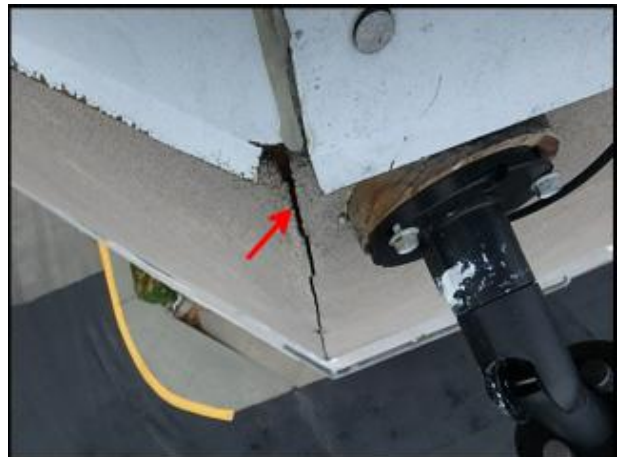
Crack needs to be gouged and slivered with EPS prior to panzer corner mesh application; typical

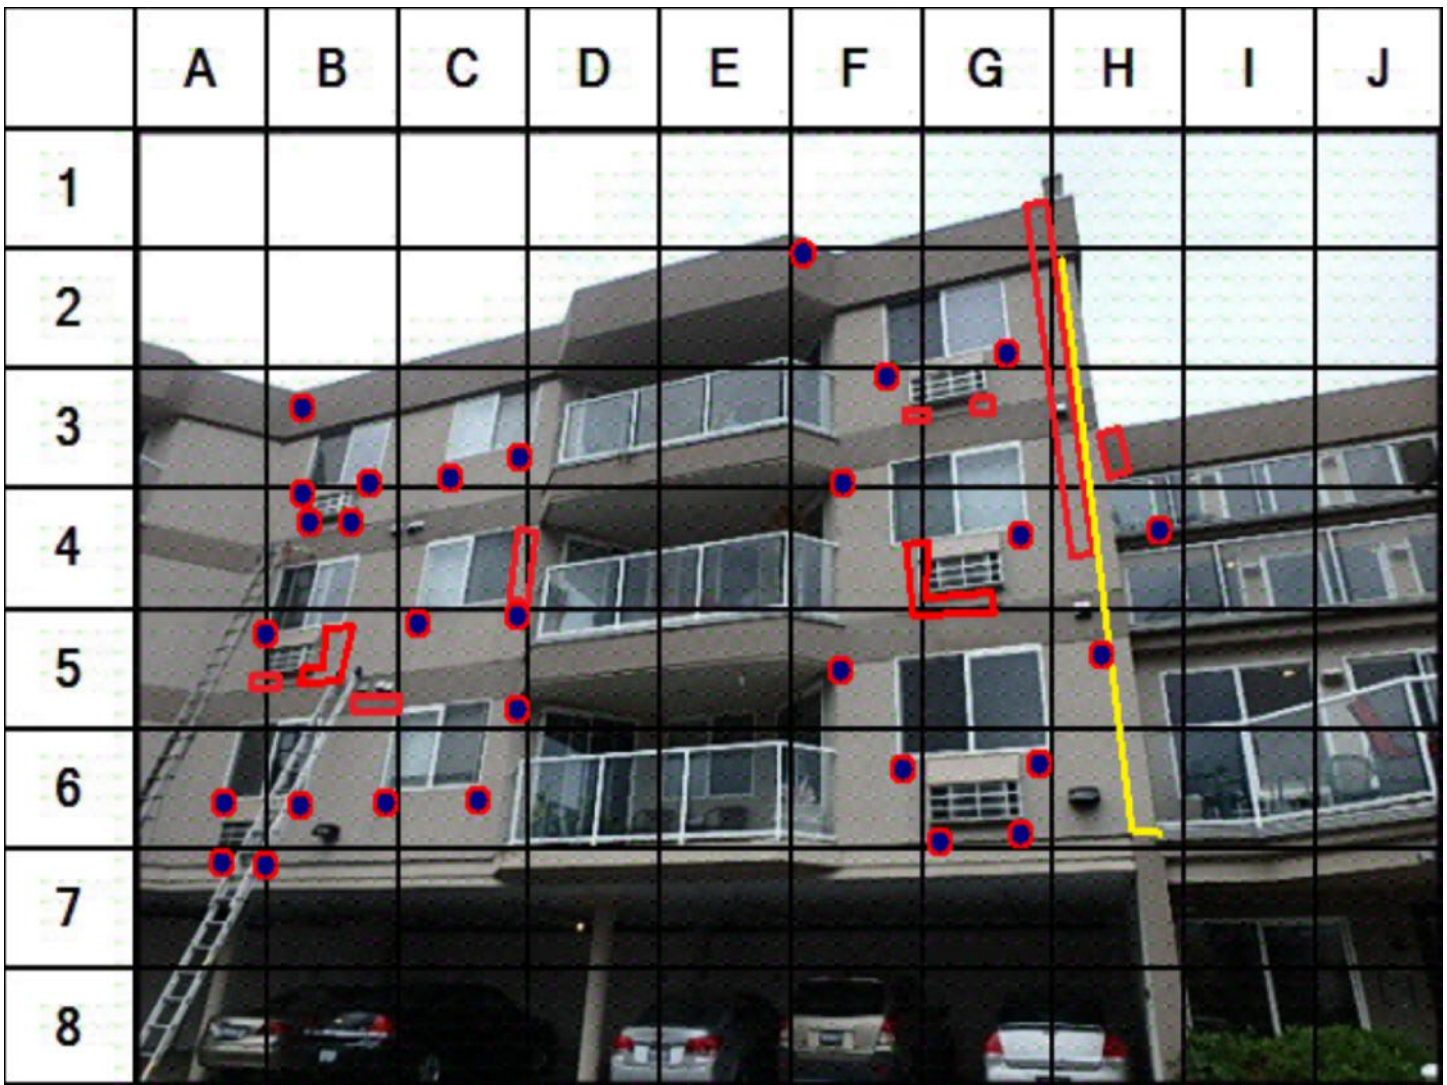
# Front Center Elevation

Grid Location	Item Description	Moisture Readings	Substrate Condition	Observations
B3-F2	Roof cap flashings	8% - 12%	Firm	Roof cap flashings probed within low moisture range.
B4-H4	Windows	7% - 15%	Firm	Windows probed with low moisture range.
B4-G6	PTAC	8% - 11%	Firm	PTACs probed with low moisture range.
F3-F5	Deck terminations	8% - 9%	Firm	Deck terminations probed with low moisture range.
A5-B5	Soft substrate	12%	Soft	Approximate area of soft substrate needs to be removed and replaced.
B5	Soft substrate	14%	Soft	Approximate area of soft substrate needs to be removed and replaced.
B5	Soft substrate	16%	Soft	Approximate area of soft substrate needs to be removed and replaced.
C4-D4	Soft substrate	15%	Soft	Approximate area of soft substrate needs to be removed and replaced.
F3	Soft substrate	14%	Soft	Approximate area of soft substrate needs to be removed and replaced.
G3	Soft substrate	15%	Soft	Approximate area of soft substrate needs to be removed and replaced.

F4-G4	Soft substrate	16%	Soft	Approximate area of soft substrate needs to be removed and replaced.
G1-G4	Soft substrate	13%	Soft	Approximate area of soft substrate needs to be removed and replaced.
H3	Soft substrate	14%	Soft	Approximate area of soft substrate needs to be removed and replaced.

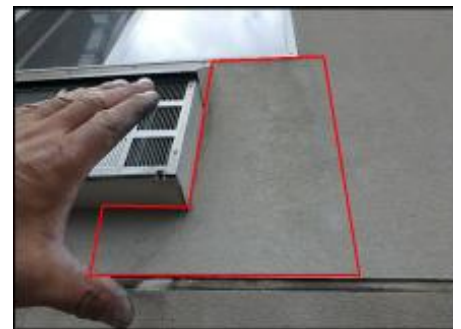
Approximate area of soft substrate needs to be removed and replaced (B5)

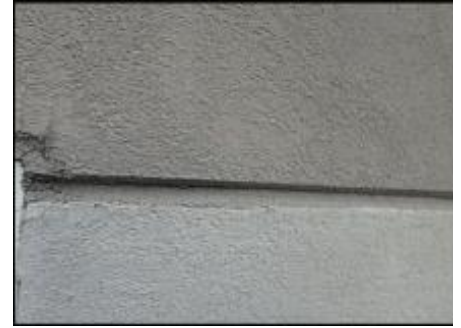
7/8" Sprint board application does not allow for minimum 3/4" foam at base of v-groove; hairline cracks observed; detail needs bond breaker tape and silicone sealant joint application; typical

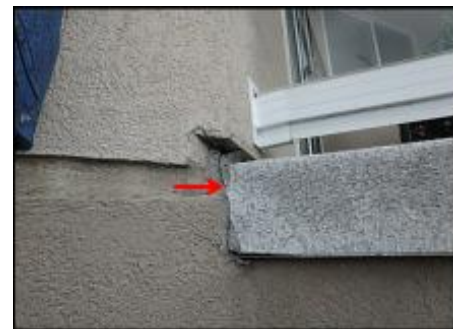
Deck termination needs end dam flashing installation; typical

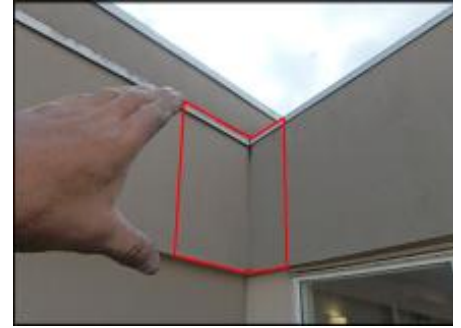
Approximate area of soft substrate needs to be removed and replaced (H3)

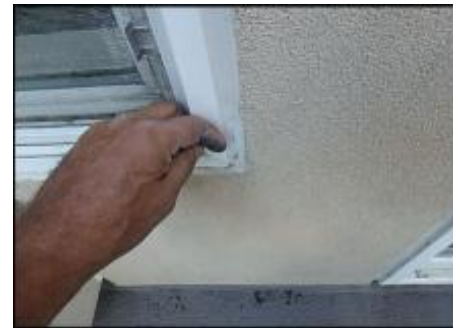
Sealant joint failure at window jamb needs to be removed and replaced (H3)

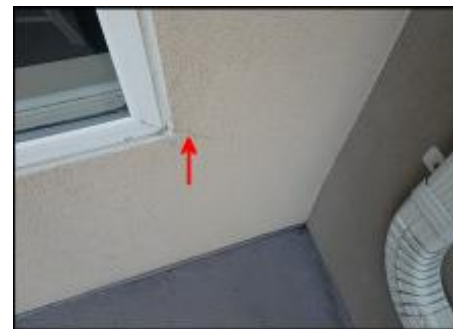
Crack needs to be gouged and slivered with EPS prior to base coat, mesh and finish coat application; typical

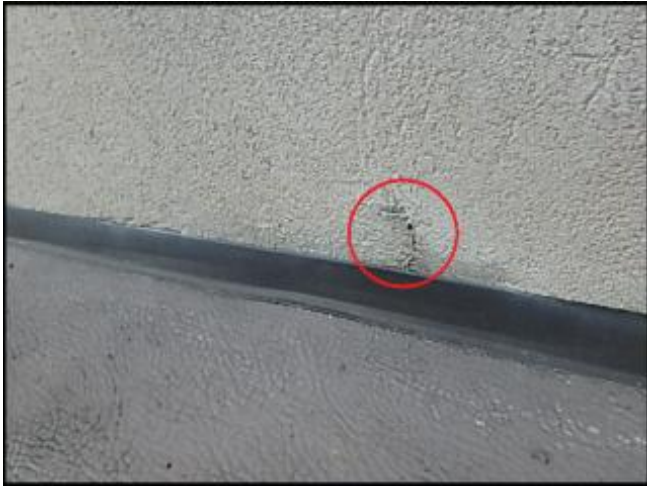
Area of impact damage will be remediated with base coat, mesh and finish coat application over entire system; typical

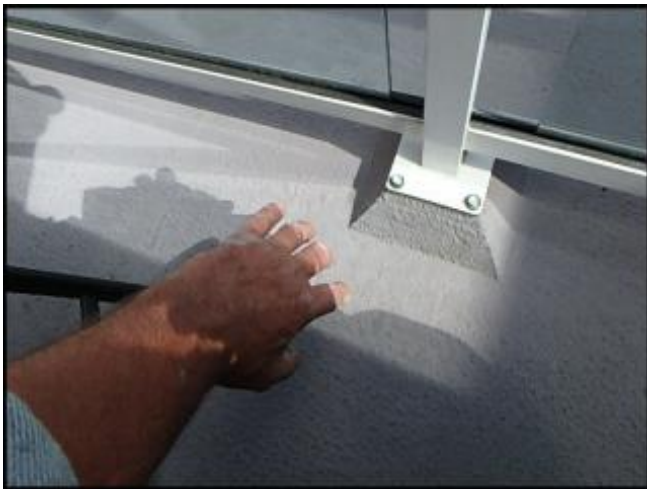
Recommend replacement of deck coat due to blistering observed (H4-J4)

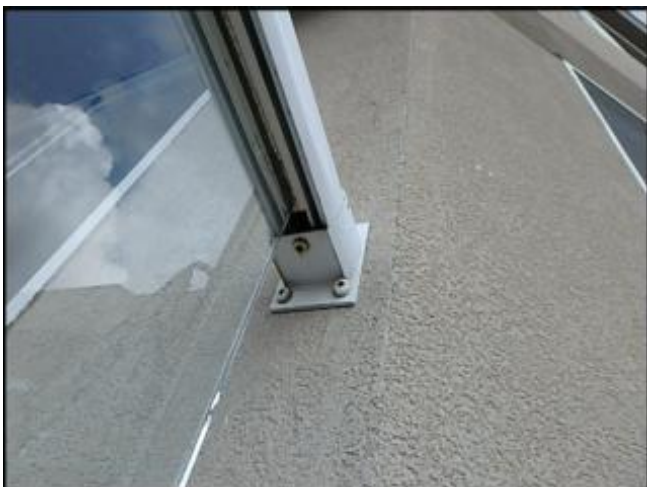
Railing fasteners need to be sealed; typical

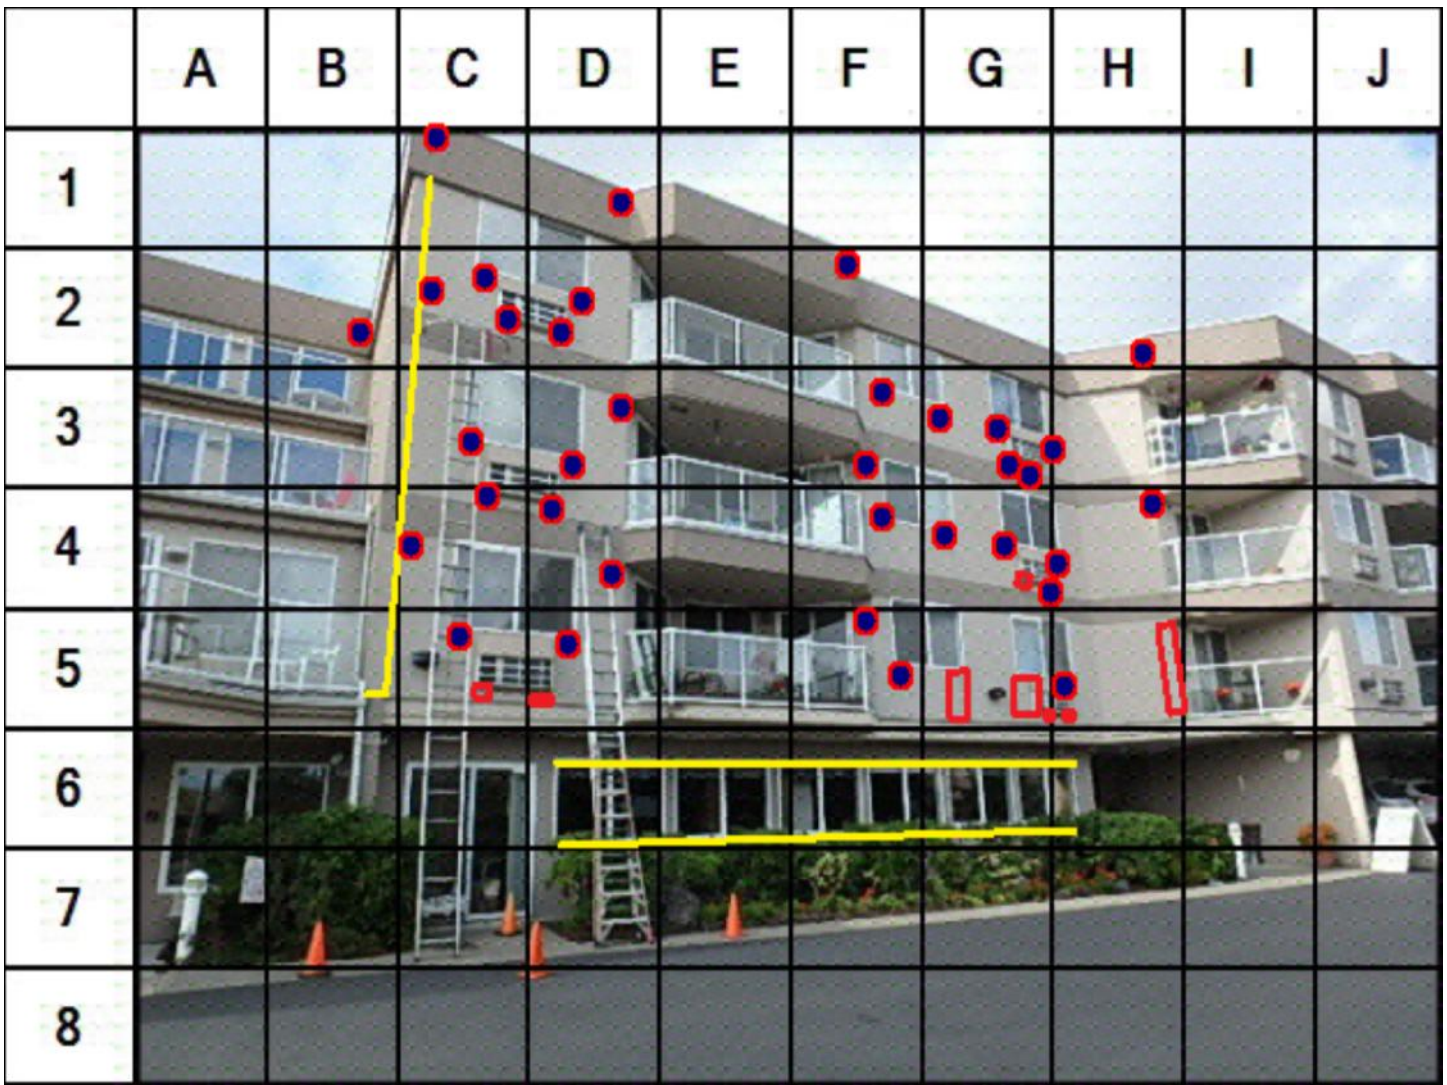
Grid Location	Item Description	Moisture Readings	Substrate Condition	Observations
B2-H2	Roof cap flashings	11% - 14%	Firm	Roof cap flashings probed within low moisture range.
C2-C4	Field readings	9% - 11%	Firm	Field readings probed within low moisture range.
C2-H5	Windows	8% - 14%	Firm	Windows probed within low moisture range.
C2-G4	PTAC	7% - 12%	Firm	PTAC's probed within low moisture range.
D3-H4	Deck terminations	12% - 15%	Firm	Deck terminations probed within low moisture range.
C5	Soft substrate	15%	Soft	Approximate area of soft substrate needs to be removed and replaced.
D5	Soft substrate	13%	Soft	Approximate area of soft substrate needs to be removed and replaced.
G5	Soft substrate	16%	Soft	Approximate area of soft substrate needs to be removed and replaced.
G5	Soft substrate	15%	Soft	Approximate area of soft substrate needs to be removed and replaced.
H5	Soft substrate	14%	Soft	Approximate area of soft substrate needs to be removed and replaced.

H5	Soft substrate	17%	Soft	Approximate area of soft substrate needs to be removed and replaced.

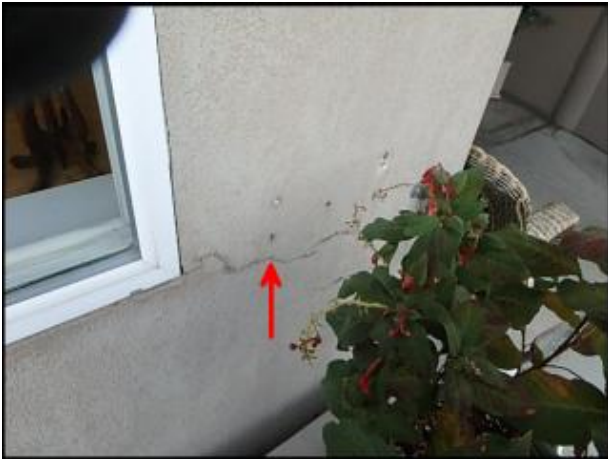
Area of compression damage needs expansion joint installation (H7)

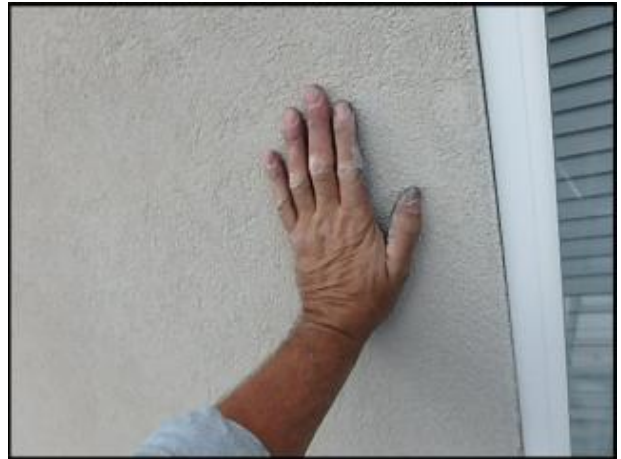
Area of insufficiently attached EIFS needs fasteners installed prior to base coat, mesh and finish coat application; typical

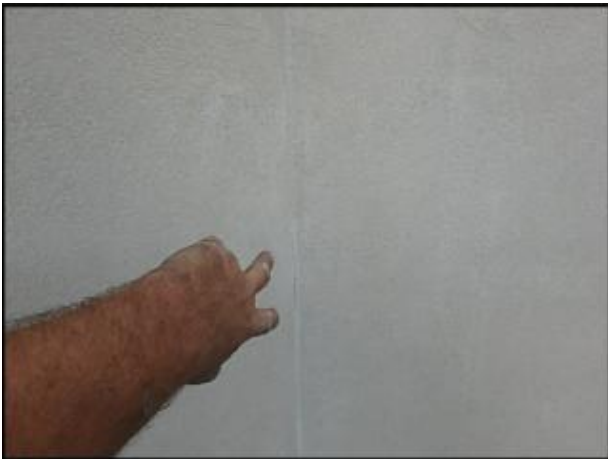
Cracks need to be gouged and slivered with EPS prior to base coat, mesh and finish coat application; typical

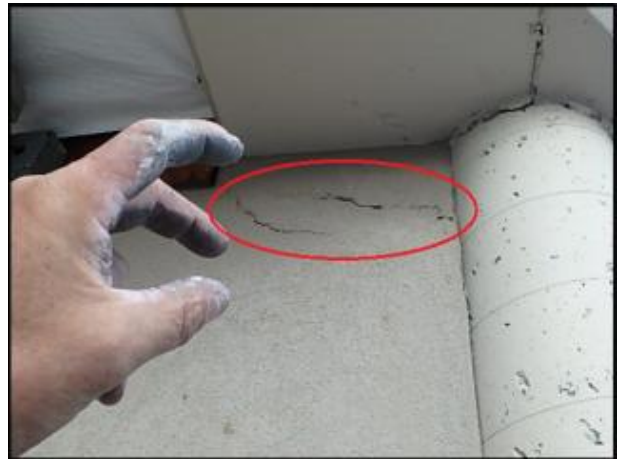
Compression damage needs to be gouged and slivered with EPS prior to base coat, mesh and finish coat application (J6)

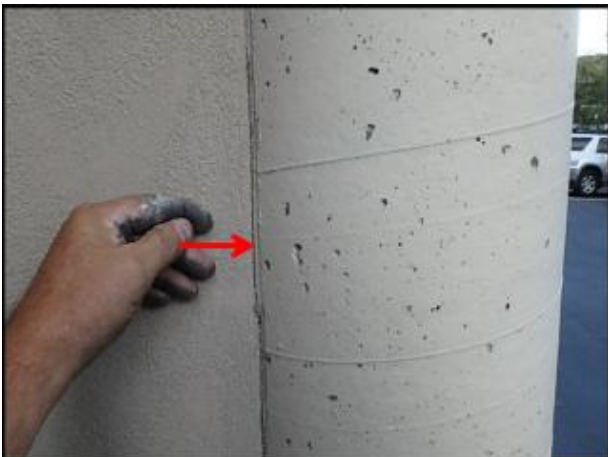
7/8" EIFS needs to be removed at column prior to base coat and mesh application to accommodate 3/4" silicone sealant joint application (J6-J7)

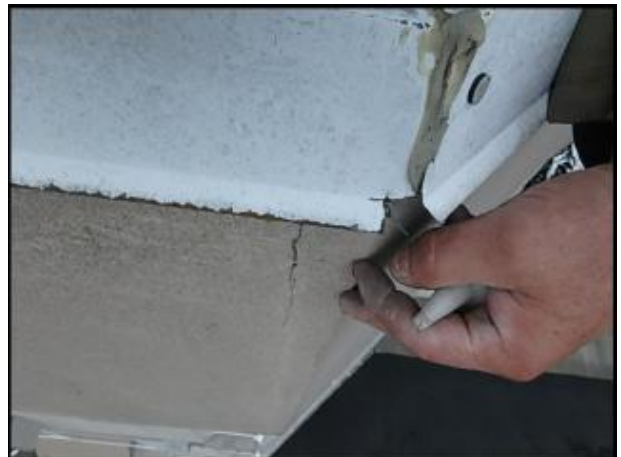
Larger crack at fascia needs to be gouged and slivered with EPS prior to panzer mesh corner installation due to lack of backing at framing members; typical

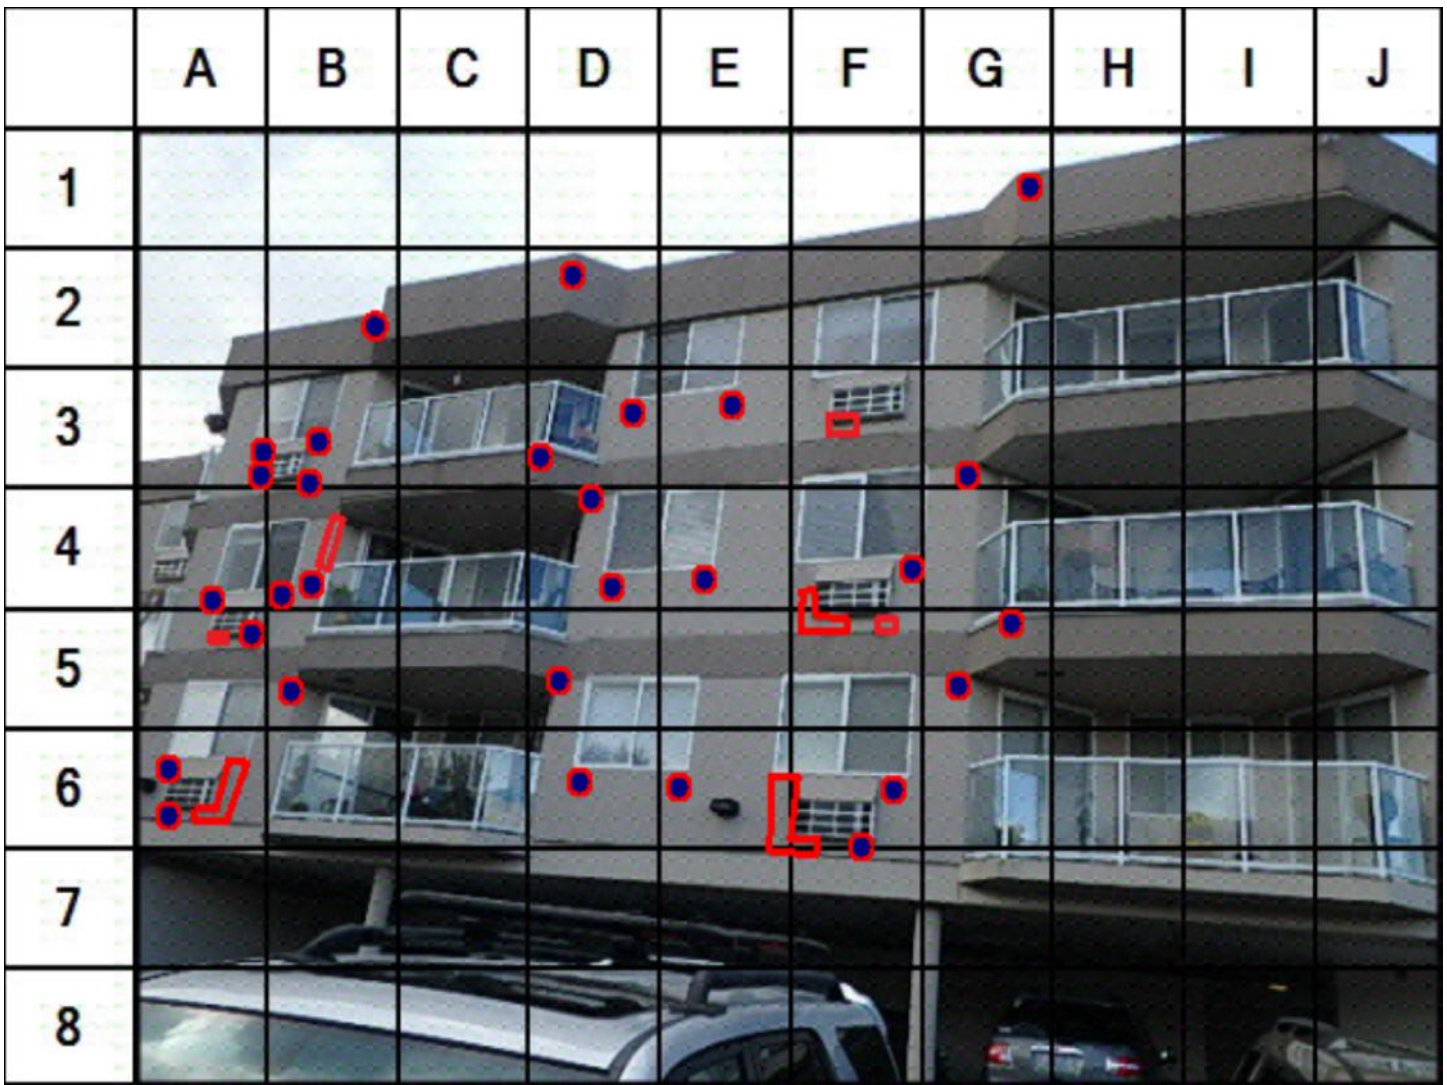
# Front Right Elevation

Grid Location	Item Description	Moisture Readings	Substrate Condition	Observations
B2-G1	Roof cap flashings	7% - 10%	Firm	Roof cap flashings probed within low moisture range.
A3-F6	Windows	9% - 12%	Firm	Windows probed within low moisture range.
A3-F7	PTAC	8% - 11%	Firm	PTACs probed within low moisture range.
B4	Field reading	16%	Firm	Field reading probed within medium moisture range.
B5-G5	Deck terminations	11% - 14%	Firm	Deck terminations probed within low moisture range.
A5	Soft substrate	15%	Soft	Approximate area of soft substrate needs to be removed and replaced.
A6	Soft substrate	15%	Soft	Approximate area of soft substrate needs to be removed and replaced.
B4	Soft substrate	16%	Soft	Approximate area of soft substrate needs to be removed and replaced.
F3	Soft substrate	13%	Soft	Approximate area of soft substrate needs to be removed and replaced.
F4-F5	Soft substrate	15%	Soft	Approximate area of soft substrate needs to be removed and replaced.

F5	Soft substrate	14%	Soft	Approximate area of soft substrate needs to be removed and replaced.
E6-F7	Soft substrate	16%	Soft	Approximate area of soft substrate needs to be removed and replaced.

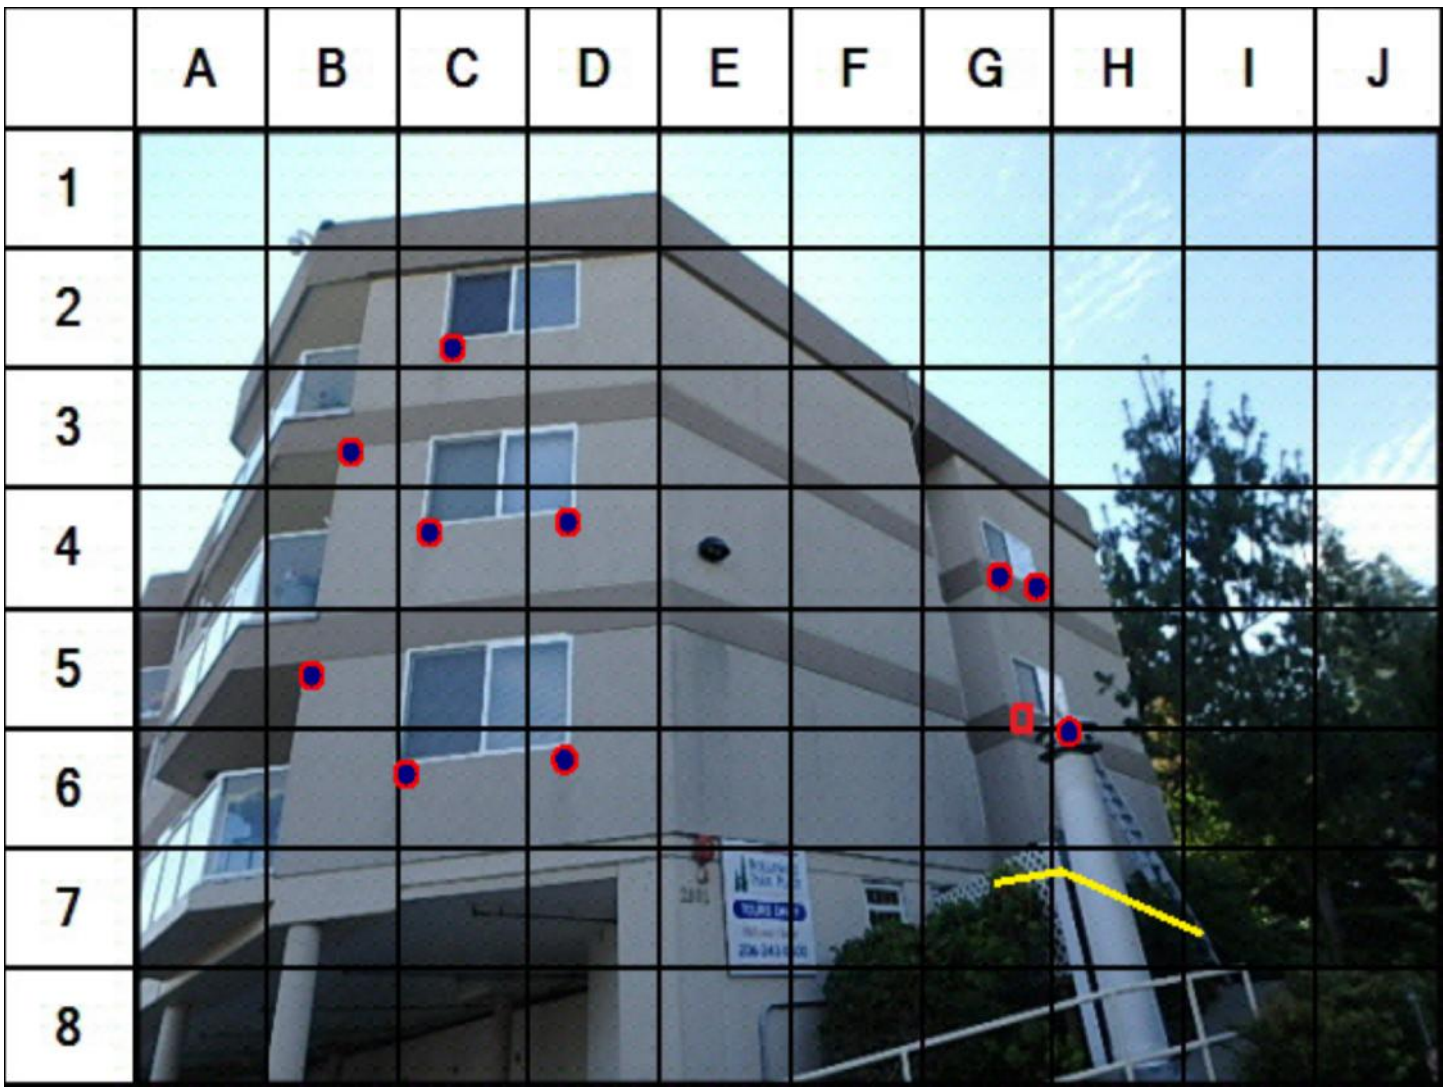
# Right Elevation

Grid Location	Item Description	Moisture Readings	Substrate Condition	Observations
B3-B5	Deck terminations	9% - 10%	Firm	Deck terminations probed within low moisture range.
C2-H6	Windows	7% - 12%	Firm	Windows probed within low moisture range.
G5-G6	Soft substrate	12%	Soft	Approximate area of soft substrate needs to be removed and replaced.

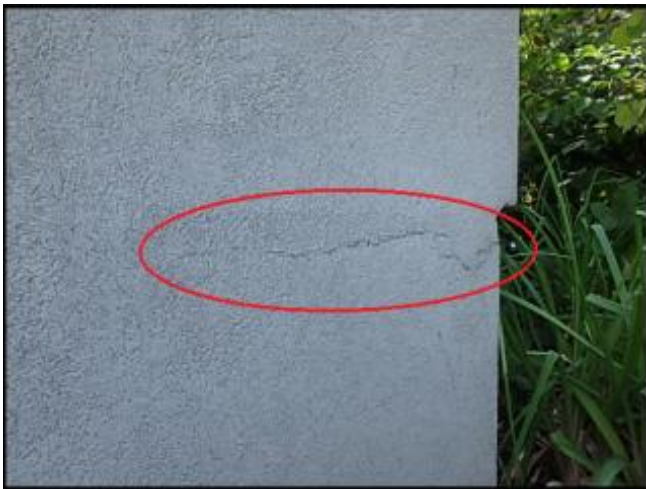
Compression observed at floor line at wood substrate to concrete substrate (I7)

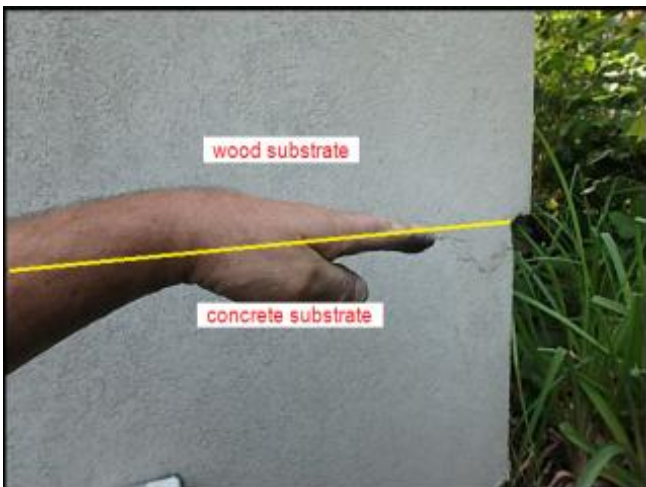
Wood substrate to concrete substrate needs expansion joint installation (G7-I7)

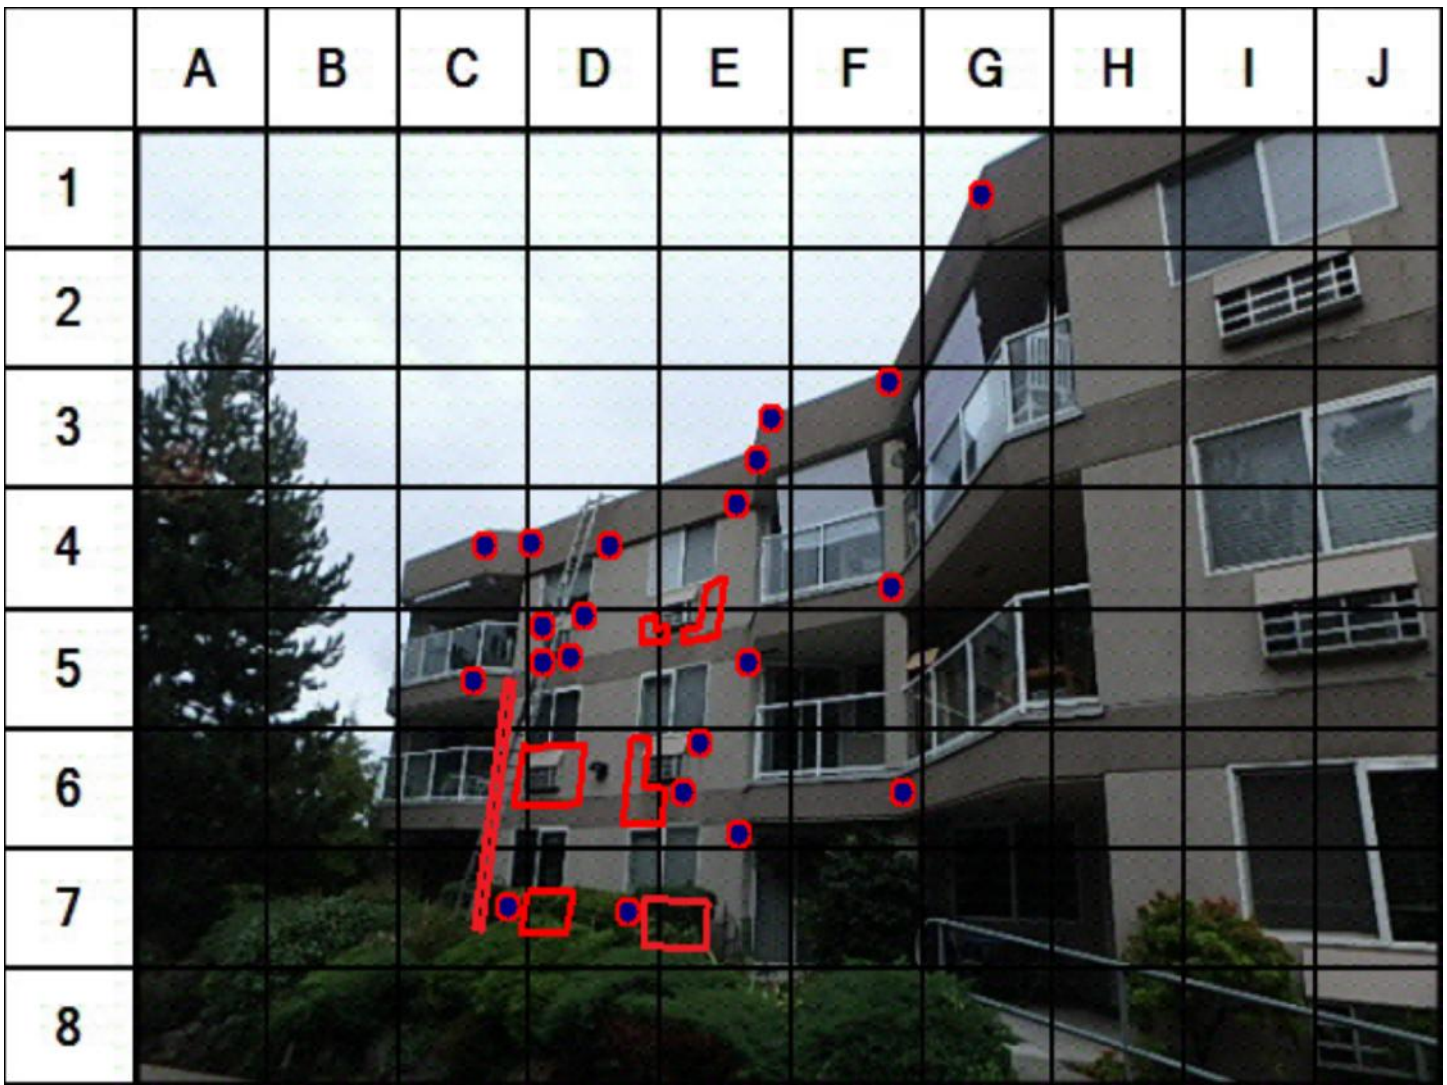
# Rear Left Elevation

Grid Location	Item Description	Moisture Readings	Substrate Condition	Observations
C4-G1	Roof cap flashings	9% - 12%	Firm	Roof cap flashings probed within low moisture range.
C5	Deck attachment	12%	Firm	Deck attachment probed within low moisture range.
D5-E6	Windows	8% - 11%	Firm	Windows probed within low moisture range.
D5-E6	PTAC	13% -16%	Firm	PTACs probed within low to medium moisture range.
C5-C7	Soft substrate	15%	Soft	Approximate area of soft substrate needs to be removed and replaced.
C6-D6	Soft substrate	21%	Soft	Approximate area of soft substrate needs to be removed and replaced.
C7-D7	Soft substrate	14%	Soft	Approximate area of soft substrate needs to be removed and replaced.
D4-E4	Base of system	10% - 8%	Firm	Base of system probed within low moisture range.
D5-E5	Soft substrate	16%	Soft	Approximate area of soft substrate needs to be removed and replaced.
D6	Soft substrate	16%	Soft	Approximate area of soft substrate needs to be removed and replaced.

D7-E7	Soft substrate	15%	Soft	Approximate area of soft substrate needs to be removed and replaced.
E4-E5	Soft substrate	15%	Soft	Approximate area of soft substrate needs to be removed and replaced.
E5-F6	Deck terminations	9%, 11%	Firm	Deck terminations probed within low moisture range.

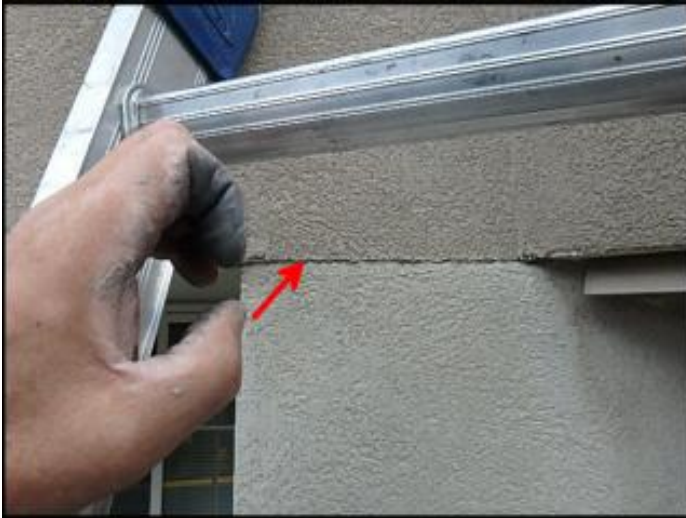
Crack needs to be gouged and slivered with EPS prior to base coat, mesh and finish coat application; typical

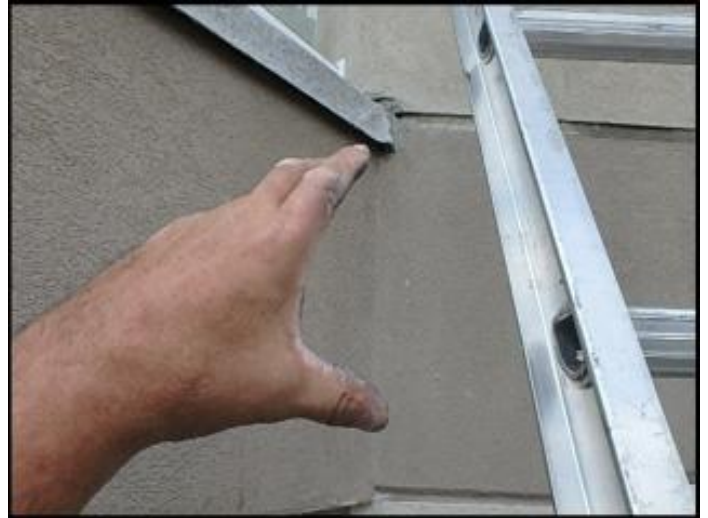
Inconclusive probing results below deck due to OSB substrate cut out to accommodate steel bracket installation; recommend random intrusive evaluation upon system remediation to determine framing condition; typical

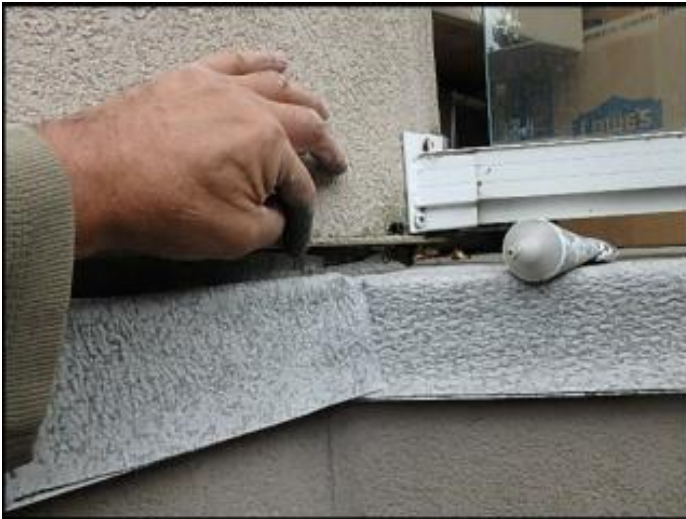
Recommend replacement of deck membrane due to installation defects and failure observed; typical

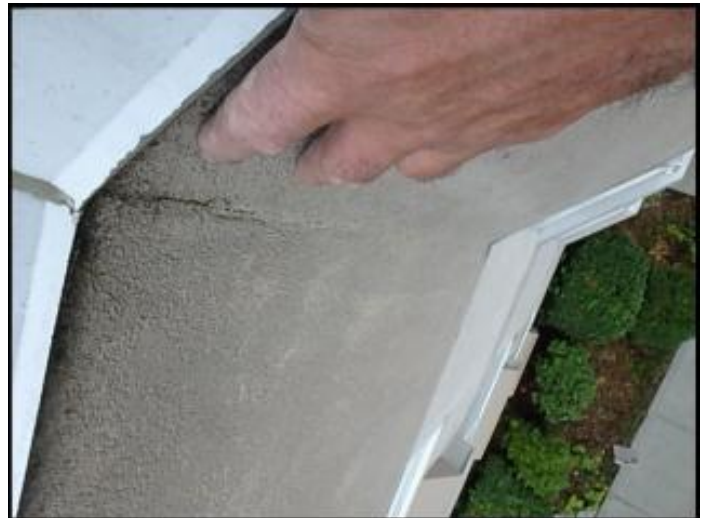
Larger crack at fascia needs to be gouged and slivered with EPS prior to panzer mesh corner installation due to lack of backing at framing members; typical

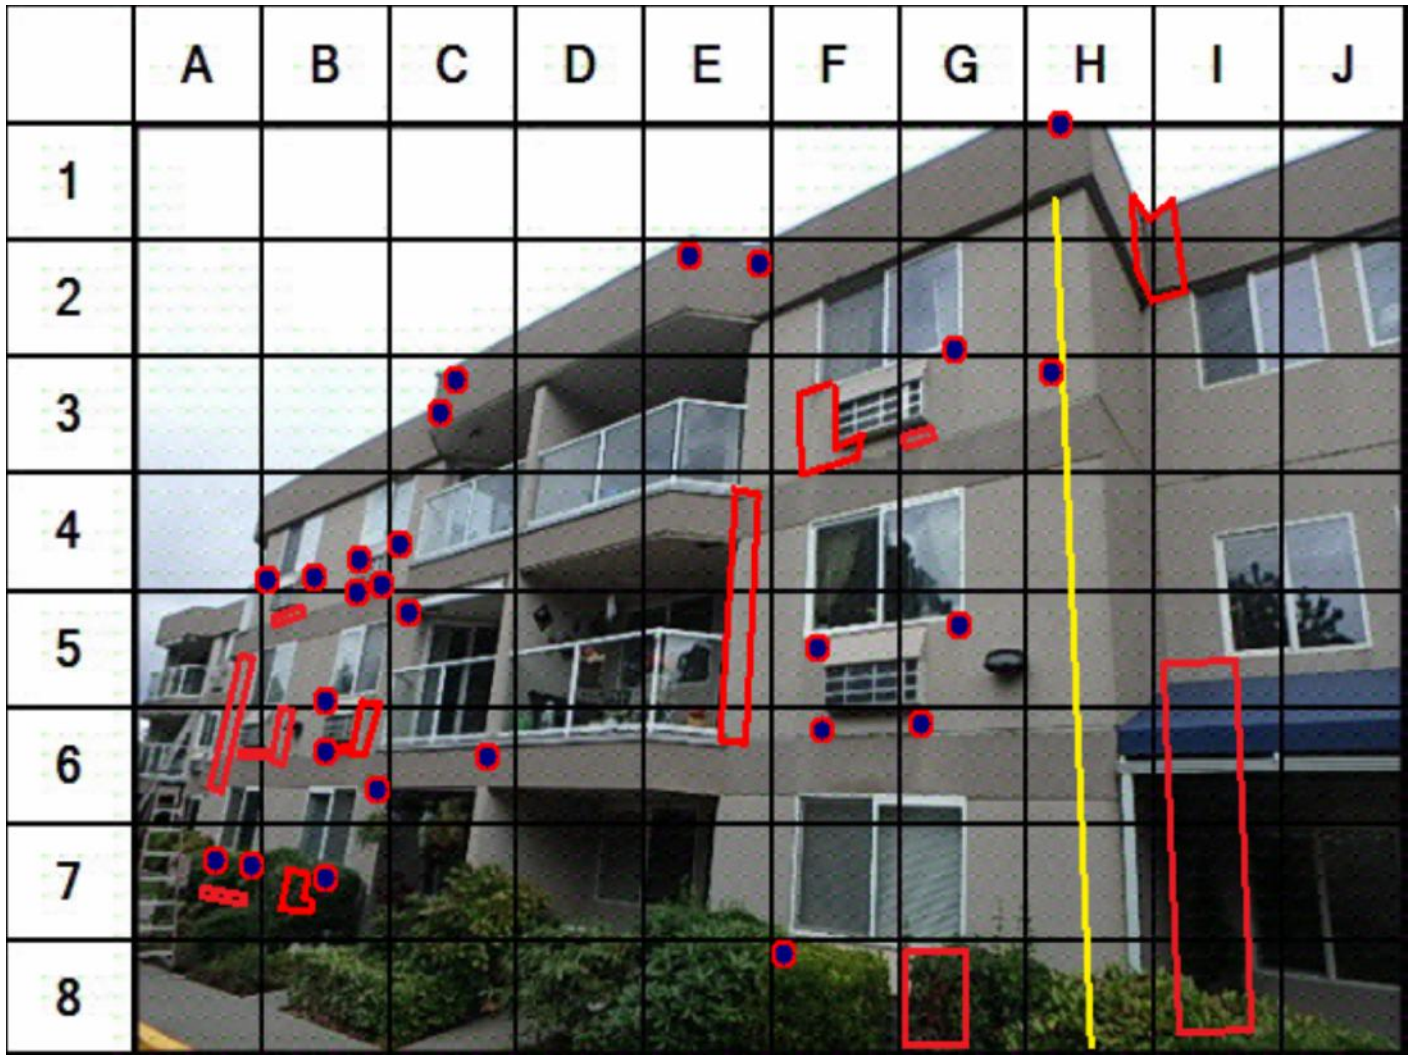
Grid Location	Item Description	Moisture Readings	Substrate Condition	Observations
A5-A6	Soft substrate	17%	Soft	Approximate area of soft substrate needs to be removed and replaced.
A6-B6	Soft substrate	16%	Soft	Approximate area of soft substrate needs to be removed and replaced.
A7	Soft substrate	15%	Soft	Approximate area of soft substrate needs to be removed and replaced.
B4-G5	Windows	9% - 12%	Firm	Windows probed within low moisture range.
B5	Soft substrate	14%	Soft	Approximate area of soft substrate needs to be removed and replaced.
B5-G6	PTAC	12% - 14%	Firm	PTACs probed within low moisture range.
B6	Soft substrate	16%	Soft	Approximate area of soft substrate needs to be removed and replaced.
B5-B6	Soft substrate	16%	Soft	Approximate area of soft substrate needs to be removed and replaced.
B6	Soft substrate	15%	Soft	Approximate area of soft substrate needs to be removed and replaced.
B7	Soft substrate	15%	Soft	Approximate area of soft substrate needs to be removed and replaced.

C3-H1	Roof cap flashings	12% - 14%	Firm	Roof cap flashings probed within low moisture range.
C3	Base of system	12%	Firm	Base of system probed within low moisture range.
C5-C6	Deck terminations	11% - 14%	Firm	Deck terminations probed within low moisture range.
E4-E6	Soft substrate	17%	Soft	Approximate area of soft substrate needs to be removed and replaced.
F3	Soft substrate	16%	Soft	Approximate area of soft substrate needs to be removed and replaced.
G3	Soft substrate	14%	Soft	Approximate area of soft substrate needs to be removed and replaced.
G8	Soft substrate	16%	Soft	Approximate area of soft substrate needs to be removed and replaced.
H1-I2	Soft substrate	15%	Soft	Approximate area of soft substrate needs to be removed and replaced.
I5-I8	Soft substrate	15%	Soft	Approximate area of soft substrate needs to be removed and replaced.

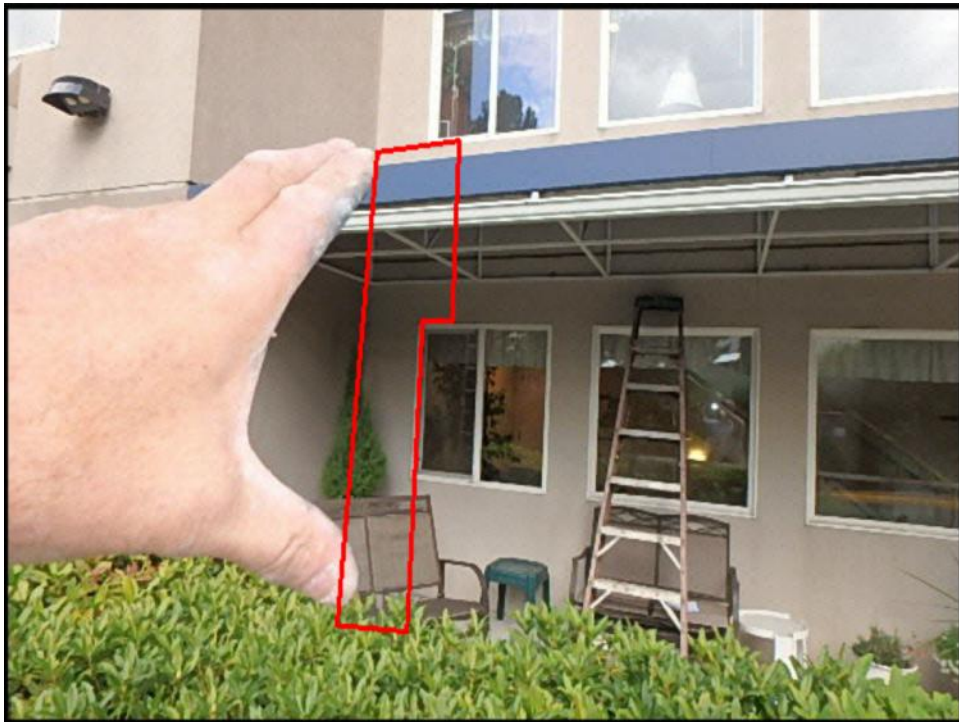
Approximate area of soft substrate needs to be removed and replaced (I5-I8)
