# Moisture Survey Inspection

January 1, 2019

123 Pleasant Lane  
Pleasantville, WA 98000

Sound Exterior Inspections, LLC performed a moisture survey inspection on January 1, 2019 of the EIFS Sprint Barrier System installed on the building located at 123 Pleasantville Lane, Pleasantville, Washington at the request of John Doe, LLC.

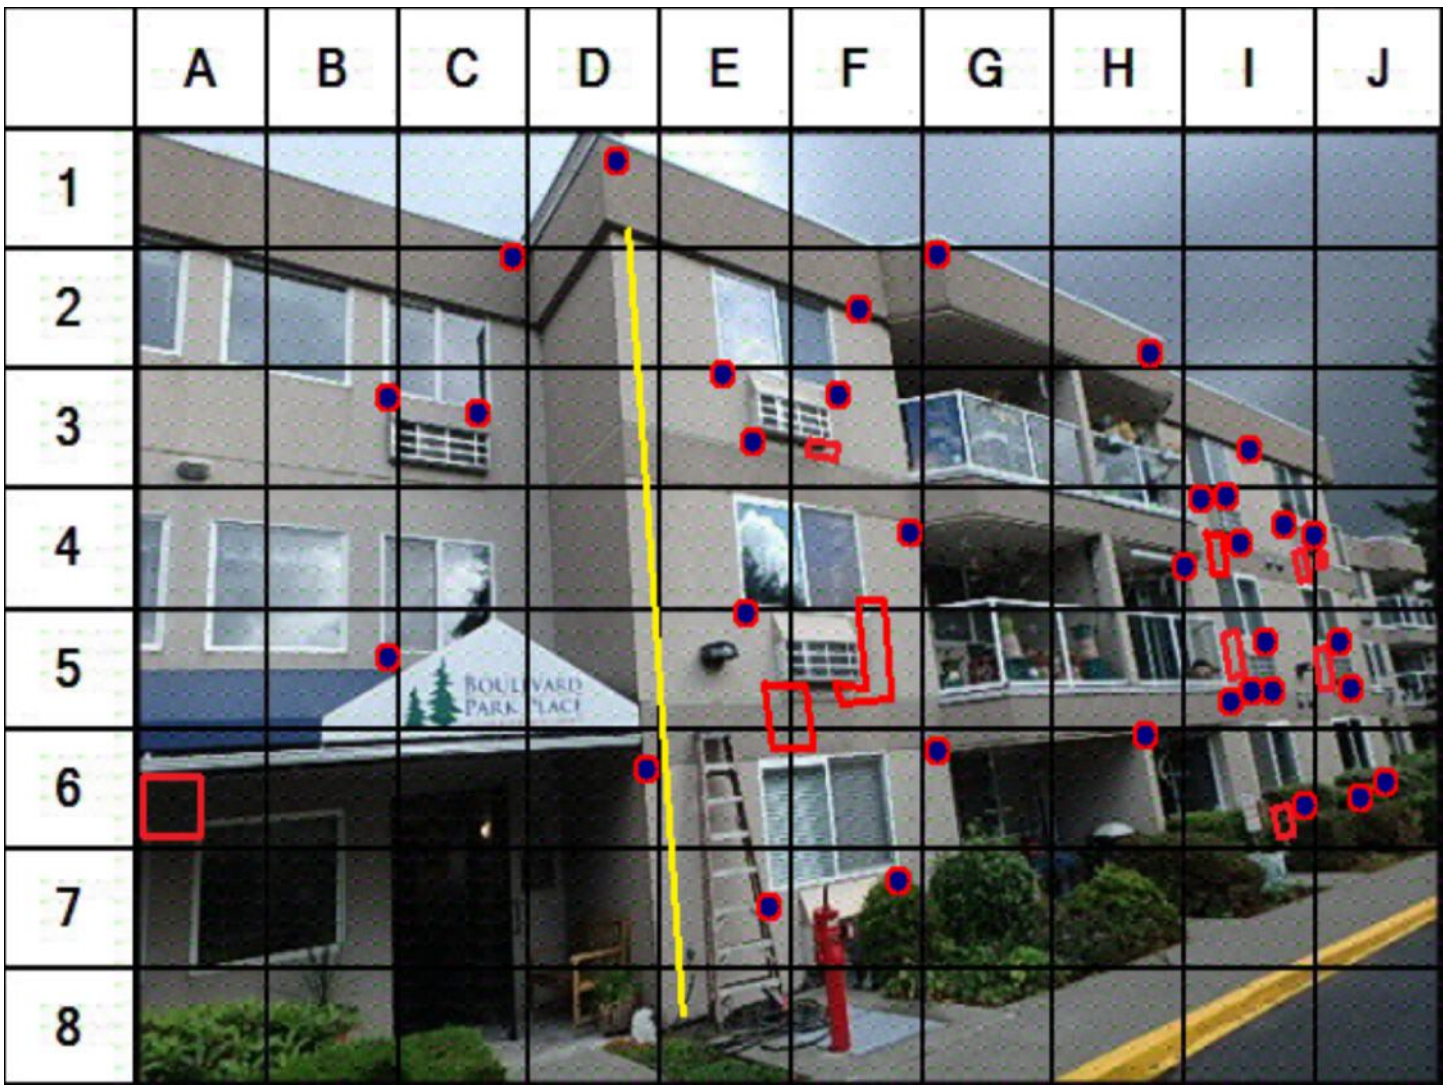
Grid Location	Item Description	Moisture Readings	Substrate Condition	Observations
A6	Soft substrate	13%	Soft	Approximate area of soft substrate needs to be removed and replaced.
B3-J6	Windows	11% - 15%	Firm	Windows probed within low moisture range.
C2-H2	Roof cap flashings	8% - 11%	Firm	Roof cap flashings probed within low moisture range.
D6	Awning termination	9%	Firm	Awning termination probed within low moisture range.
E3-J6	PTAC	8% - 11%	Firm	PTACs probed within low moisture range.
E5-G6	Soft substrate	15%	Soft	Approximate area of soft substrate needs to be removed and replaced.
F2	Base of system	12%	Firm	Base of system probed within low moisture range.
F3	Soft substrate	15%	Soft	Approximate area of soft substrate needs to be removed and replaced.
F4-F5	Soft substrate	14%	Soft	Approximate area of soft substrate needs to be removed and replaced.
F4-I5	Deck terminations	10% - 14%	Firm	Deck terminations probed within low moisture range.

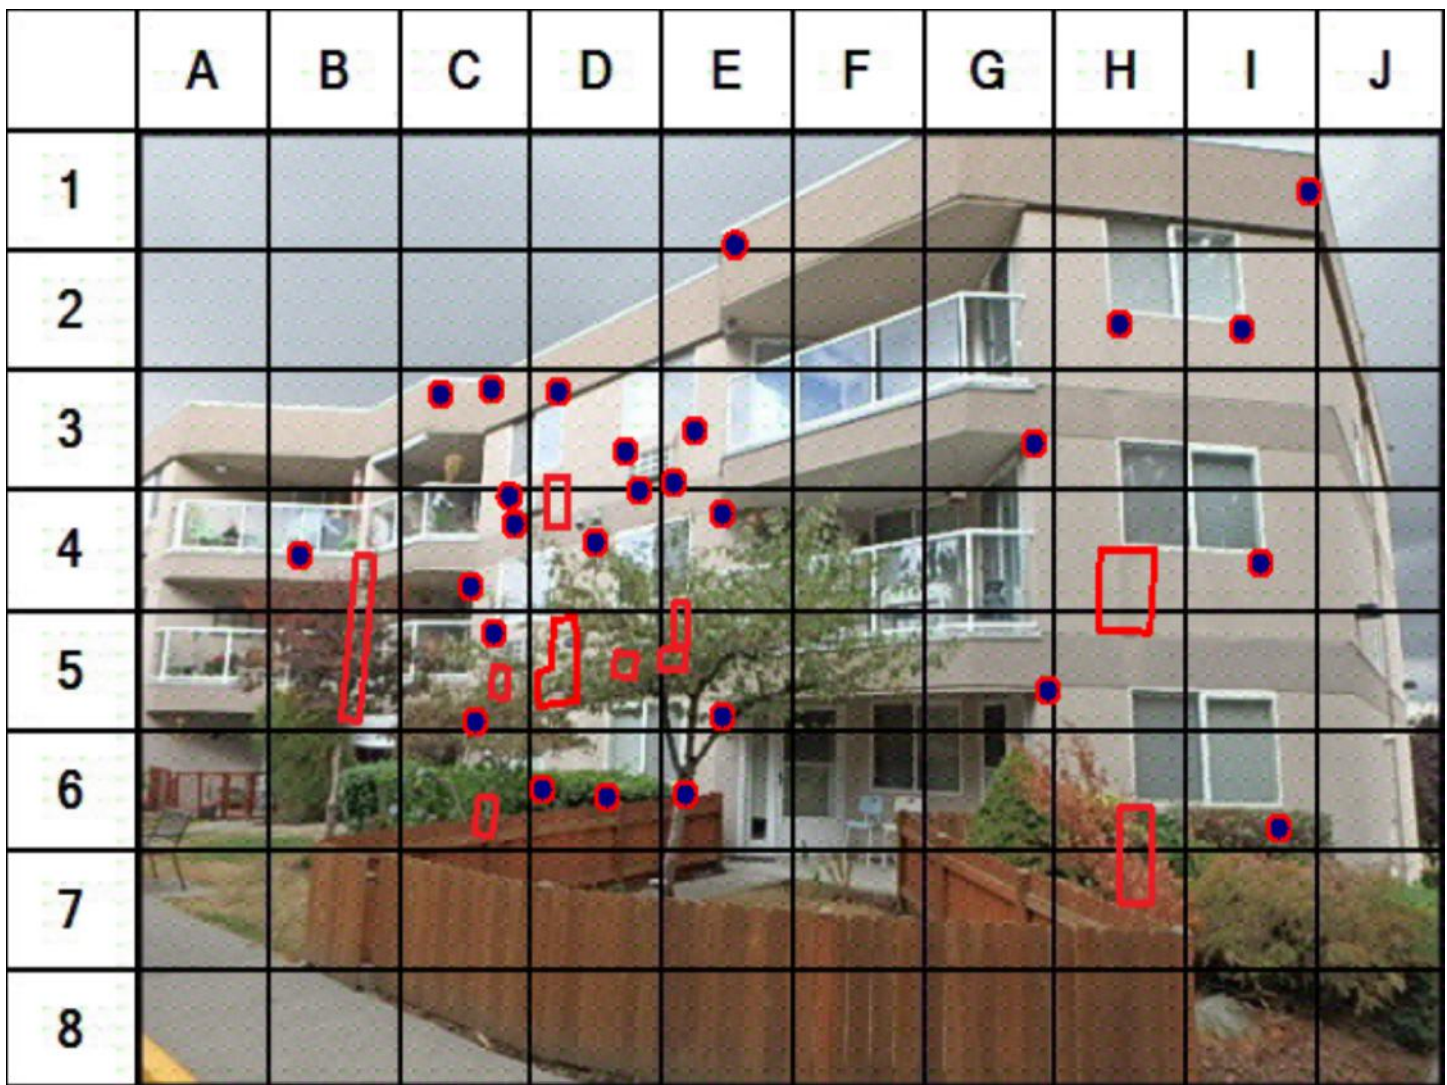
Grid Location	Item Description	Moisture Readings	Substrate Condition	Observations
B4	Railing attachment	8%	Firm	Railing attachment probed within low moisture range.
B4-B5	Soft substrate	16%	Soft	Approximate area of soft substrate needs to be removed and replaced.
C3-E1	Roof cap flashings	10% - 12%	Firm	Roof cap flashings probed within low moisture range.
C4-I6	Windows	10% - 15%	Firm	Windows probed within low moisture range.
C4-E3	PTAC	12% - 16%	Firm	PTACs probed within low moisture range.
C4-G5	Deck terminations	8% - 12%	Firm	Deck terminations probed within low moisture range.
C5	Soft substrate	14%	Soft	Approximate area of soft substrate needs to be removed and replaced.
C6	Soft substrate	15%	Soft	Approximate area of soft substrate needs to be removed and replaced.
D3	Base of system	11%	Firm	Base of system probed within low moisture range.
D3-D4	Soft substrate	15%	Soft	Approximate area of soft substrate needs to be removed and replaced.

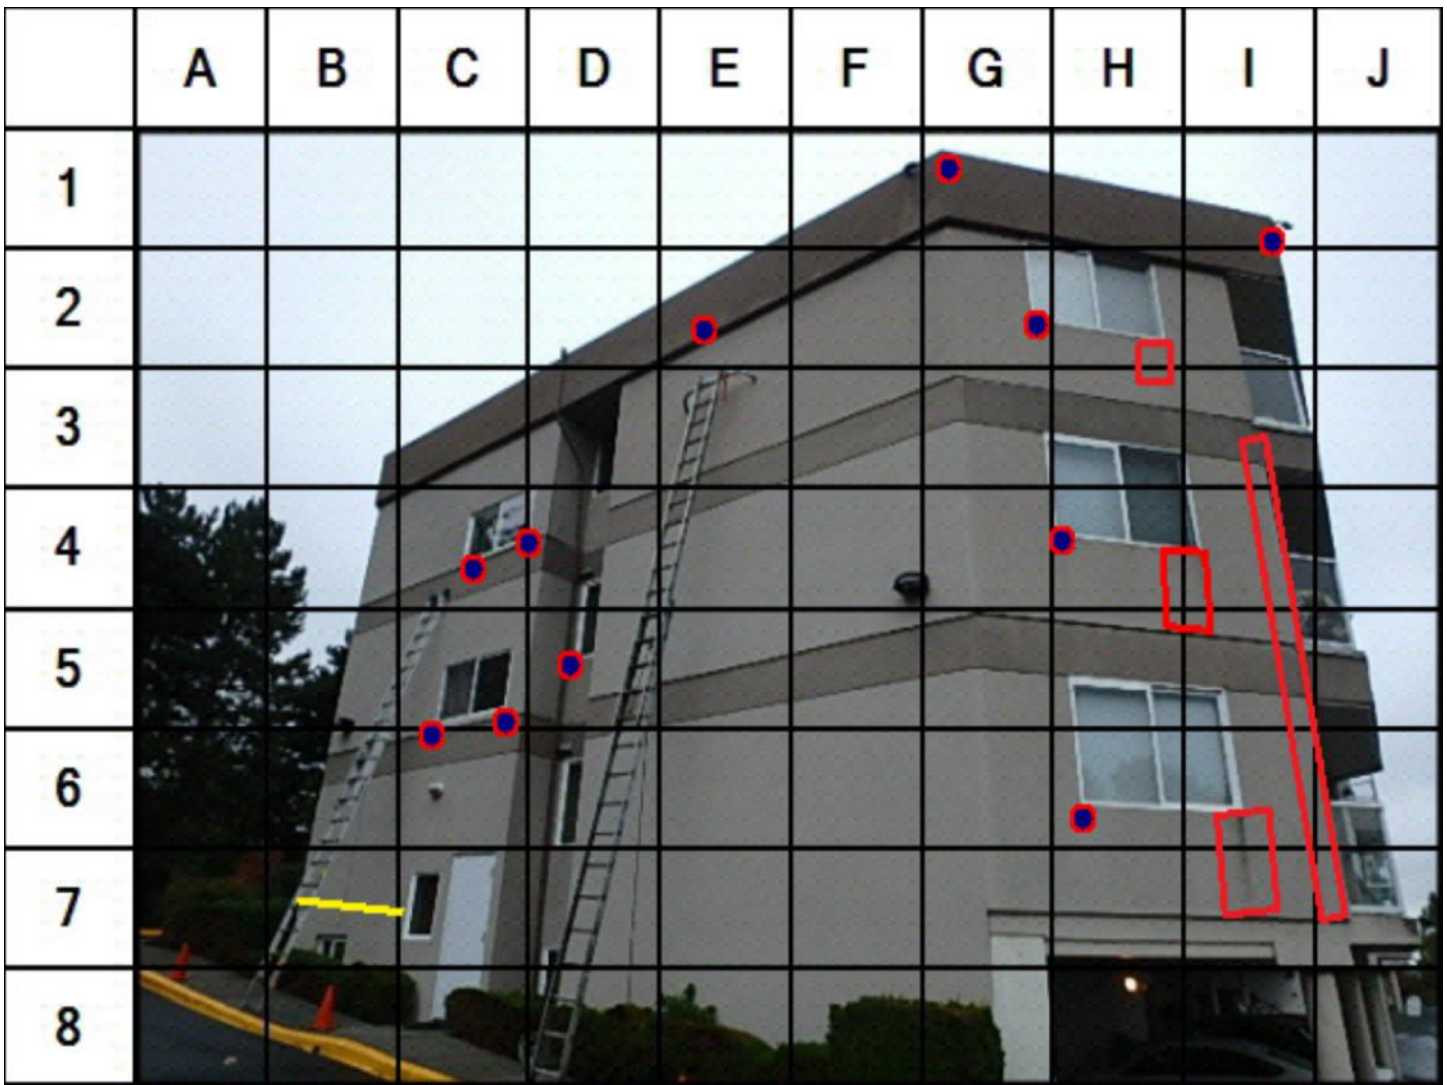
Grid Location	Item Description	Moisture Readings	Substrate Condition	Observations
C4-H6	Windows	8% - 14%	Firm	Windows probed within low moisture range.
E2	Base of system	9%	Firm	Base of system probed within low moisture range.
G1-I1	Roof cap flashings	9% - 9%	Firm	Roof cap flashings probed within low moisture range.
H2-H3	Soft substrate	15%	Soft	Approximate area of soft substrate needs to be removed and replaced.
H4-I5	Soft substrate	14%	Soft	Approximate area of soft substrate needs to be removed and replaced.
I6-I7	Soft substrate	17%	Soft	Approximate area of soft substrate needs to be removed and replaced.
I3-J7	Soft substrate	17%	Soft	Approximate area of soft substrate needs to be removed and replaced.

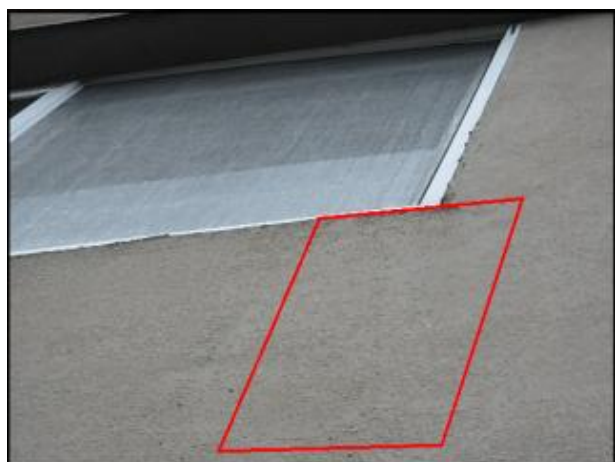
Approximate area of soft substrate needs to be removed and replaced (H2)

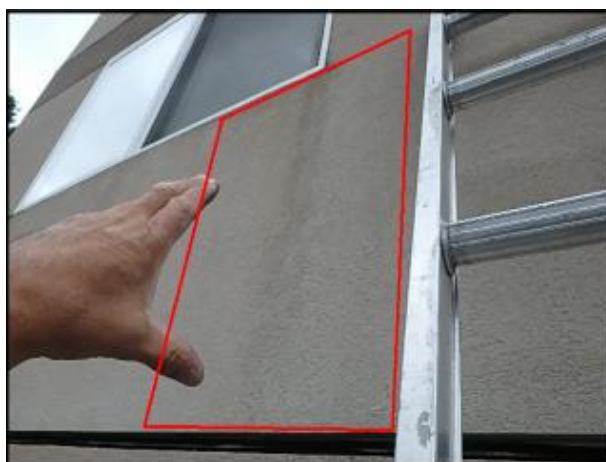
Approximate area of soft substrate needs to be removed and replaced (H4-15)

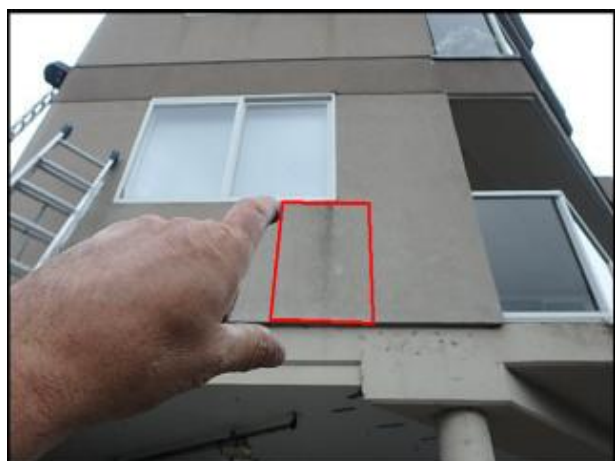
Approximate area of soft substrate needs to be removed and replaced (I6-17)

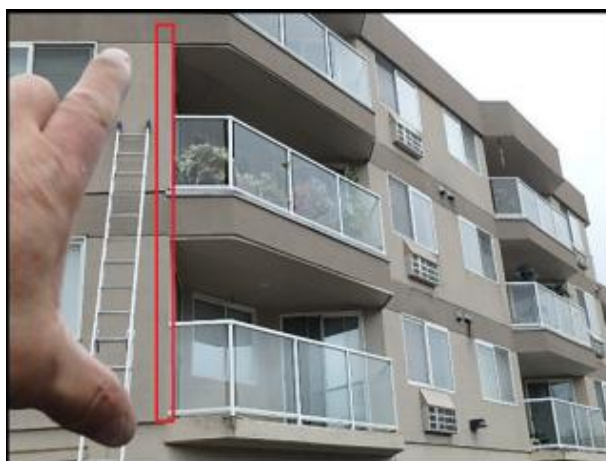
Approximate area of soft substrate needs to be removed and replaced (I3-J7)

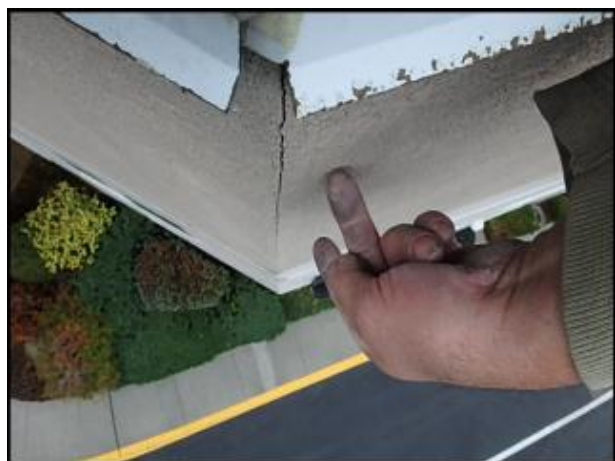
Larger crack at fascia needs to be gouged and slivered with EPS prior to panzer mesh corner installation due to lack of backing at framing members; typical
