Moisture Survey Inspection Report

January 1, 2017

123 Pleasant Lane
Pleasantville, Washington, 98999

Moisture Inspection Summary

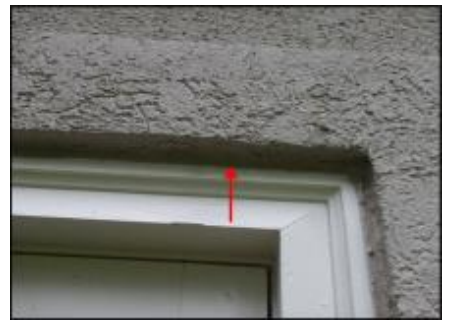
No drip flashing installed at window head; sealant joint installed; no remediation necessary; typical

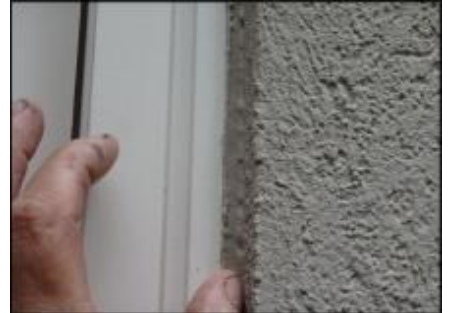
Sealant joint in good condition at window perimeter; typical

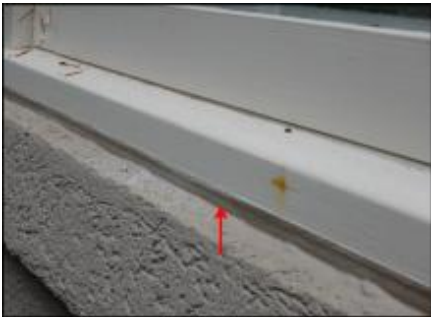
Sealant joint in good condition at window perimeter; typical

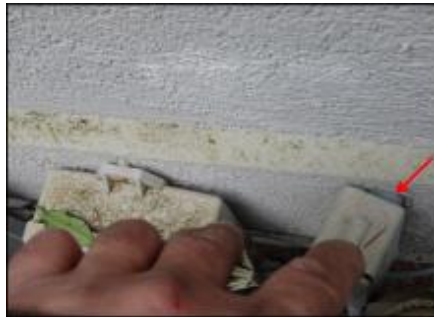
Penetration needs sealant joint application (C7)

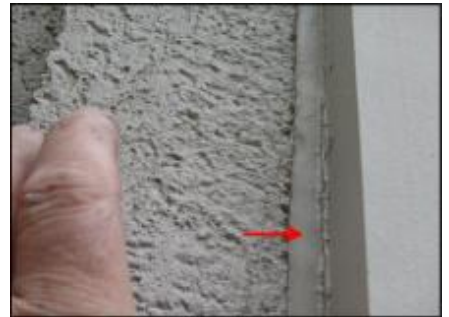
Sealant joint in good condition at garage door head and jambs; typical

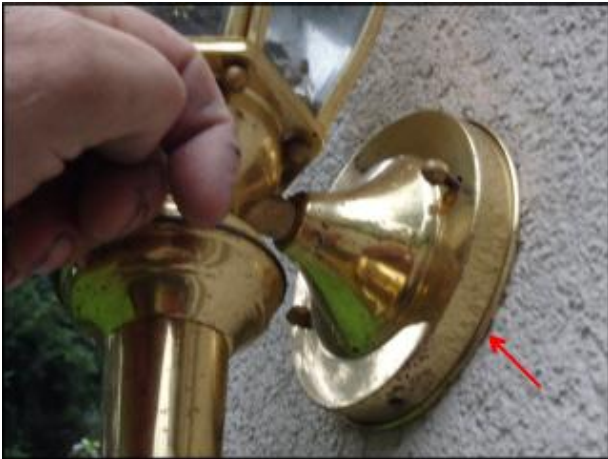
Light penetration needs to be sealed; typical

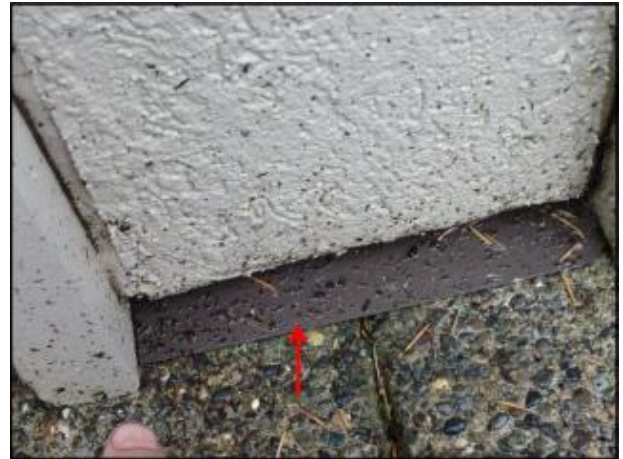
Flashing installed at base of system at garage

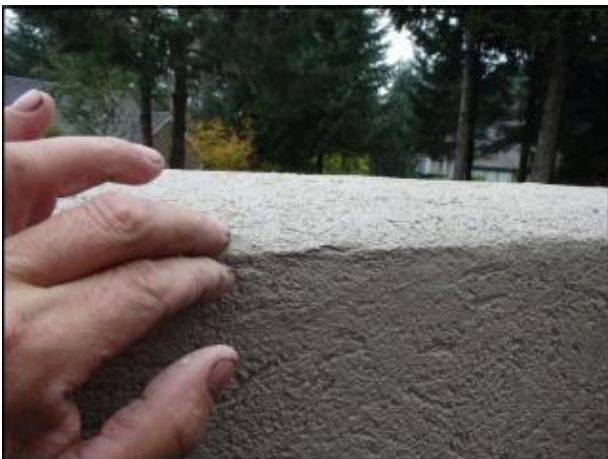
Cracking observed at deck wall and cap; deck wall and cap need elastomeric coating application

The cracking at the deck caps and walls as indicated in this report can be remediated with elastomeric coating application to protect against moisture intrusion.

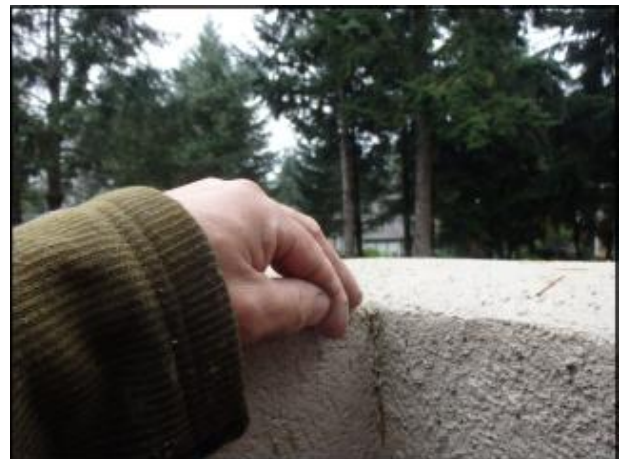
Cracking observed at deck wall and cap; deck wall and cap need elastomeric coating application

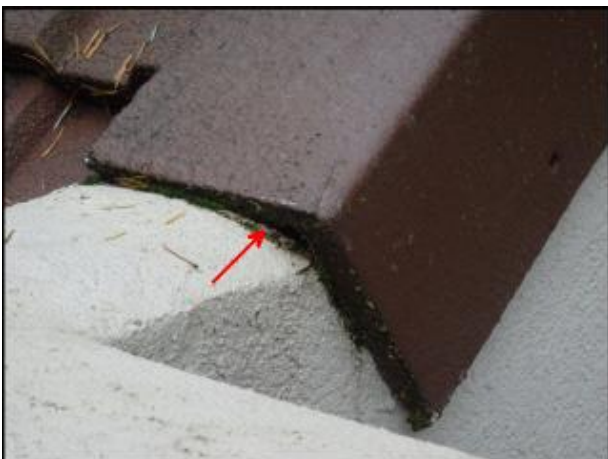
Recommend removing roof tile for elastomeric coating application (G2, H3)

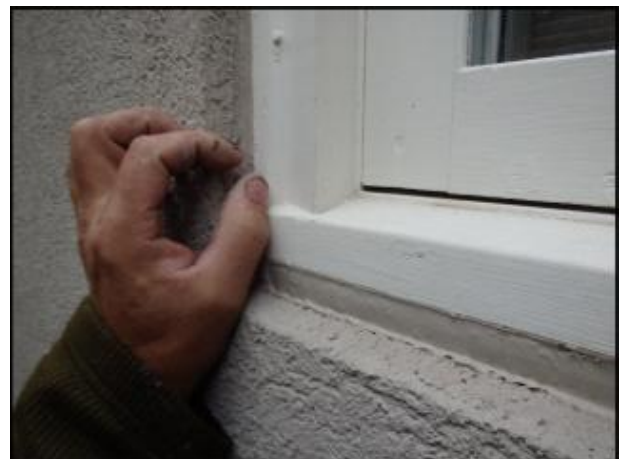
Sealant joint in good condition at window perimeter; typical

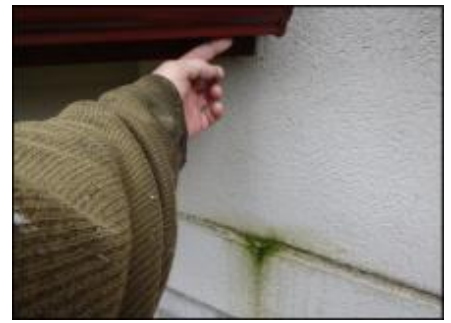
Leak at gutter end cap needs remediation (B4)

There are two gutter end caps that need to be sealed to prevent further leaking.

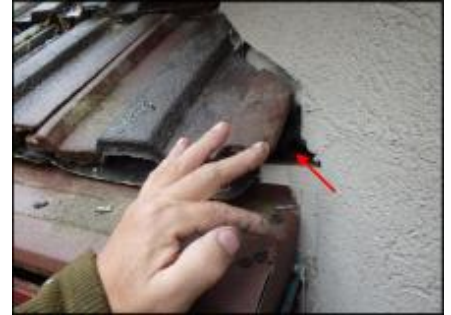
Roof termination needs flashing installed (B4)

The gap at the roof termination at the front right elevation needs a flashing installed, and the roof termination at the rear left elevation needs a one-piece (seamless) kickout flashing installed.

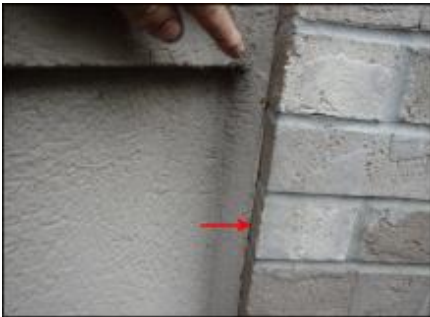
EIFS to brick needs sealant joint application (A5-A7)

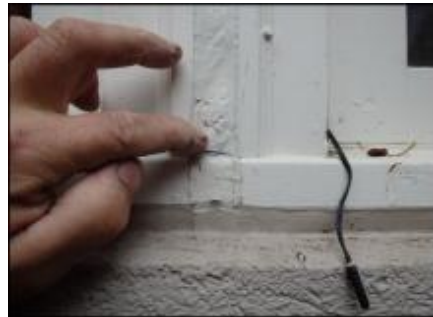
Area of thin sealant application at window mullion needs additional sealant application (A5)

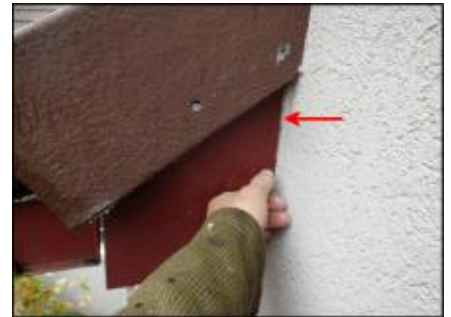
Sealant joint in good condition at fascia termination; typical

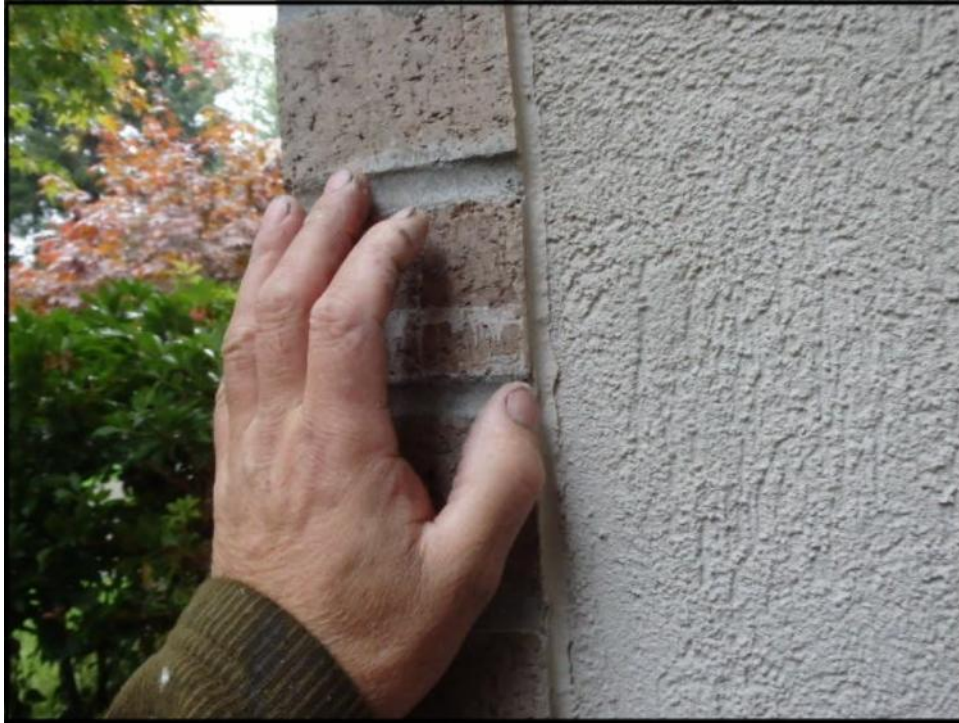
Sealant joint in good condition at EIFS to brick (E5-E7)

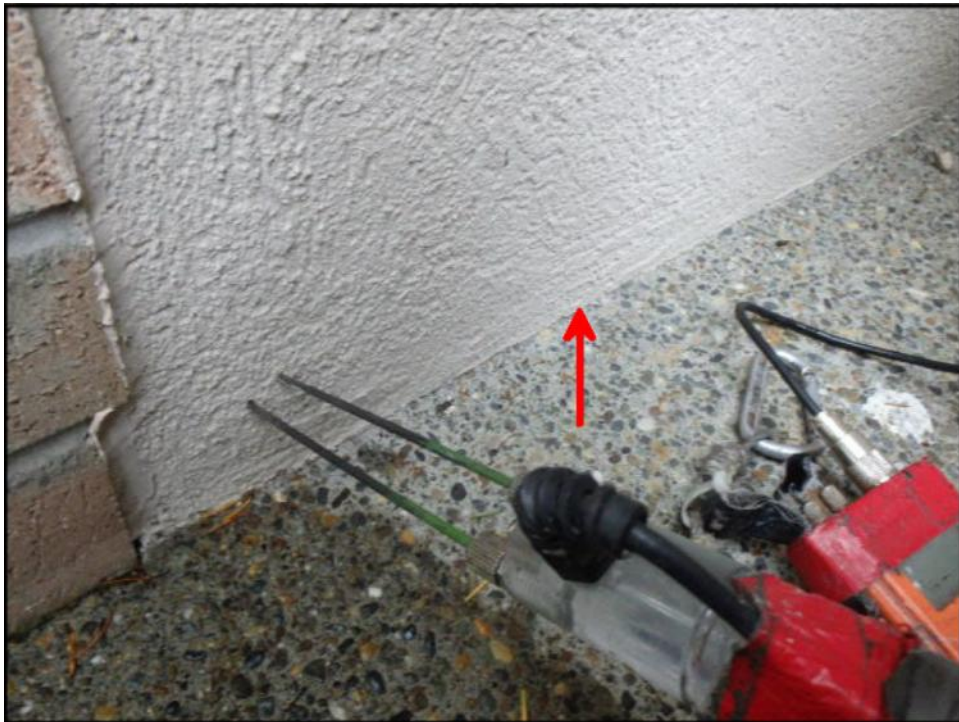
Low moisture readings obtained at concrete poured to base of system;
detail can be remediated with sealant joint application; typical

There are areas indicated in this report where the concrete is poured to the base of system. This practice does not adhere to industry standards; however, due to low moisture readings obtained in these areas, this detail can be remediated with sealant joint application to protect against moisture intrusion.

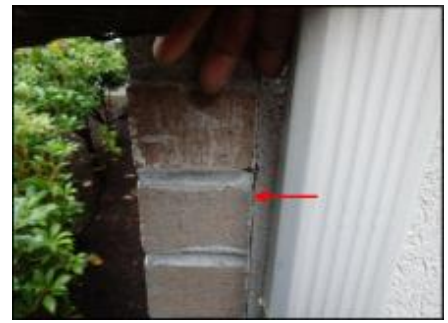
EIFS to brick needs sealant joint application (A1-B8)

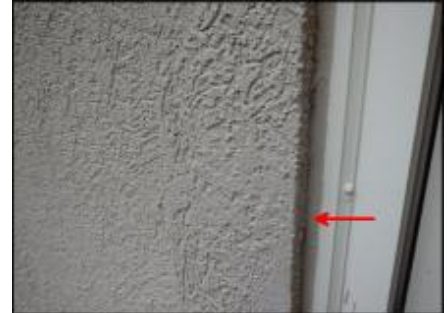
Sealant joint in good condition at window perimeter; typical

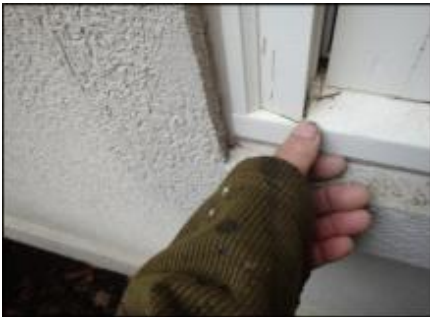
Window construction adequately sealed; typical

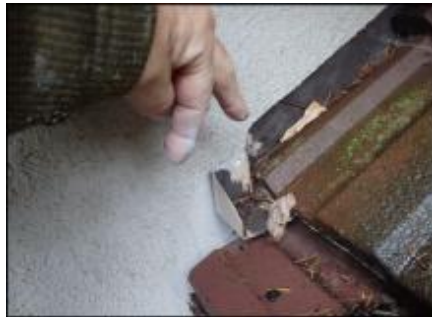
Sealant applied at secondary roof termination (G2)

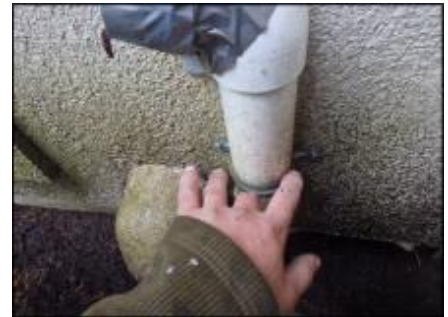
Utility fasteners need to be sealed (G6)

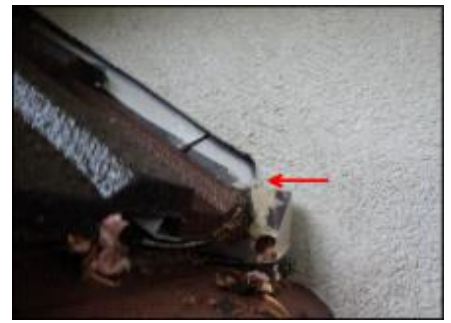
Sealant applied at secondary roof termination (E3)

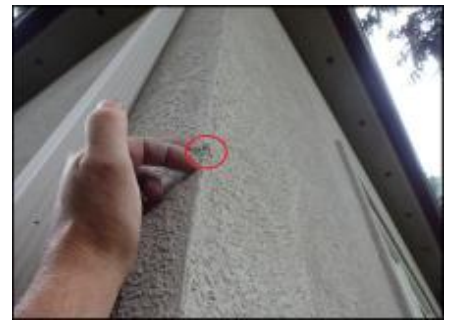
Area of impact damage needs remediation (C4)

There are areas of impact damage as indicated in this report that need to be remediated.

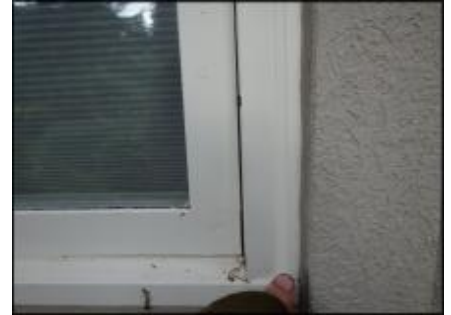
Sealant joint in good condition at window perimeter; typical

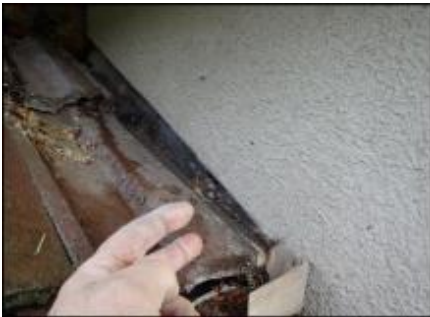
Sealant applied at secondary roof termination (H3)

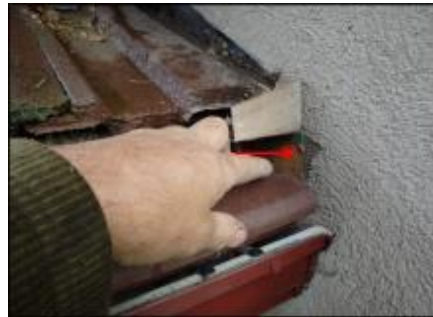
Exposed Sprock board at gutter termination needs base coat and mesh application (H3)

The areas of exposed Sprint board and EPS at the roof terminations indicated in this report need base coat and mesh application to protect against moisture intrusion.

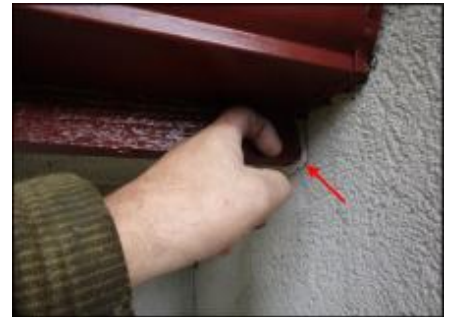
Sealant joint failure at fascia termination needs remediation (H3)

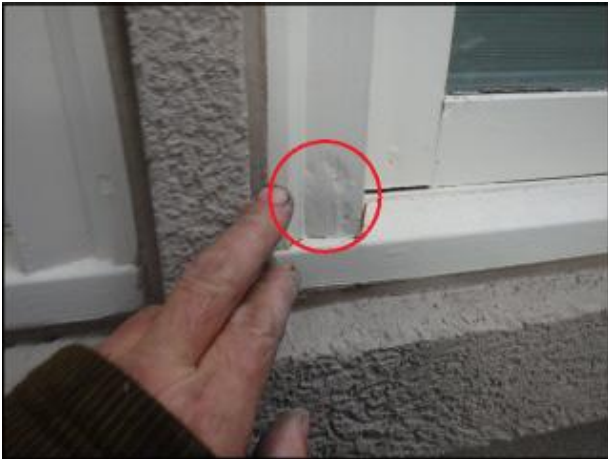
Area of wood rot at window construction needs remediation (I7)

There are areas of wood rot at the window at the rear left elevation that need to be remediated to protect against moisture intrusion.

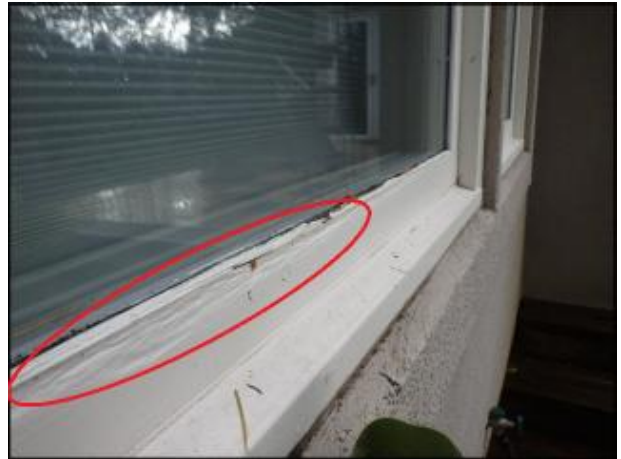
Area of wood rot at window construction needs remediation (I7)

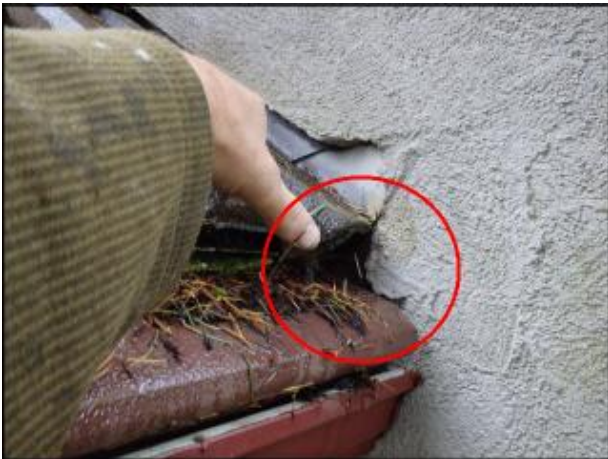
Grid Location	Item Description	Moisture Readings	Substrate Condition	Observations
E7	Windows	12%	Firm	
H3	Secondary roof termination	13%	Firm	
H2	Base of chimney	11%	Firm	
I7	Windows	11%	Firm	
J4-J7	Kickout	39%, 40%, 27%, 32%	Firm

Roof termination needs one-piece (seamless) kickout flashing installed (J3)

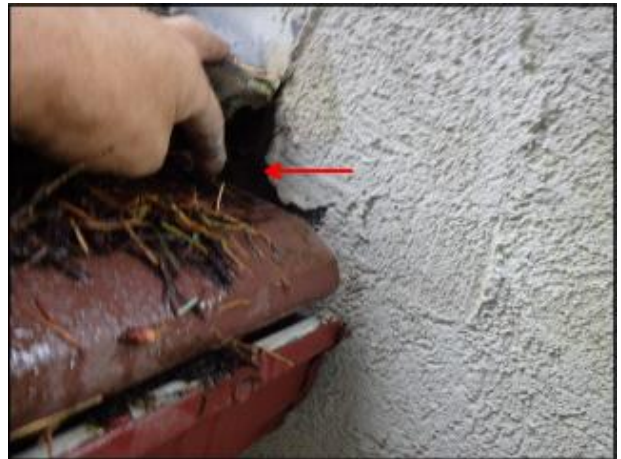
Exposed Sprock board at gutter termination needs base coat and mesh application (J3)

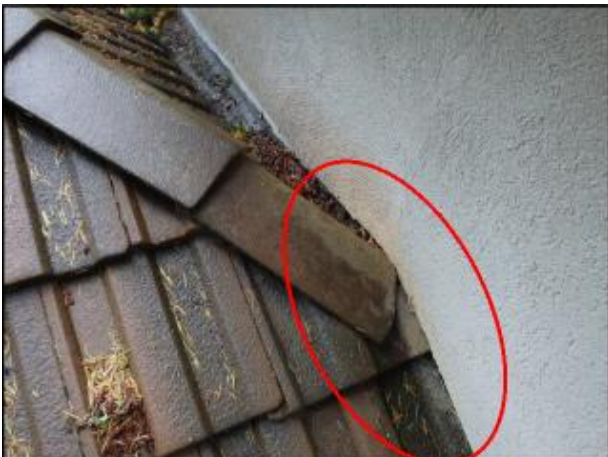
Dead valley needs to be cleared of debris to allow for drainage; recommend further evaluation to determine necessary remediation to allow for unobstructed water flow to gutter (I3-J3)

The dead valley at the roof at the rear left elevation needs to be cleared of debris to allow for drainage. Further evaluation of this area by a roofing contractor is recommended to determine necessary remediation to allow for unobstructed water flow to the gutter.

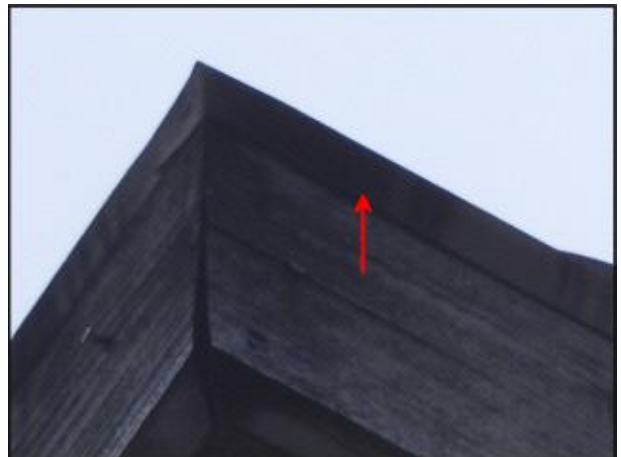
Flashing at chimney cap adequately extends over wood trim to protect against moisture intrusion

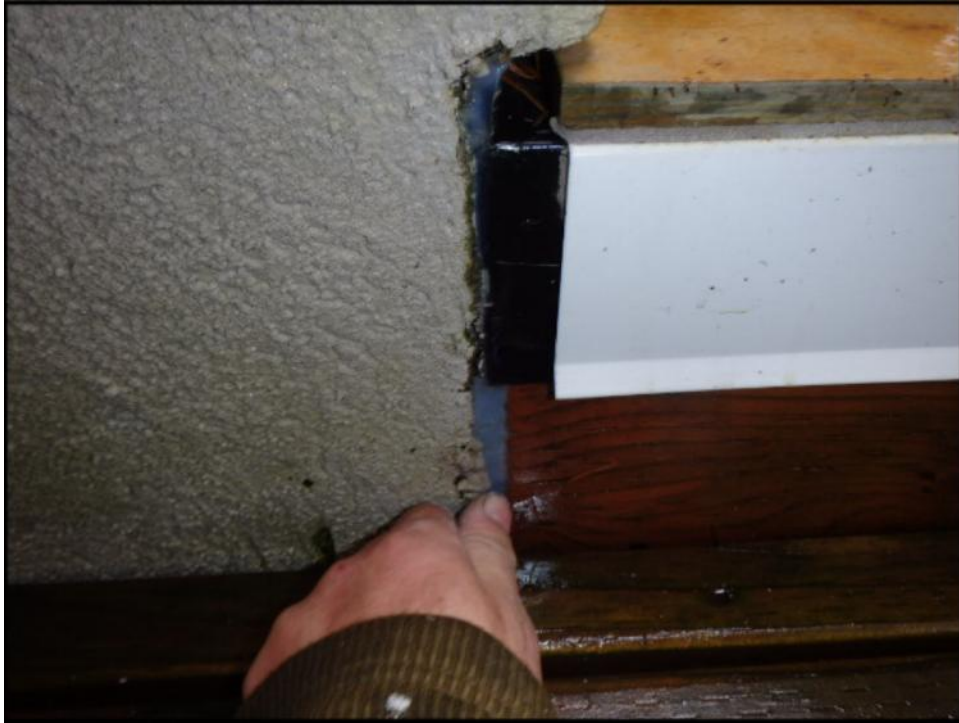
Sealant joint and end dam in good condition at deck termination (J8)

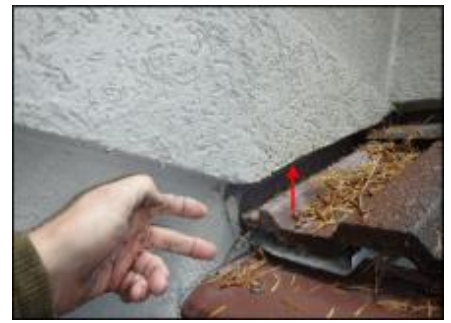
Exposed EPS at roof termination needs base coat and mesh application (F4)

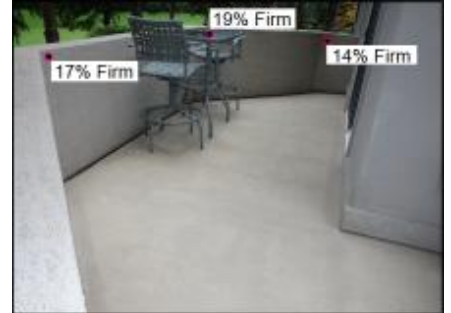
Moisture readings obtained at interior deck wall (F3-H3)

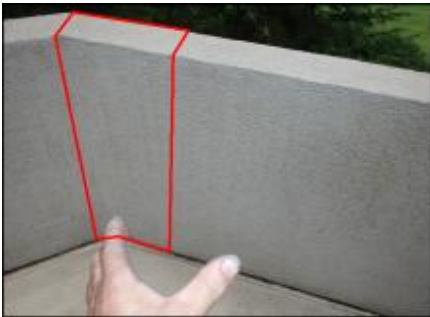
Approximate area of soft substrate needs to be removed and replaced (I3)

Grid Location	Item Description	Moisture Readings	Substrate Condition	Observations
C6	Windows	12%	Firm	
E3	Windows	10%	Firm	
E4	Roof termination	10%	Firm	
G6	Windows	9%	Firm	
I3	Soft substrate	30%	Soft	Approximate area of soft substrate needs to be removed and replaced.

There is one area indicated in this report where soft substrate was detected upon probing. This area will need to be removed and explored further to determine the extent of damage and necessary remediation.

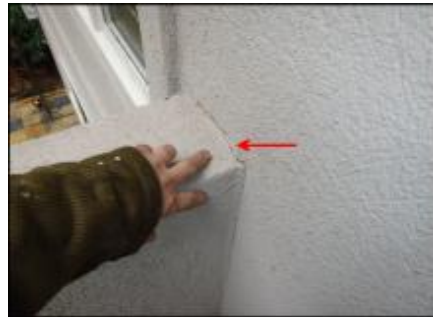
Crack at deck wall to dwelling wall needs sealant joint application (F3)

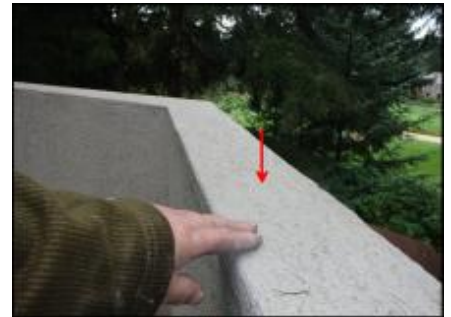
Cracking observed at non-sloped EIFS deck cap; deck cap needs elastomeric coating application (F3-I3)

The non-sloped deck caps at the rear right and left left elevations need to be remediated with elastomeric coating application to protect against moisture saturation.

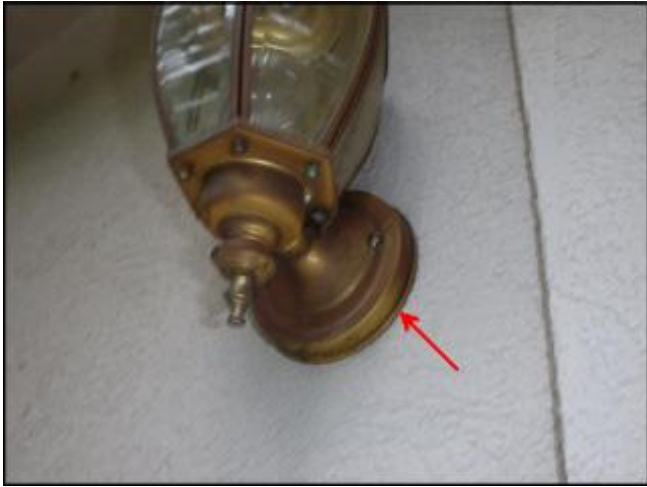
Light penetration needs to be sealed; typical

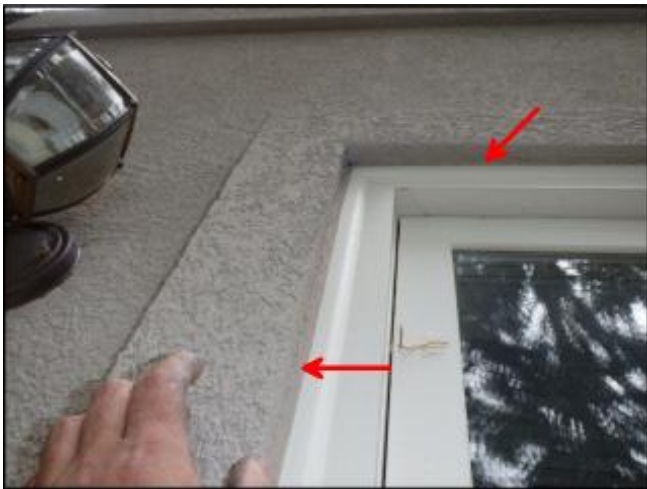
Sealant joint in good condition at door head and jambs; typical

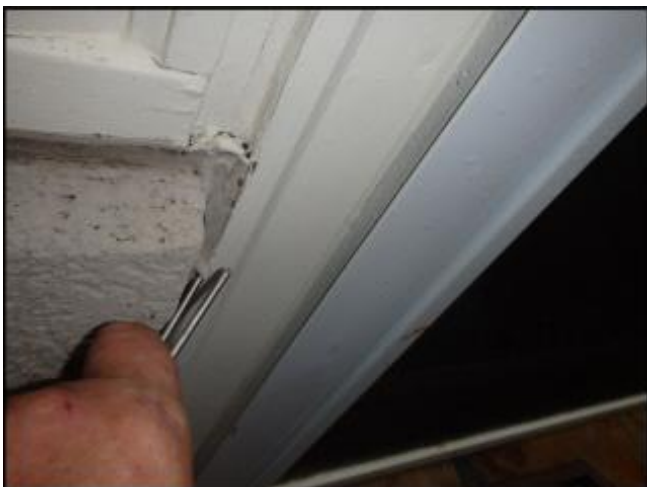
Area of sealant joint failure at door jamb needs touch-up (C6)

There are utility penetrations and areas where the EIFS is terminated to the brick that need sealant joint application. There is one area of sealant joint failure at the door jamb at the rear right elevation that needs to be remediated and all light penetrations need to be sealed.

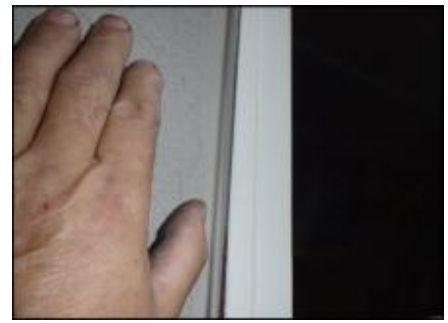
Sealant joint in good condition at window perimeter; typical

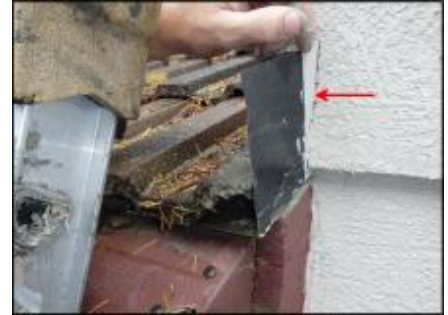
Roof step flashing needs sealant joint application (F4)

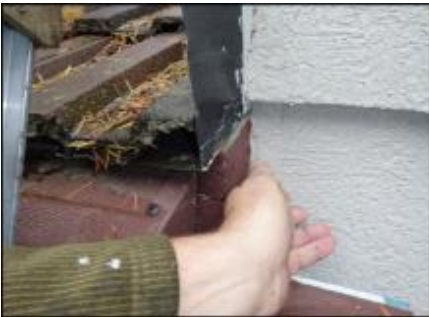
Sealant joint in good condition at roof termination; typical

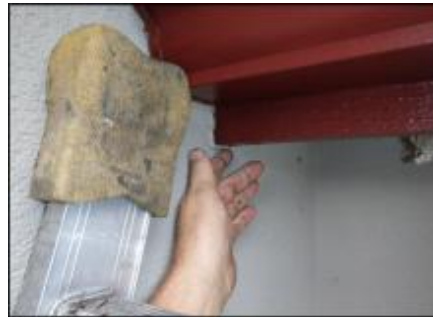
Sealant joint in good condition at fascia termination; typical

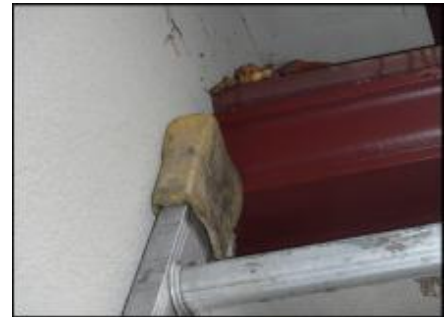
Leak at gutter end cap needs to be sealed (J1)

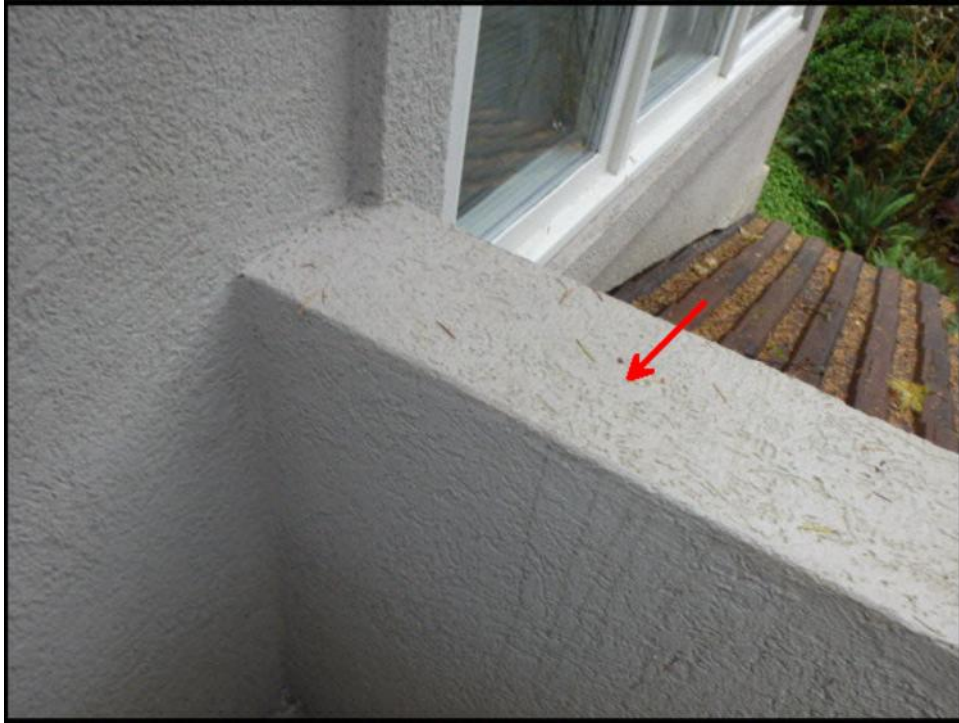
Non-sloped EIFS deck cap needs elastomeric coating application (D4-F3)

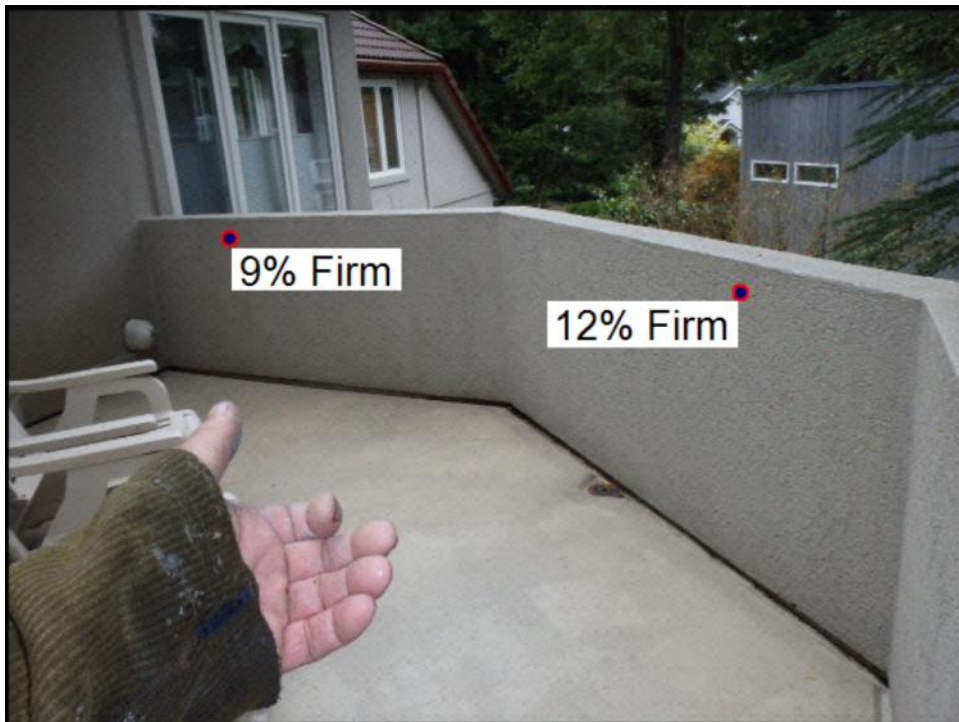
Low moisture readings obtained at interior deck wall

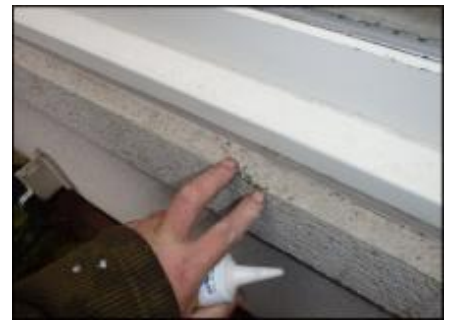
Area of impact damage needs remediation; typical of elevation

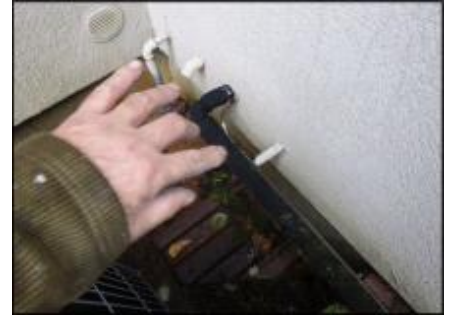
Penetrations need sealant joint application (A7)

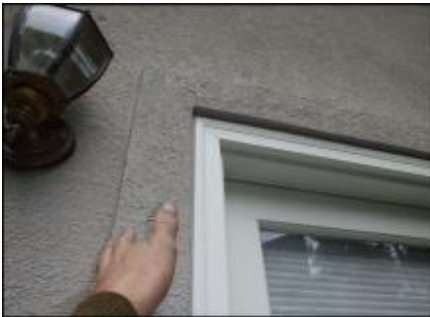
Sealant joint in good condition at door head and jambs; typical

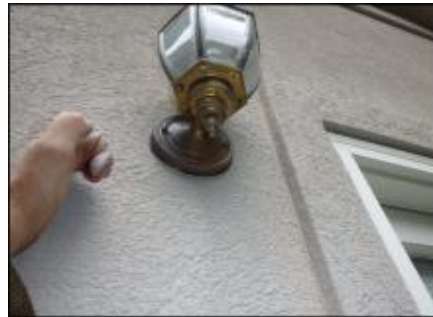
Light penetration needs to be sealed; typical

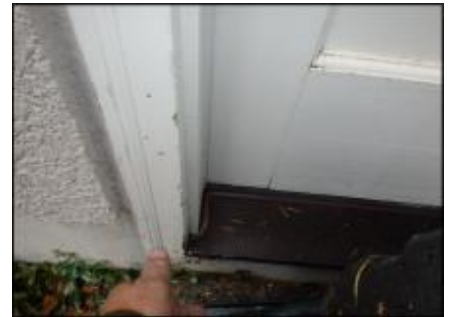
Sealant in good condition at door threshold (J7)

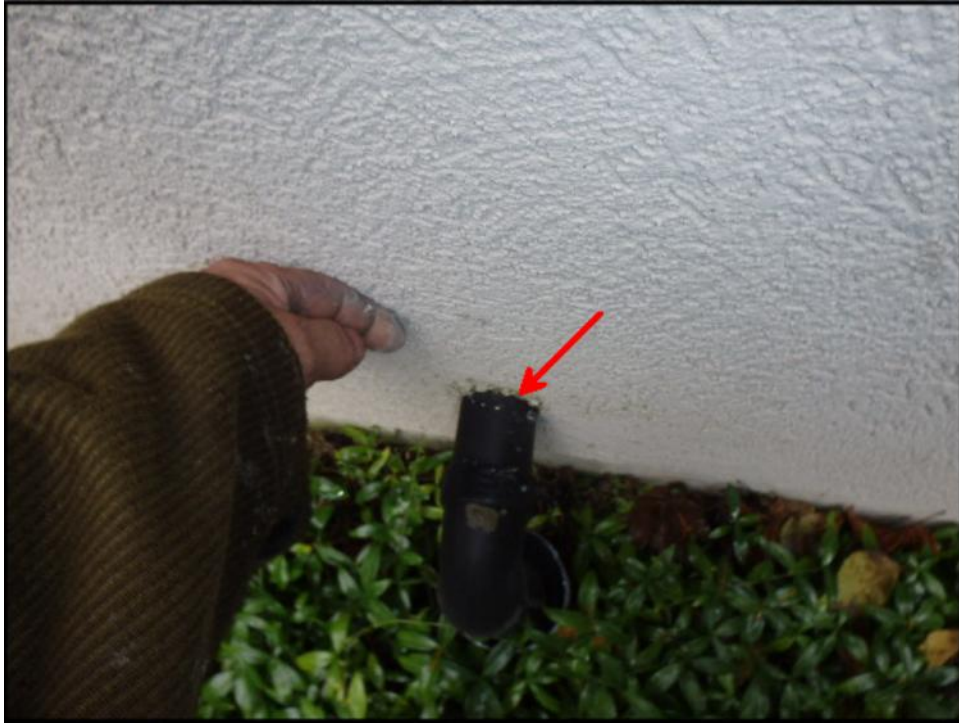
Penetration needs sealant joint application (H7)
