# Sound Exterior Inspections, LLC

**August 21, 2007**

**Doe Residence**

**121 Your Street  
Yourtown, WA 98999**

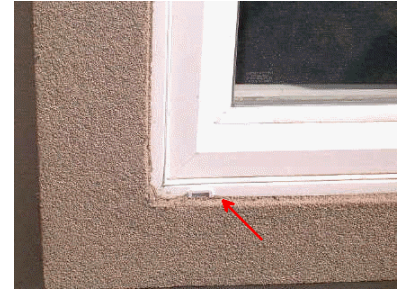
Window detail needs remediation to accommodate sealant joint and window weep hole; typical

The EIFS manufacturer specifications require 1/2" working sealant joint consisting of backer rod and sealant. If this cannot be achieved, it is recommend that bond breaker tape and sealant be used to achieve a 1/2" working joint. When sealing window perimeters, great care should be taken to ensure weep holes are not sealed.

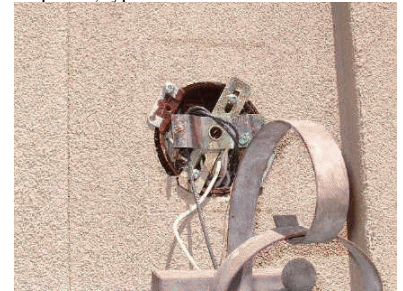
Light fixture needs sealant joint application

Any areas below the roof line where EIFS terminates at another material needs to be sealed. This may include flashings, light fixtures, utility penetrations, vents, or other types of breaches to the EIFS cladding.

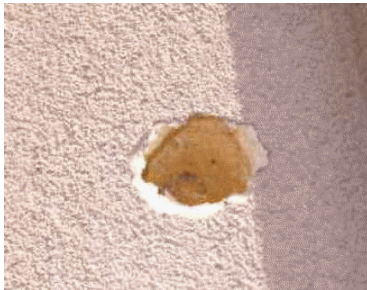
Bird damage needs remediation (B2)

There are areas indicated in the report where impact damage or exposed cracks were found. These areas will need to be repaired to help prevent moisture intrusion.

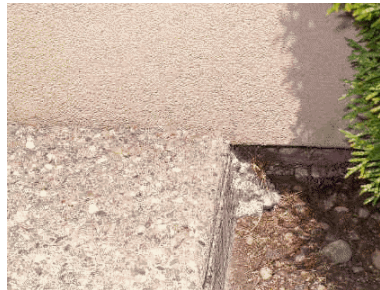
Concrete poured to EIFS not per manufacturer's specifications

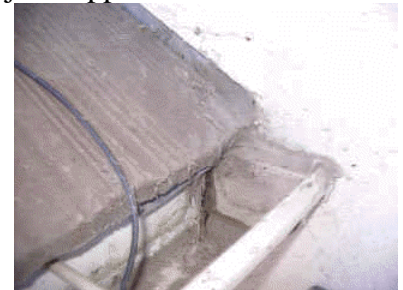
Roof termination needs kickout flashing installed

Kickout flashing needs to be installed at the location indicated in this report to help prevent further moisture intrusion and damage to substrate.

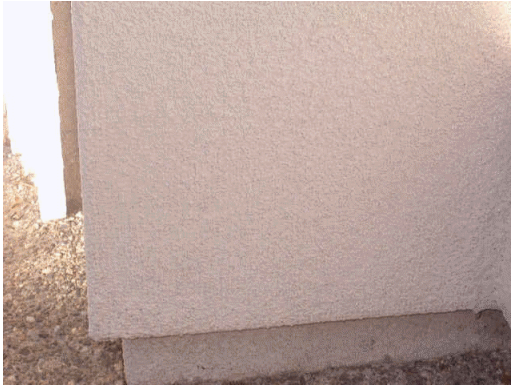
Visible mesh patterning through finish coat application indicates lack of proper amount of base coat at original application

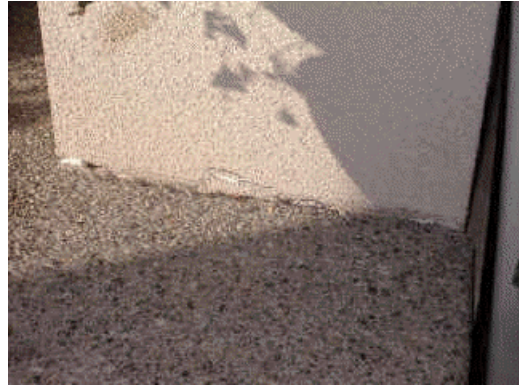
Settling and cracking occurring at concrete poured to EIFS; area needs flashing installed; typical

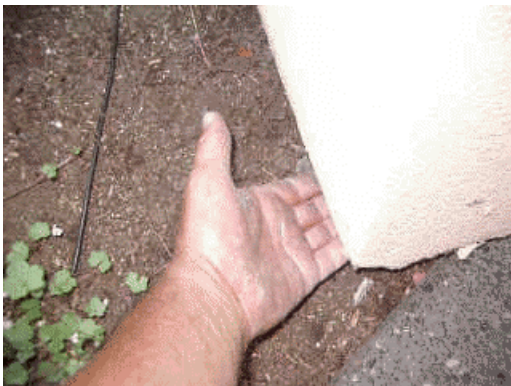
Exposed foam at base of system needs mesh and base coat application; typical

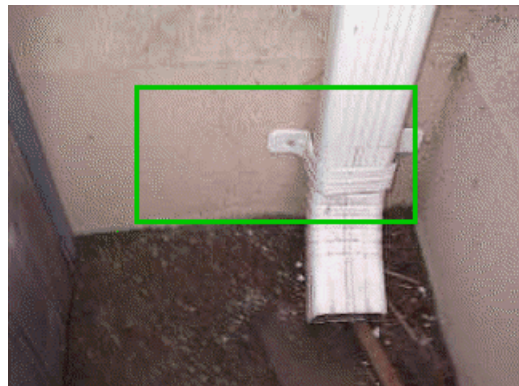
Approximately 1' x 2' area of soft substrate needs to be removed and replaced

There is one area as indicated in the report where the substrate was soft when probed. This area will need to be removed and explored further to determine the extent of damage and necessary remediation.

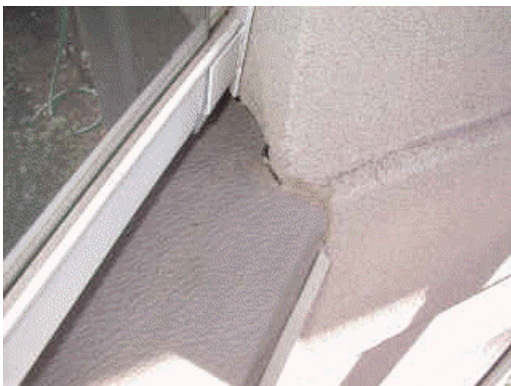
Deck termination needs end dam installed; elevated moisture readings obtained below; typical

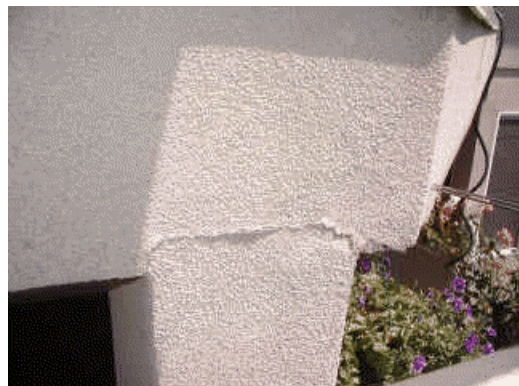
Area of compression cracking occurring needs remediation
