# Moisture Survey Inspection

January 1, 2019

123 Pleasant Lane  
Pleasantville, WA 98000

Sound Exterior Inspections, LLC performed a moisture survey inspection on January 1, 2019 of the EIFS Sprint Barrier System installed on the building located at 123 Pleasantville Lane, Pleasantville, Washington at the request of John Doe, LLC.

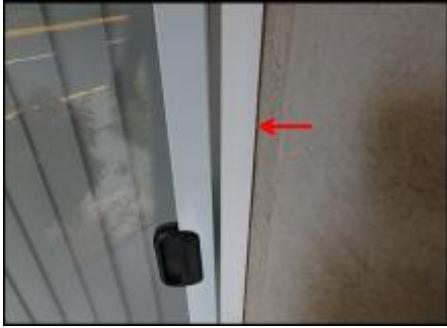
7/8" EIFS needs to be removed at interior deck door head and jambs prior to base coat and mesh application to accommodate 3/4" silicone sealant joint application; typical

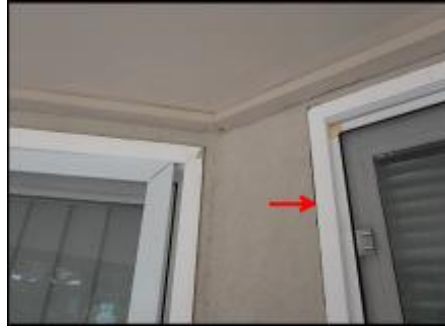
7/8" EIFS needs to be removed at interior deck window perimeter prior to base coat and mesh application to accommodate 3/4" silicone sealant joint application; typical

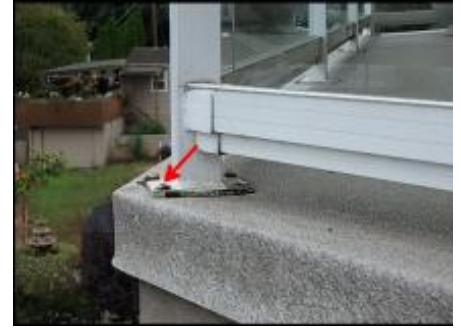
Railing fasteners needs to be sealed; typical

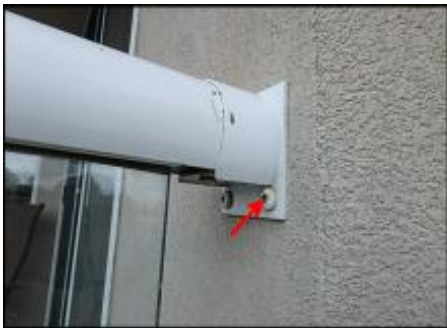
Railing fasteners need to be sealed; typical

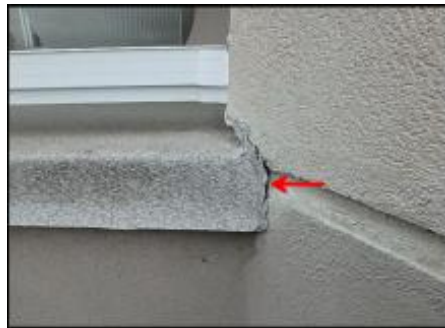
Deck termination needs end dam flashing installation; typical

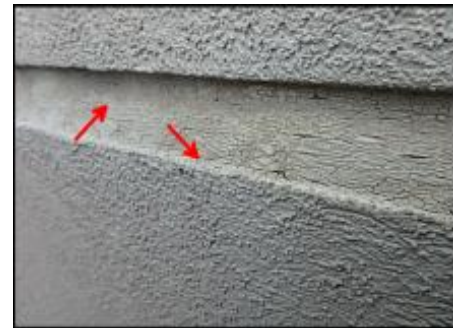
Sealant at floor line expansion joint needs to be removed and EIFS removed at base of joint prior to base coat, mesh and silicone sealant joint application; typical

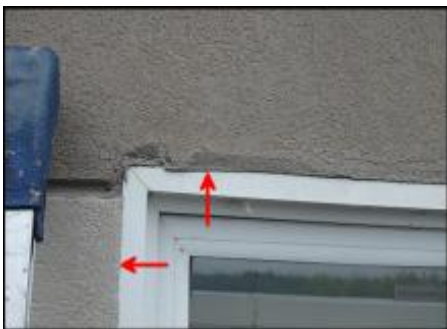
7/8" EIFS needs to be removed at window perimeter prior to base coat and mesh application to accommodate 3/4" silicone sealant joint application; typical

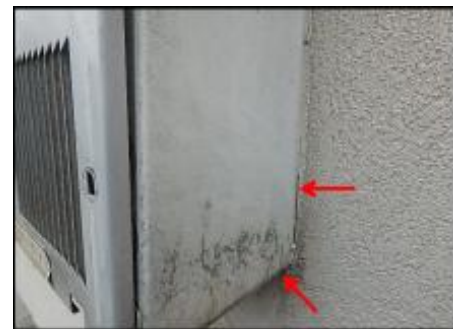
7/8" EIFS needs to be removed at PTAC perimeter prior to base coat and mesh application to accommodate 3/4" silicone sealant joint application; typical

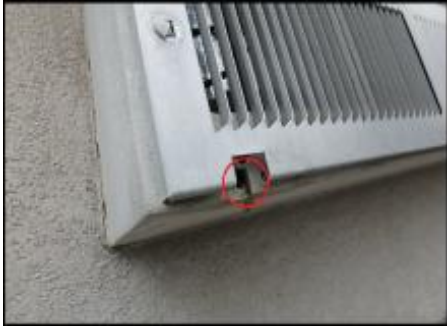
PTAC needs factory drip tubes installed to divert water away from system; typical

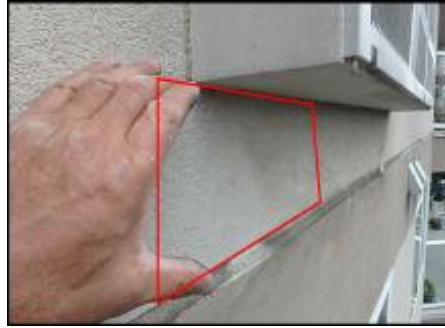
Approximate area of soft substrate needs to be removed and replaced (C4)

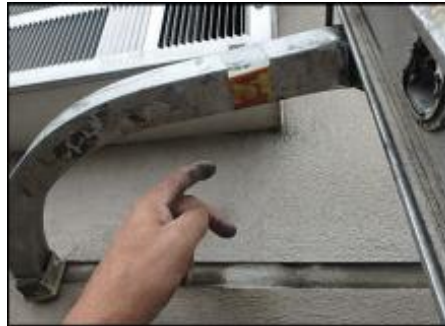
Crack needs to be gouged and slivered with EPS prior to base coat, mesh and finish coat application; typical

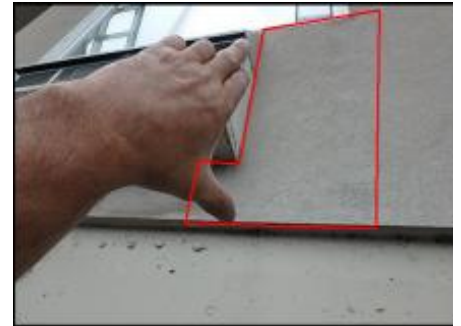
Approximate area of soft substrate needs to be removed and replaced (C5-C6)

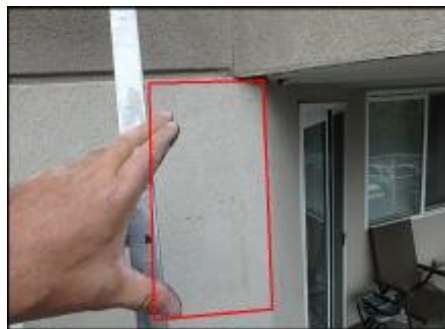
Approximate area of soft substrate needs to be removed and replaced (E4)

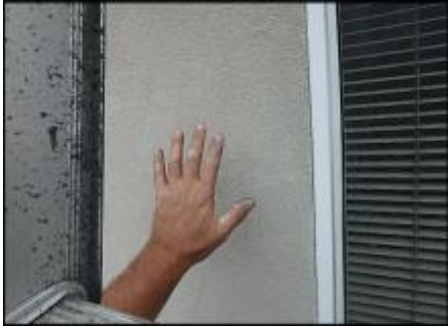
Area of unattached EIFS needs fasteners installed prior to base coat, mesh and finish coat application; typical

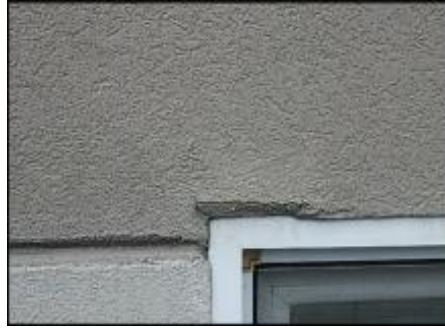
7/8" EIFS needs to be removed at window perimeter prior to base coat and mesh application to accommodate 3/4" silicone sealant joint application; typical

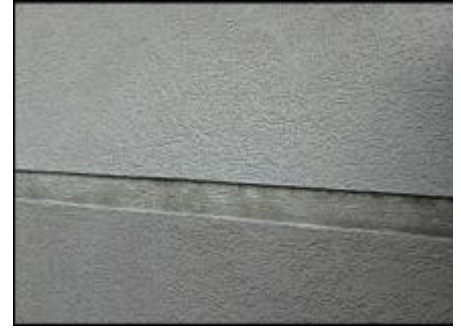
Sealant at floor line expansion joint needs to be removed and EIFS removed at base of joint prior to base coat, mesh and silicone sealant joint application; typical

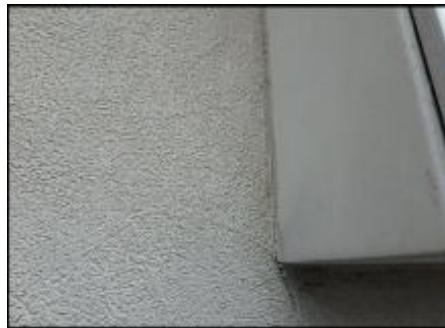
7/8" EIFS needs to be removed at PTAC perimeter prior to base coat and mesh application to accommodate 3/4" silicone sealant joint application; typical

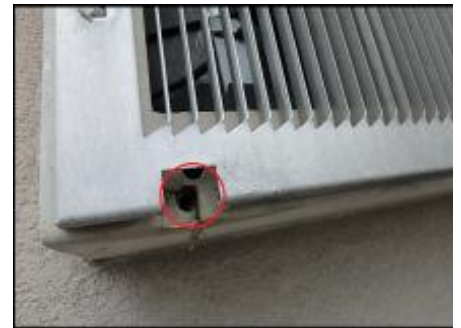
PTAC needs factory drip tubes installed to divert water away from system; typical

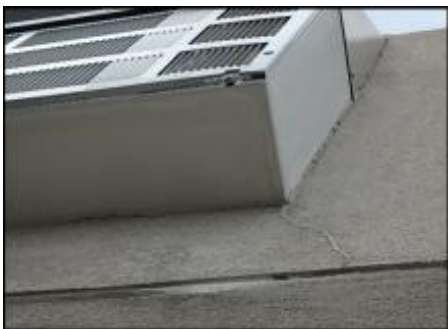
Cracks need to be gouged and slivered with EPS prior to base coat, mesh and finish coat application; typical

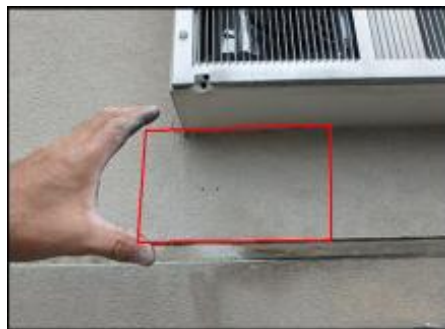
Approximate area of soft substrate needs to be removed and replaced (A5-B5)

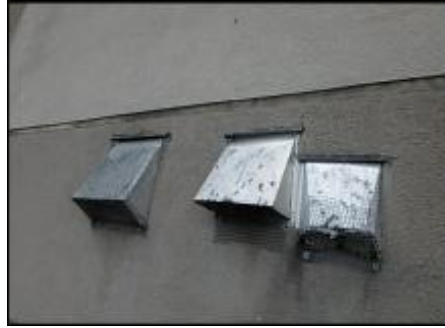
7/8" EIFS needs to be removed at vents prior to base coat and mesh application to accommodate 3/4" silicone sealant joint application; recommend replacing vents upon system remediation; typical

It is recommended that all vents be replaced upon remediation of EIFS cladding.

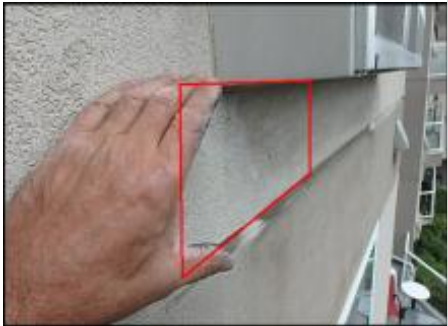
Approximate area of soft substrate needs to be removed and replaced (F3-G3)

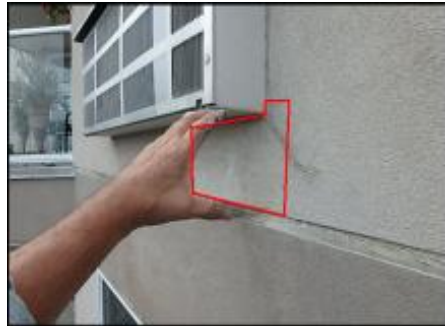
Approximate area of soft substrate needs to be removed and replaced (G3)

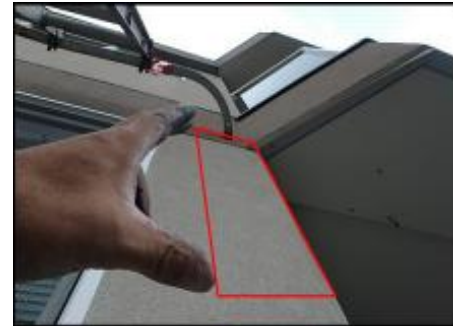
Approximate area of soft substrate needs to be removed and replaced (D4-C4)

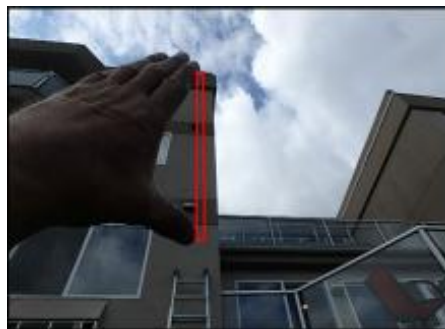
Approximate area of soft substrate needs to be removed and replaced (G1-H4)

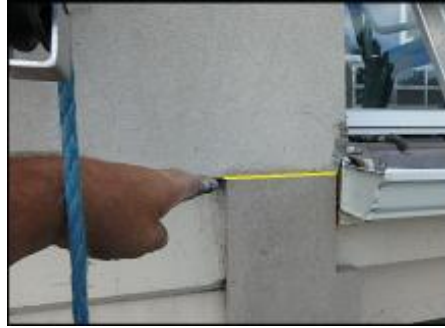
Area of compression damage needs expansion joint installation (H6)

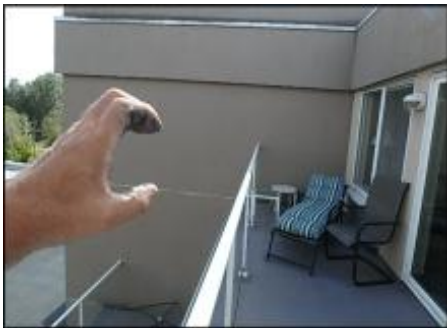
EIFS installed over concrete wall (H2-H6)

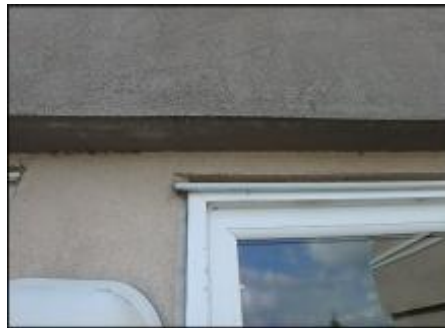
Head flashings installed at window heads; 3/4" sealant joint installed at window jambs and sills (H3-J3)

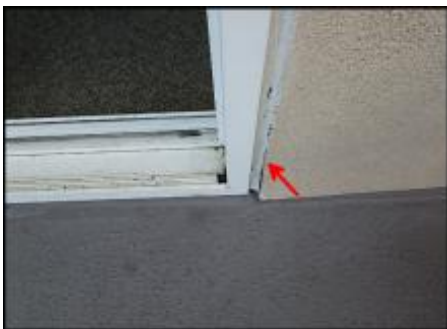
Sealant joint failure at door jamb needs to be removed and replaced (H3)

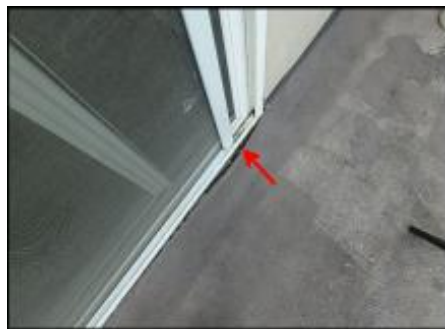
Deck membrane needs to be removed and replaced due to failure observed (H5-J6)

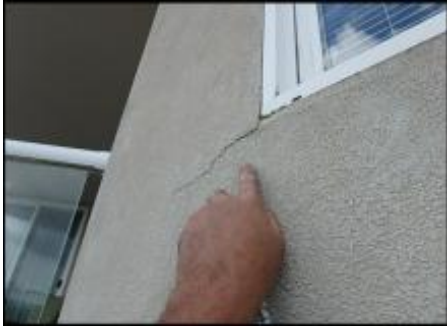
Crack needs to be gouged and slivered with EPS prior to base coat, mesh and finish coat application; typical

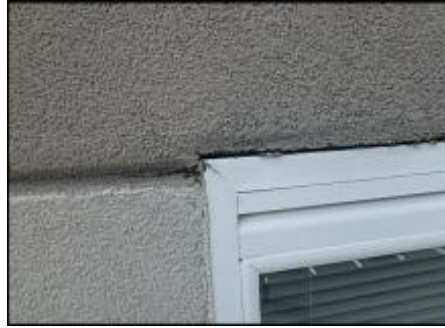
7/8" EIFS needs to be removed at window perimeter prior to base coat and mesh application to accommodate 3/4" silicone sealant joint application; typical

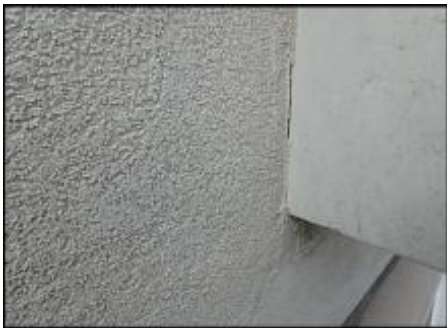
7/8" EIFS needs to be removed at PTAC perimeter prior to base coat and mesh application to accommodate 3/4" silicone sealant joint application; typical

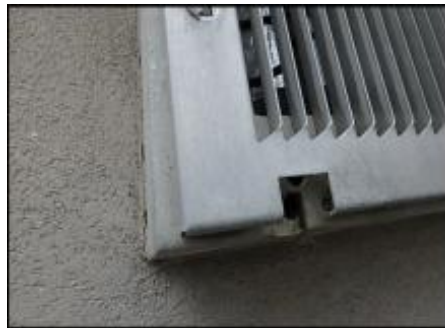
PTAC needs factory drip tubes installed to divert water away from system; typical

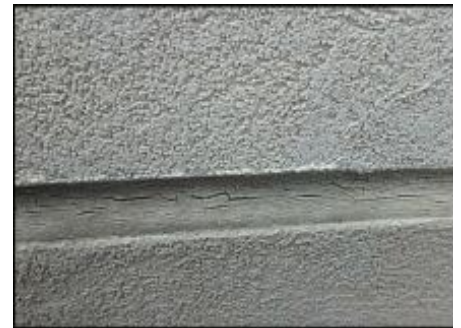
Sealant at floor line expansion joint needs to be removed and EIFS removed at base of joint prior to base coat, mesh and silicone sealant joint application; typical

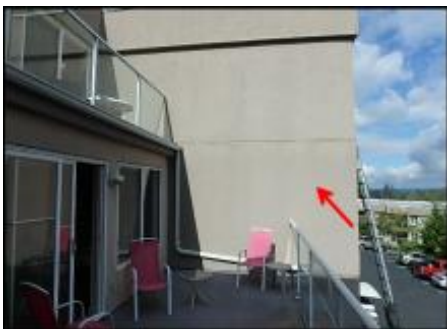
EIFS applied over concrete substrate at wall (B2-B5)

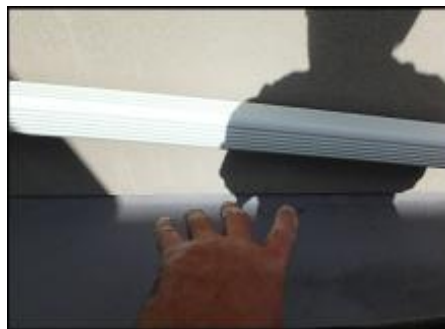
Hairline cracks will be remediated with application of base coat, mesh and finish coat application over entire system; typical

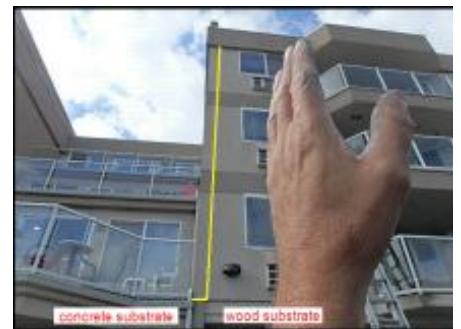
Concrete substrate to wood substrate needs expansion joint installation (C1-C5)

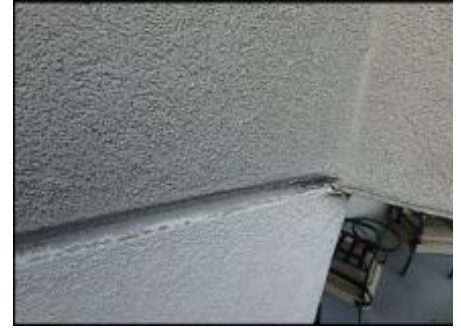
7/8" Sprint board application does not allow for minimum 3/4" foam at base of v-groove; hairline cracks observed; detail needs bond breaker tape and silicone sealant joint application; typical

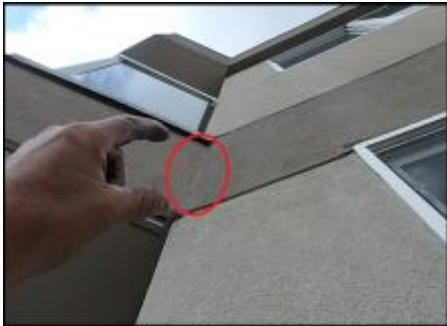
Inconclusive probing results below deck due to OSB substrate cut out to accommodate steel bracket installation; recommend random intrusive evaluation upon system remediation to determine framing condition; typical

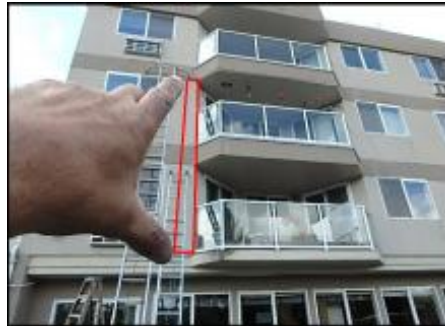
Approximate area of soft substrate needs to be removed and replaced (H5)

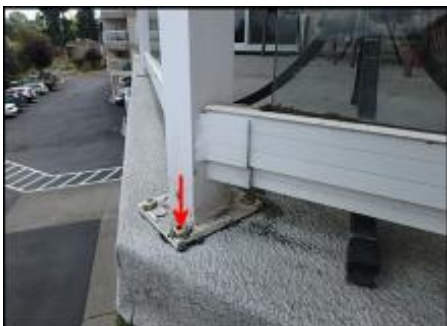
Deck fasteners need to be sealed; typical

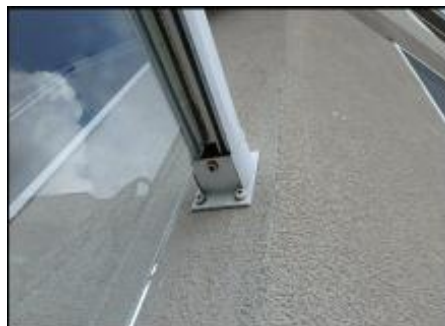
Railing fasteners need to be sealed; typical

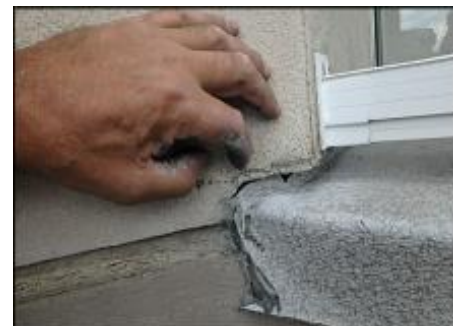
Recommend replacement of deck membrane due to installation defects and failure observed; typical

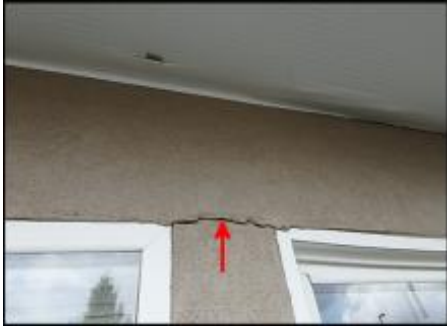
Area of compression damage needs expansion joint installation (D6-H6)

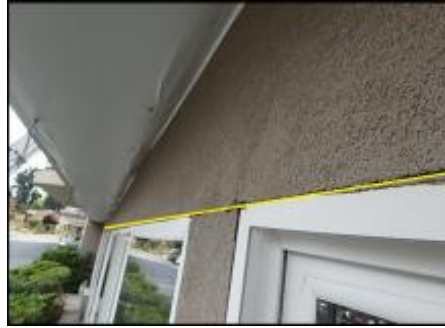
Window heads need expansion joint installation (D6-H6)

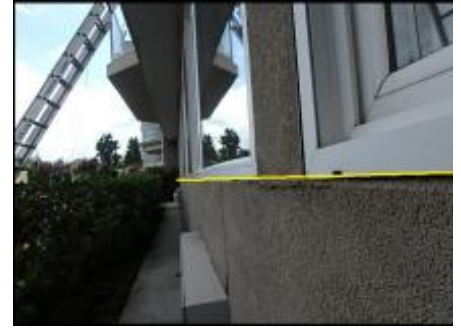
Window sills need expansion joint installation (D6-H6)

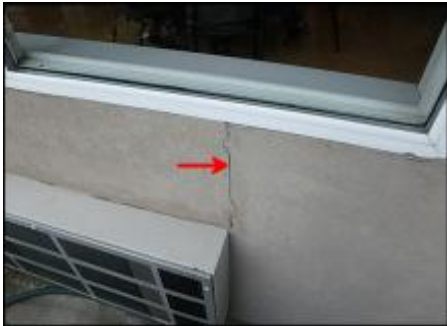
Cracks need to be gouged and slivered with EPS prior to base coat, mesh and finish coat application; typical

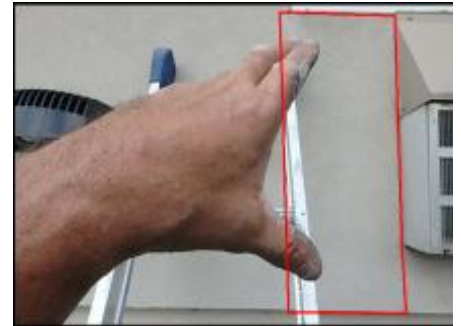
Approximate area of soft substrate needs to be removed and replaced (G5)

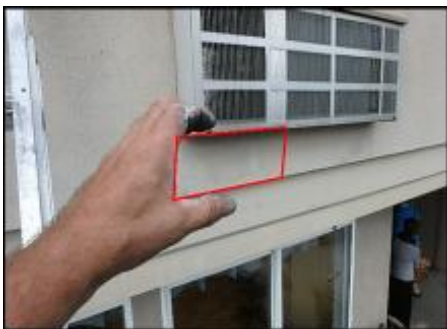
Approximate area of soft substrate needs to be removed and replaced (G5)

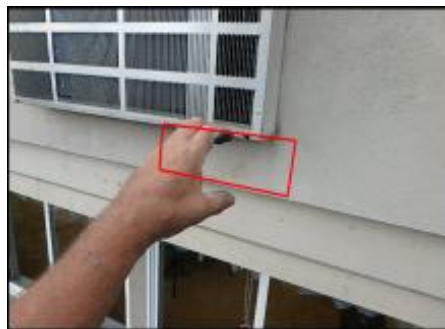
Approximate area of soft substrate needs to be removed and replaced (H5)

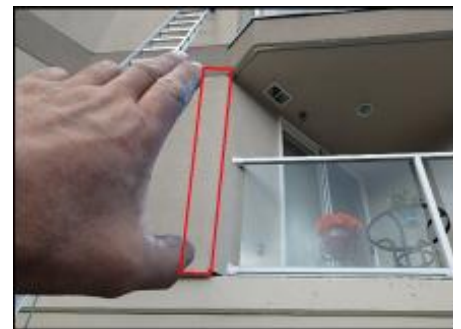
Approximate area of soft substrate needs to be removed and replaced (H5)

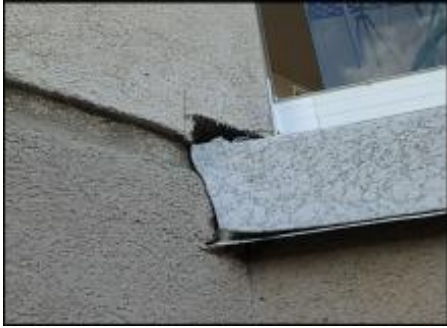
Recommend replacement of deck membrane due to installation defects and failure observed; typical

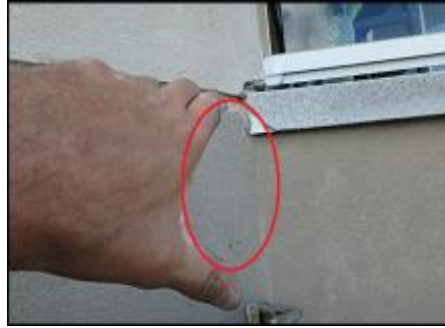
Inconclusive probing results below deck due to OSB substrate cut out to accommodate steel bracket installation; recommend random intrusive evaluation upon system remediation to determine framing condition; typical

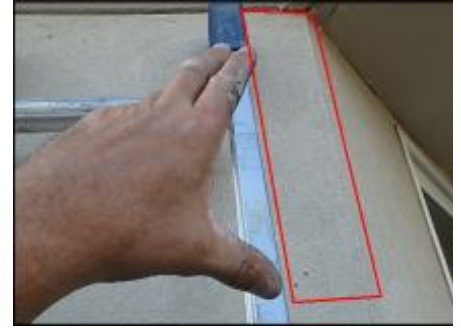
Approximate area of soft substrate needs to be removed and replaced (B4)

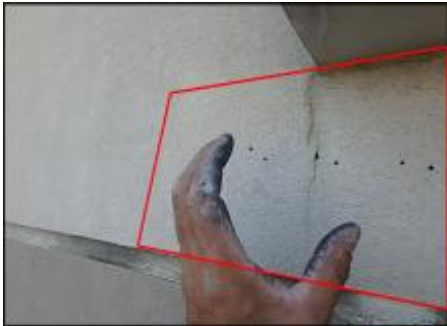
Approximate area of soft substrate needs to be removed and replaced (F3)

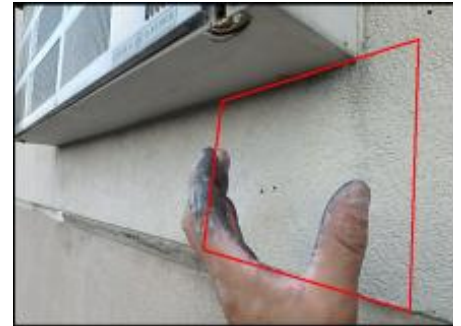
Approximate area of soft substrate needs to be removed and replaced (F5)

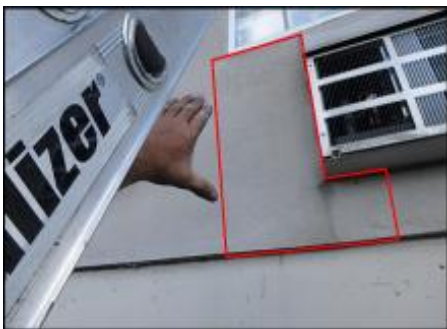
Approximate area of soft substrate needs to be removed and replaced (E6-F6)

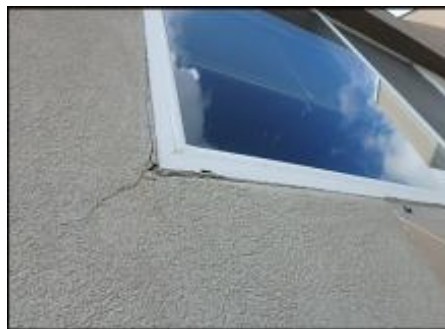
Area of insufficiently attached EIFS needs fasteners installed prior to base coat, mesh and finish coat application; typical

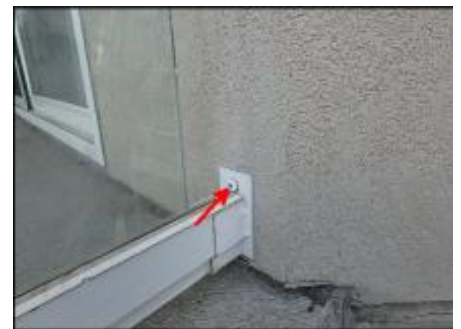
Railing fasteners need to be sealed; typical

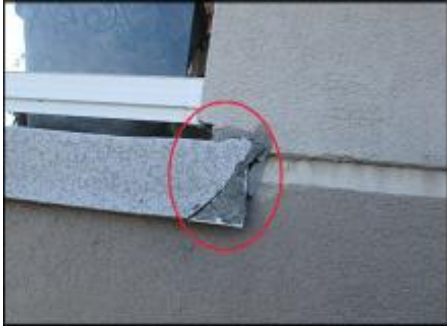
Recommend replacement of deck membrane due to installation defects and failure observed; deck termination needs end dam flashing installed; typical

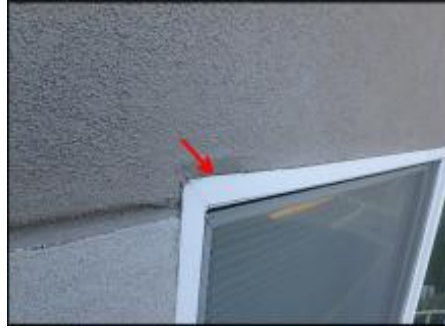
7/8" EIFS needs to be removed at window perimeter prior to base coat and mesh application to accommodate 3/4" silicone sealant joint application; typical

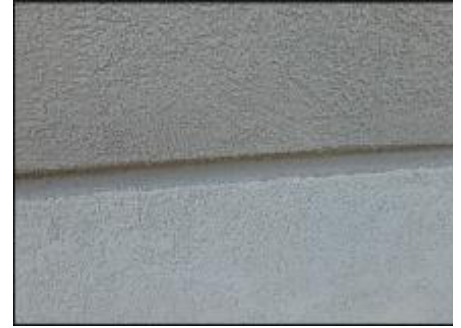
7/8" Sprint board application does not allow for minimum 3/4" foam at base of v-groove; hairline cracks observed; detail needs bond breaker tape and silicone sealant joint application; typical

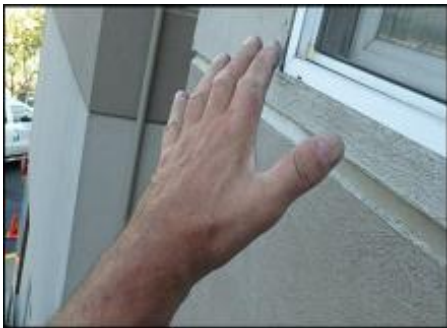
Area of insufficiently attached EIFS needs fasteners installed prior to base coat, mesh and finish coat application; typical

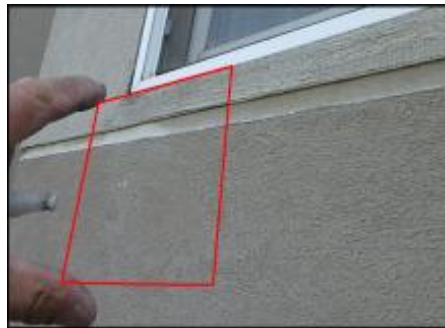
Approximate area of soft substrate needs to be removed and replaced (G5)

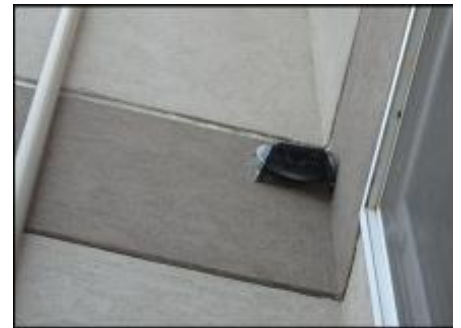
7/8" EIFS needs to be removed at vent prior to base coat and mesh application to accommodate 3/4" silicone sealant joint application; recommend replacing vent upon system remediation; typical

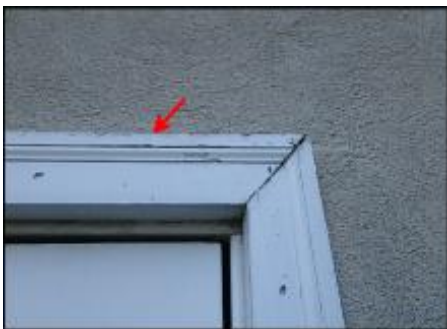
Door head needs drip flashing installation (H7)

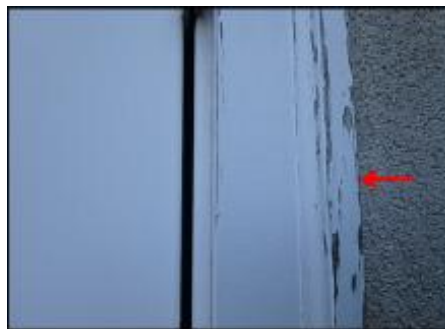
7/8" EIFS needs to be removed at door jambs prior to base coat and mesh application to accommodate 3/4" silicone sealant joint application; typical (H7)

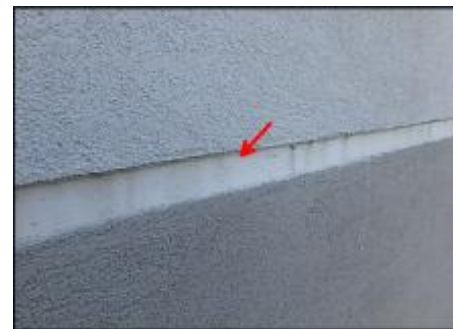
Sealant at floor line expansion joint needs to be removed and EIFS removed at base of joint prior to base coat, mesh and silicone sealant joint application; typical

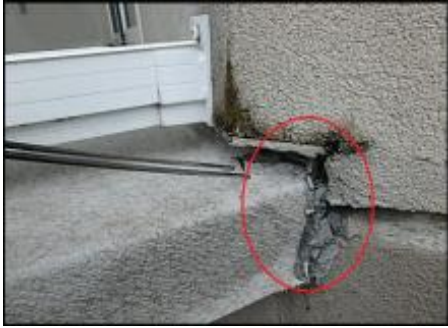
Recommend replacement of deck membrane due to installation defects and failure observed; deck termination needs end dam flashing installation; typical

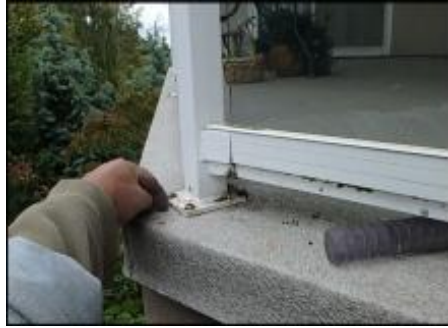
Railing fasteners need to be sealed; typical

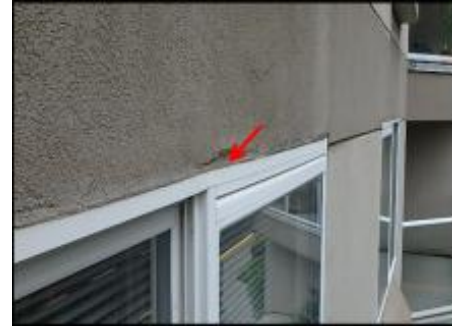
7/8" EIFS needs to be removed at window perimeter prior to base coat and mesh application to accommodate 3/4" silicone sealant joint application; typical

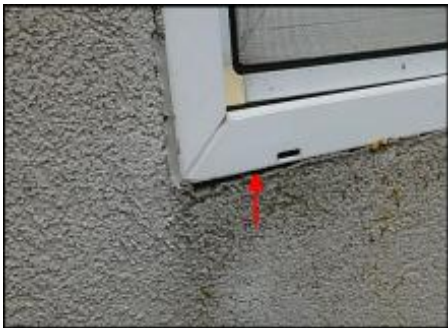
7/8" EIFS needs to be removed at window perimeter prior to base coat and mesh application to accommodate 3/4" silicone sealant joint application; typical

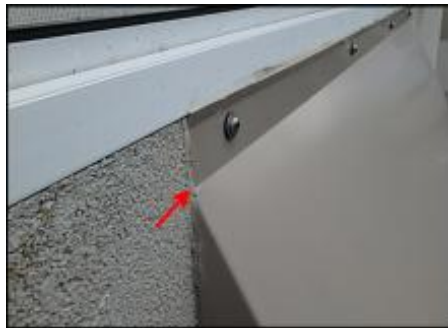
PTAC shroud terminations need remediation to accommodate 1/2" sealant joint application; typical

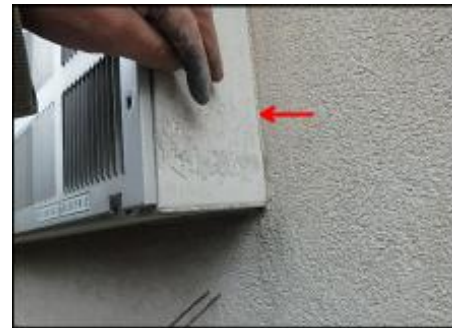
7/8" EIFS needs to be removed at PTAC perimeter prior to base coat and mesh application to accommodate 3/4" silicone sealant joint application; typical

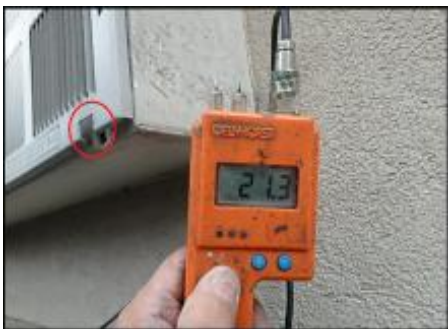
PTAC needs factory drip tubes installed to divert water away from system; typical

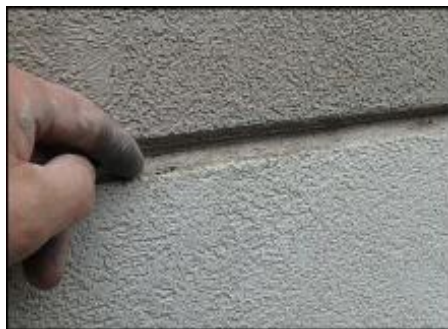
7/8" Sprint board application does not allow for minimum 3/4" foam at base of v-groove; hairline cracks observed; detail needs bond breaker tape and silicone sealant joint application; typical

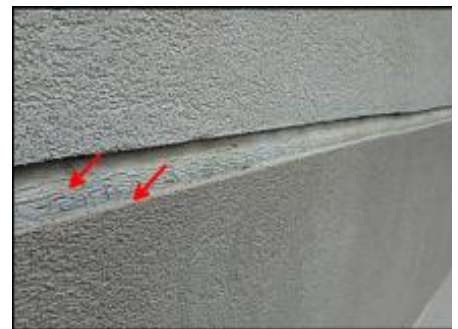
Sealant at floor line expansion joint needs to be removed and EIFS removed at base of joint prior to base coat, mesh and silicone sealant joint application; typical

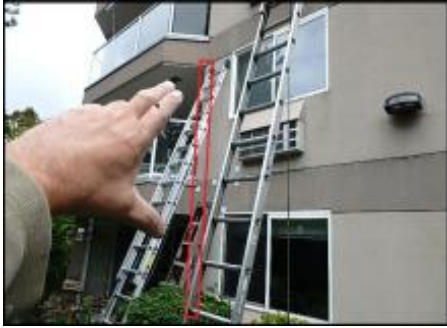
Approximate area of soft substrate needs to be removed and replaced (C5-C7)

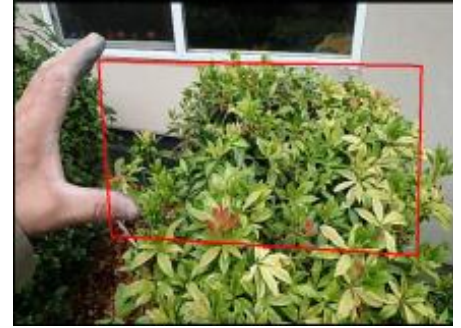
Approximate area of soft substrate needs to be removed and replaced (C7-D7)

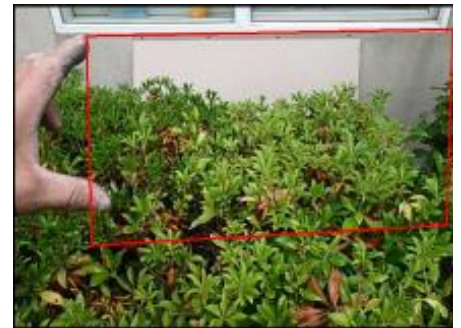
Approximate area of soft substrate needs to be removed and replaced (D7-E7)

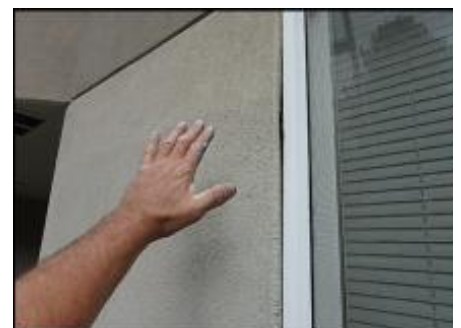
Area of insufficiently attached EIFS needs fasteners installed prior to base coat, mesh and finish coat application; typical

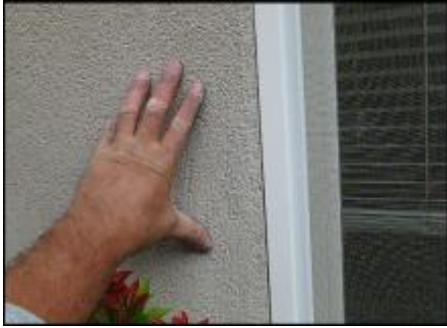
Area of insufficiently attached EIFS needs fasteners installed prior to base coat, mesh and finish coat application; typical

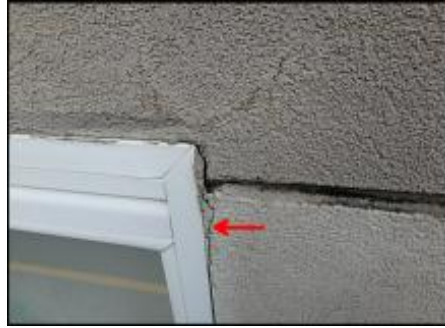
7/8" EIFS needs to be removed at window perimeter prior to base coat and mesh application to accommodate 3/4" silicone sealant joint application; typical

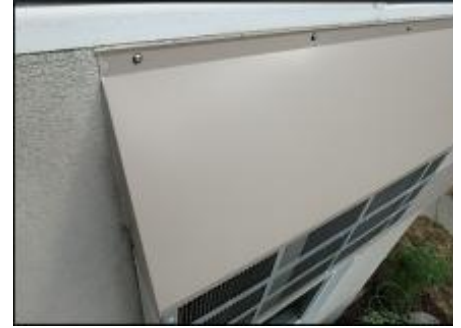
PTAC shroud terminations need remediation to accommodate 1/2" sealant joint application; typical

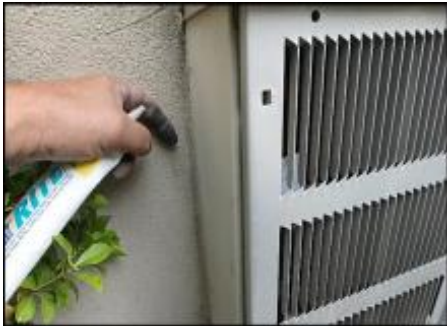
7/8" EIFS needs to be removed at PTAC perimeter prior to base coat and mesh application to accommodate 3/4" silicone sealant joint application; typical

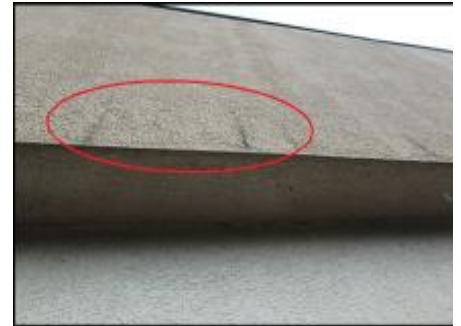
Hairline cracks will be remediated with application of base coat, mesh and finish coat application; typical

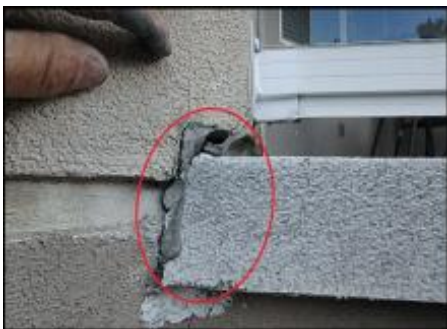
Recommend replacement of deck membrane due to installation defects and failure observed; deck termination needs end dam flashing installation; typical

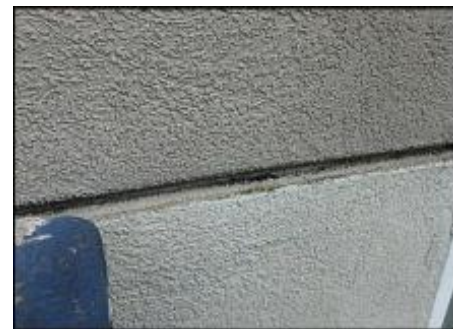
7/8" Sprint board application does not allow for minimum 3/4" foam at base of v-groove; hairline cracks observed; detail needs bond breaker tape and silicone sealant joint application; typical

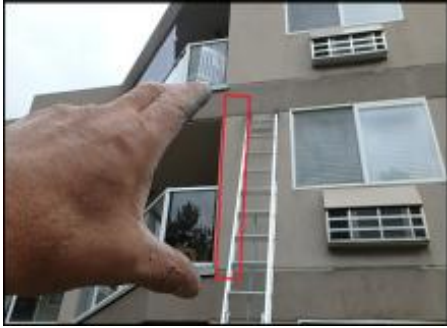
Approximate area of soft substrate needs to be removed and replaced (A5-A6)

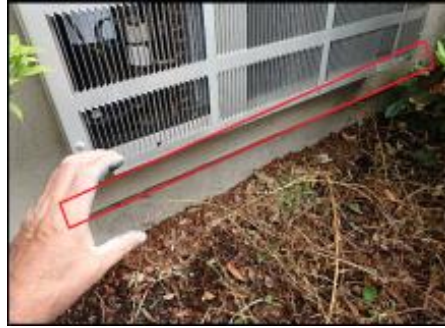
Approximate area of soft substrate needs to be removed and replaced (A7)

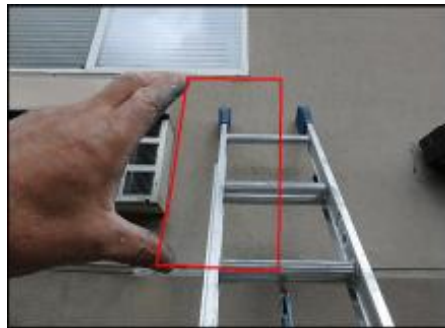
Approximate area of soft substrate needs to be removed and replaced (B6)

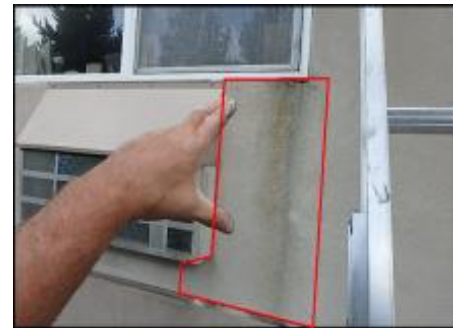
Approximate area of soft substrate needs to be removed and replaced (B6)

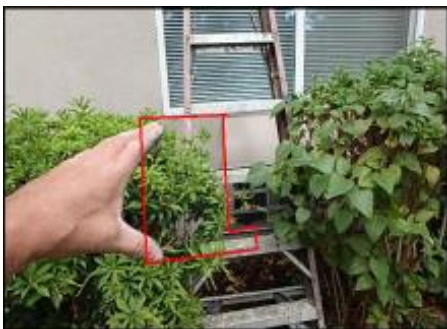
Approximate area of soft substrate needs to be removed and replaced (B7)

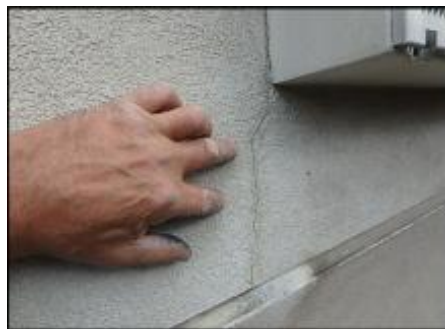
Crack needs to be gouged and slivered with EPS prior to base coat, mesh and finish coat application; typical

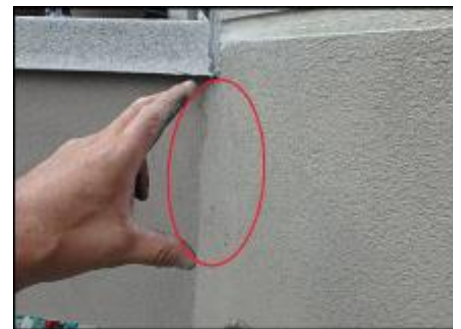
Inconclusive probing results below deck due to OSB substrate cut out to accommodate steel bracket installation; recommend random intrusive evaluation upon system remediation to determine framing condition; typical

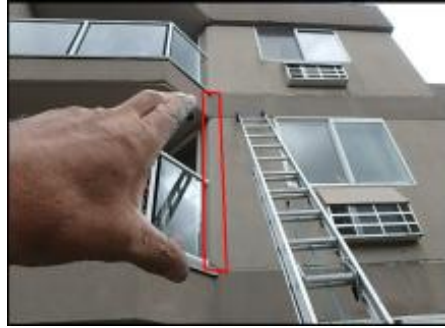
Approximate area of soft substrate needs to be removed and replaced (E4-E5)

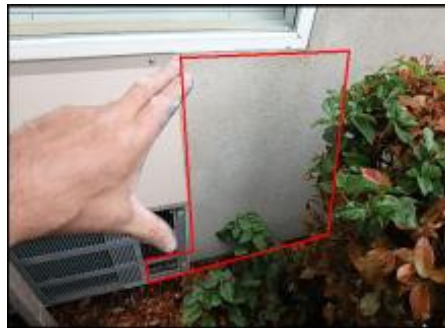
Approximate area of soft substrate needs to be removed and replaced (G8)

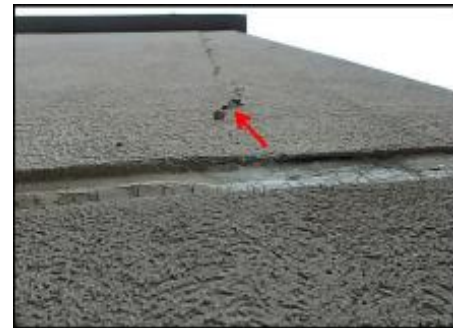
Movement crack observed at wood substrate to concrete substrate (H1-H3)

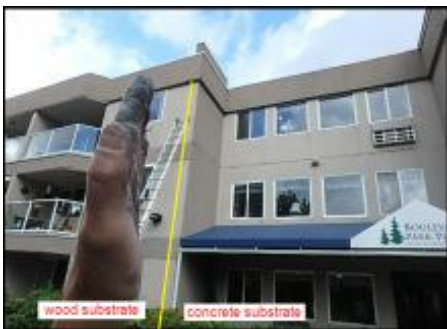
Wood to concrete substrate needs expansion joint installation (H1-H8)

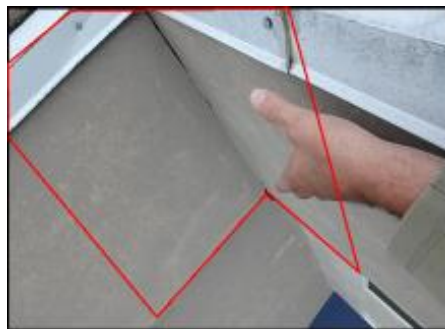
Approximate area of soft substrate needs to be removed and replaced (H1-I2)

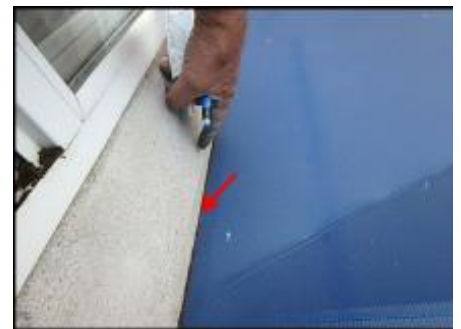
Awning to EIFS needs sealant joint application (I5-J5)

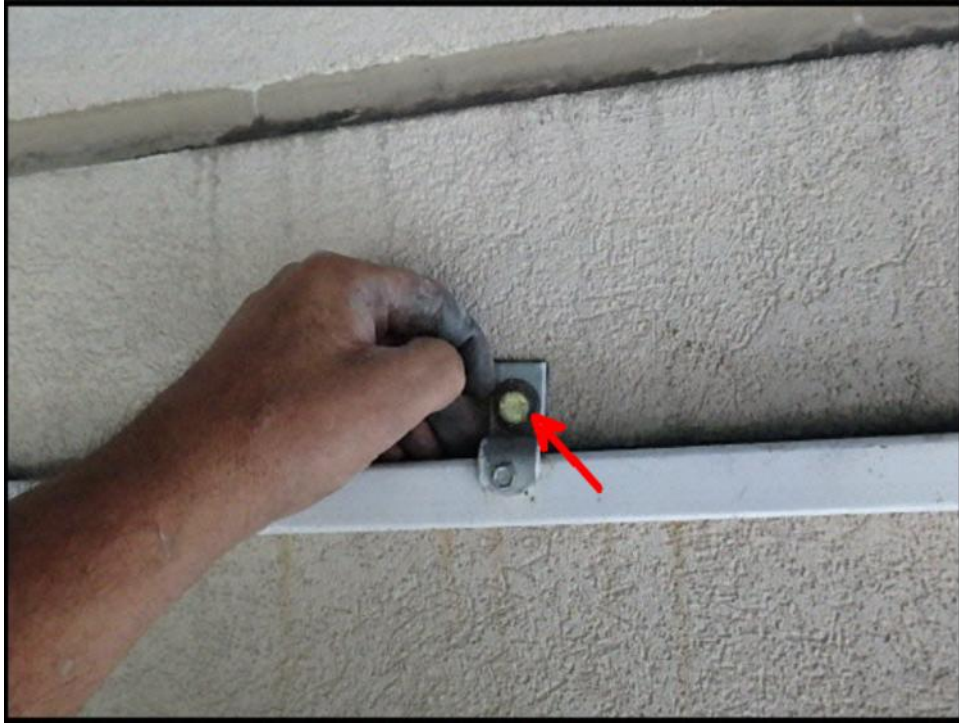
Awning fastener needs sleeve set in bed of sealant application; typical

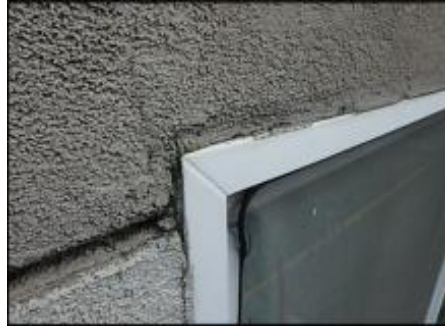
7/8" EIFS needs to be removed at window perimeter prior to base coat and mesh application to accommodate 3/4" silicone sealant joint application; typical

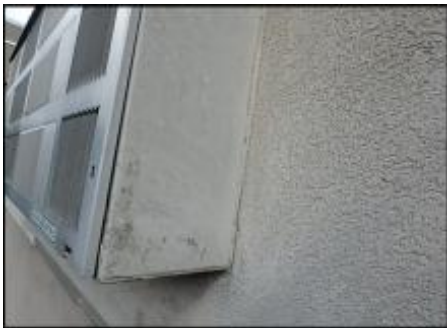
7/8" EIFS needs to be removed at PTAC perimeter prior to base coat and mesh application to accommodate 3/4" silicone sealant joint application; typical

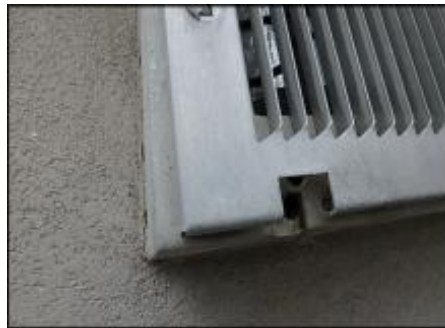
PTAC needs factory drip tubes installed to divert water away from system; typical

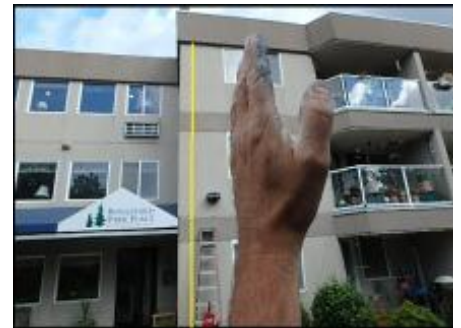
Concrete substrate to wood substrate needs expansion joint installation (D1-E8)

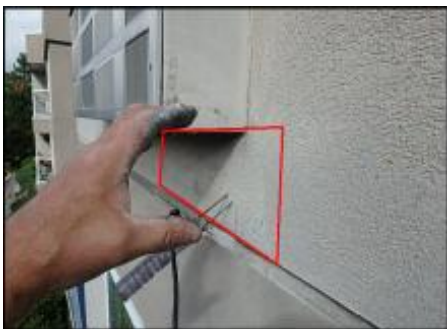
Approximate area of soft substrate needs to be removed and replaced (F3)

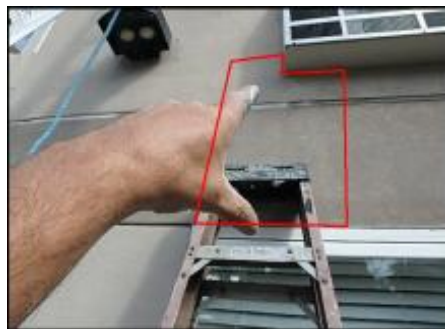
Approximate area of soft substrate needs to be removed and replaced (E5-F6)

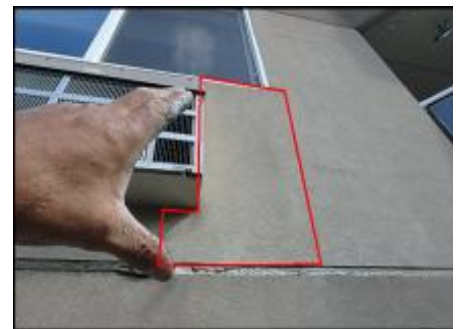
Approximate area of soft substrate needs to be removed and replaced (F5)

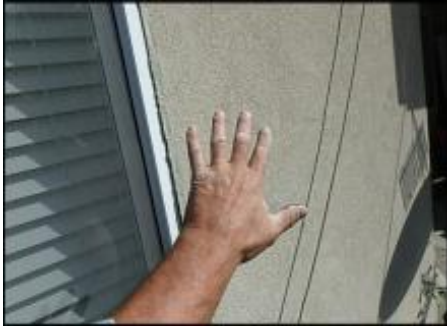
Area of insufficiently attached EIFS needs fasteners installed prior to base coat, mesh and finish coat application; typical

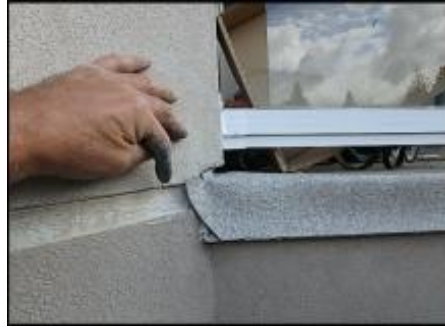
Recommend replacement of deck membrane due to installation defects and failure observed; deck termination needs end dam flashing installation; typical

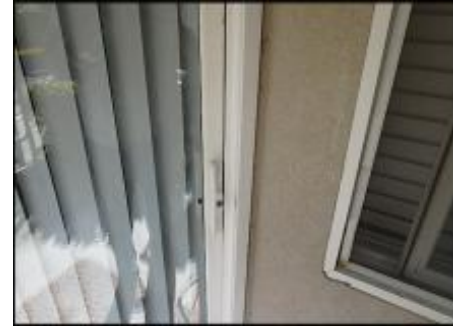
7/8" EIFS needs to be removed at interior deck door head and jambs prior to base coat and mesh application to accommodate 3/4" silicone sealant joint application; typical

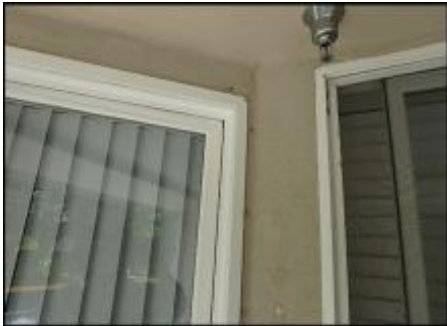
7/8" EIFS needs to be removed at interior deck window perimeter prior to base coat and mesh application to accommodate 3/4" silicone sealant joint application; typical

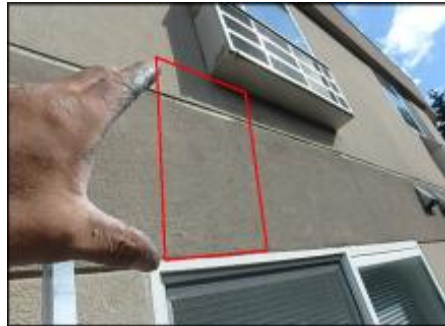
Approximate area of soft substrate needs to be removed and replaced (I4)

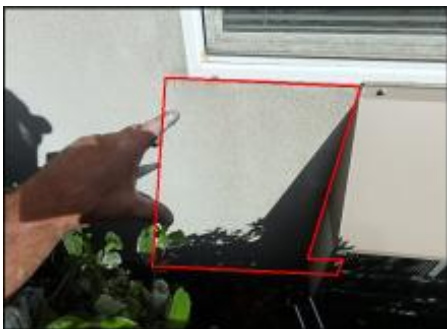
Approximate area of soft substrate needs to be removed and replaced (I6)

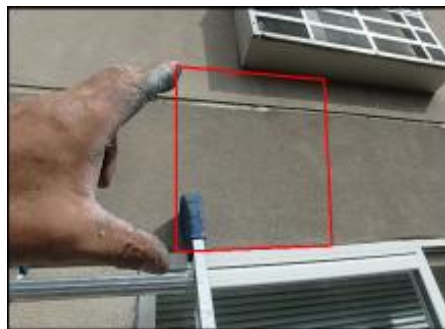
Approximate area of soft substrate needs to be removed and replaced (I4)

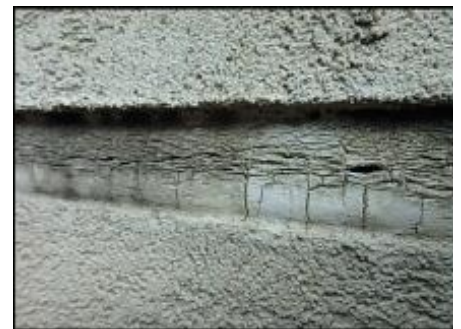
Sealant at floor line expansion joint needs to be removed and EIFS removed at base of joint prior to base coat, mesh and silicone sealant joint application; typical

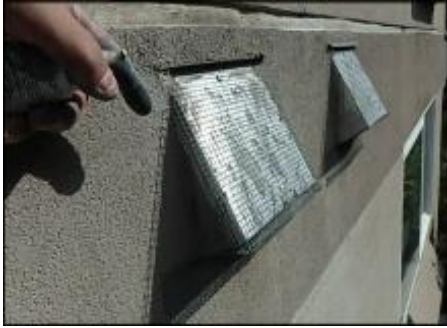
7/8" EIFS needs to be removed at vents prior to base coat and mesh application to accommodate 3/4" silicone sealant joint application; recommend replacing vents upon system remediation; typical

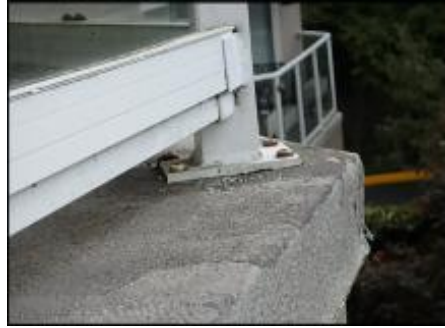
Recommend replacement of deck membrane due to installation defects and aging; typical

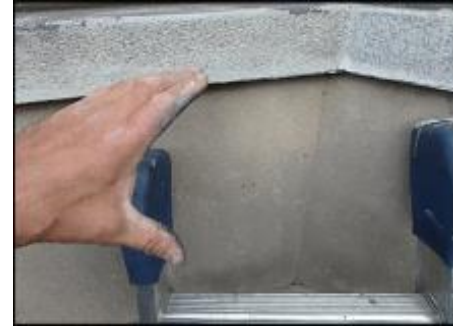
Inconclusive probing results below deck due to OSB substrate cut out to accommodate steel bracket installation; recommend random intrusive evaluation upon system remediation to determine framing condition; typical

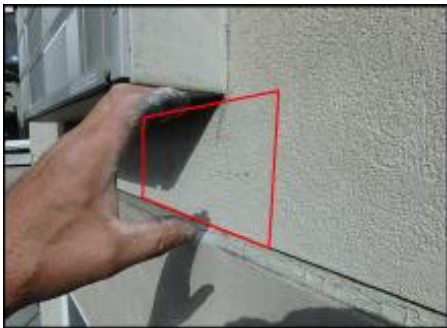
Approximate area of soft substrate needs to be removed and replaced (J4)

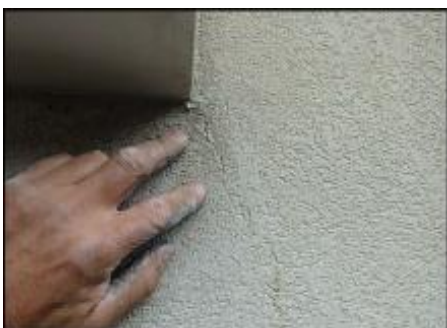
Crack needs to be gouged and slivered with EPS prior to base coat, mesh and finish coat application; typical

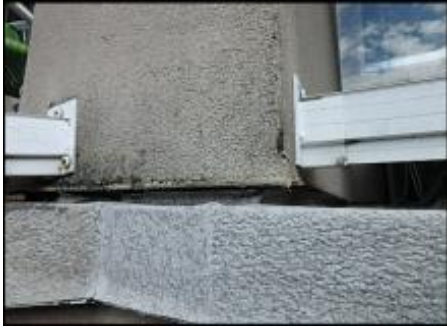
Recommend replacement of deck membrane due to installation details and aging; typical

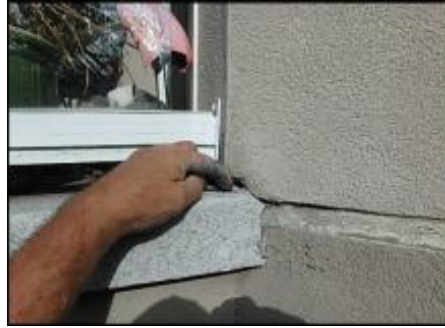
Deck termination need end dam flashing installation; typical
