# Moisture Survey Inspection

January 1, 2019

123 Pleasant Lane  
Pleasantville, WA 98000

Sound Exterior Inspections, LLC performed a moisture survey inspection on January 1, 2019 of the EIFS Sprint Barrier System installed on the building located at 123 Pleasantville Lane, Pleasantville, Washington at the request of John Doe, LLC.

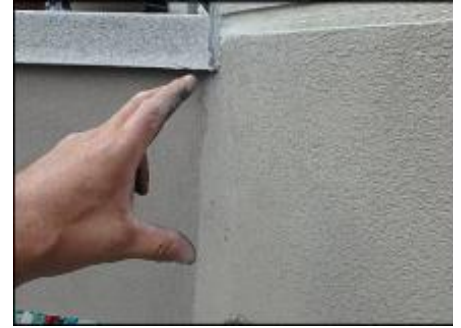
Inconclusive probing results below deck due to OSB substrate cut out to accommodate steel bracket installation; recommend random intrusive evaluation upon system remediation to determine framing condition; typical

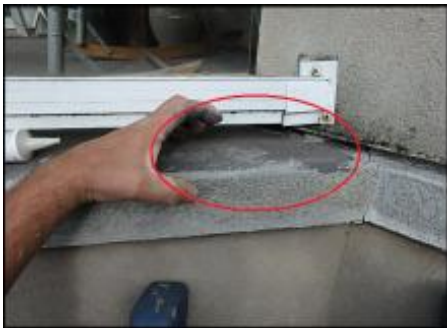
Wood rot detected at deck substrate (B4)

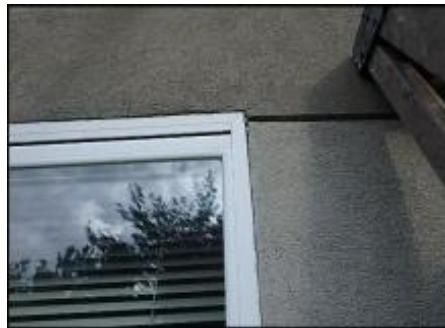
7/8" EIFS needs to be removed at window perimeter prior to base coat and mesh application to accommodate 3/4" silicone sealant joint application; typical

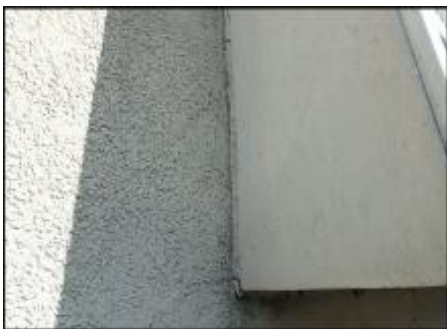
7/8" EIFS needs to be removed at PTAC perimeter prior to base coat and mesh application to accommodate 3/4" silicone sealant joint application; typical

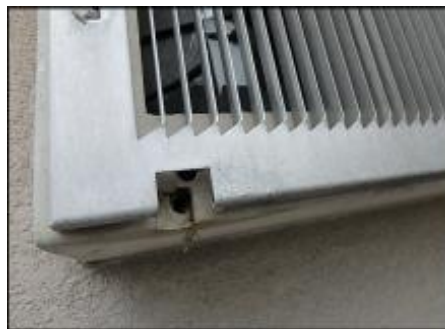
PTAC needs factory drip tubes installed to divert water away from system; typical

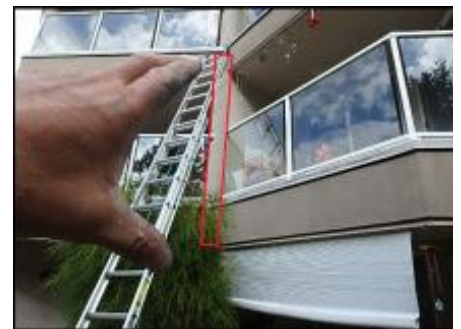
Approximate area of soft substrate needs to be removed and replaced (B4-B5)

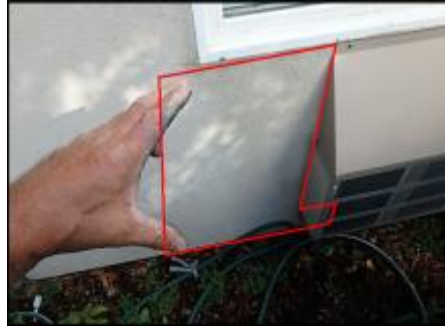
Approximate area of soft substrate needs to be removed and replaced (C6)

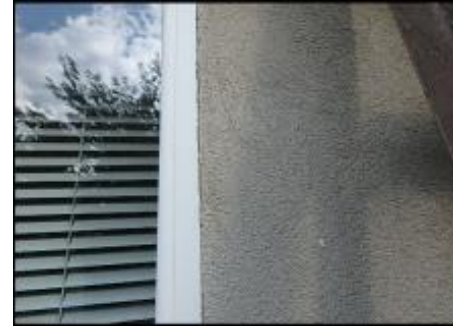
Area of insufficiently attached EIFS needs fasteners installed prior to base coat, mesh and finish coat application; typical

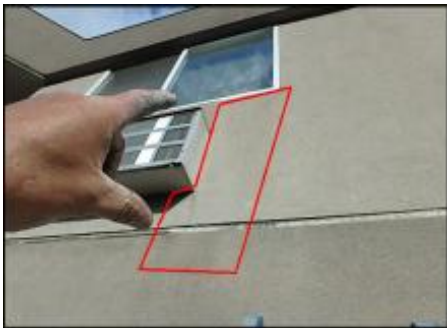
Approximate area of soft substrate needs to be removed and replaced (D3-D4)

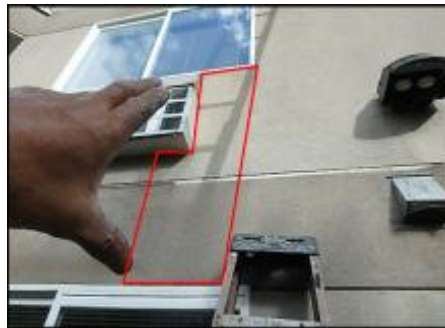
Approximate area of soft substrate needs to be removed and replaced (D5)

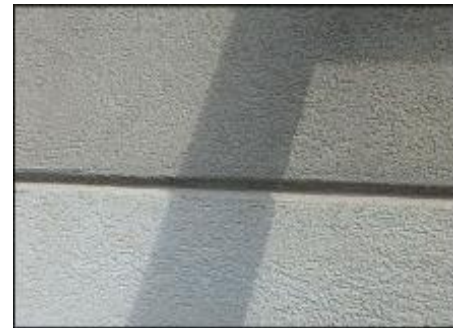
7/8" Sprint board application does not allow for minimum 3/4" foam at base of v-groove; hairline cracks observed; detail needs bond breaker tape and silicone sealant joint application; typical

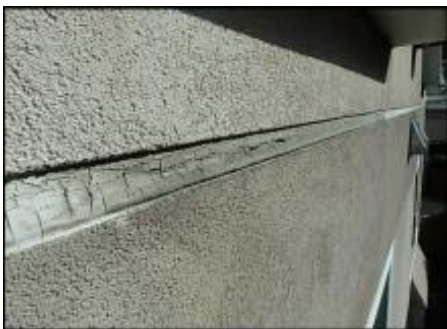
Sealant at floor line expansion joint needs to be removed and EIFS removed at base of joint prior to base coat, mesh and silicone sealant joint application; typical

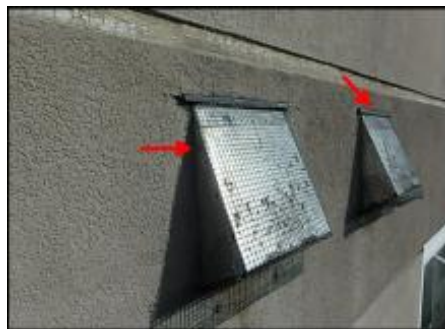
7/8" EIFS needs to be removed at vents prior to base coat and mesh application to accommodate 3/4" silicone sealant joint application; recommend replacing vents upon system remediation; typical

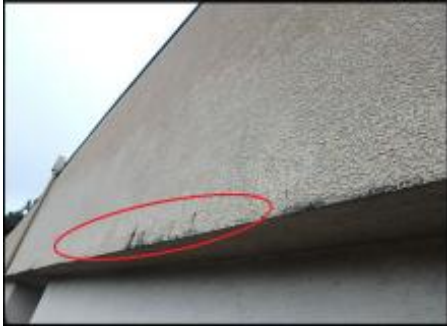
Hairline cracks will be remediated with application of base coat, mesh and finish coat application over entire system; typical

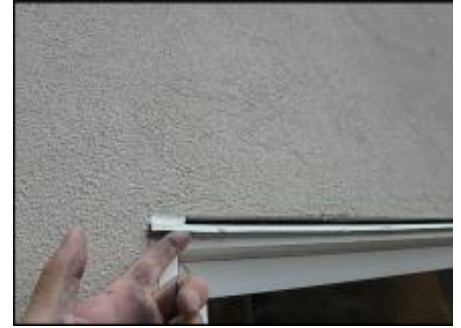
Head flashing with sealant end dams installed at remediated windows (C4-C7)

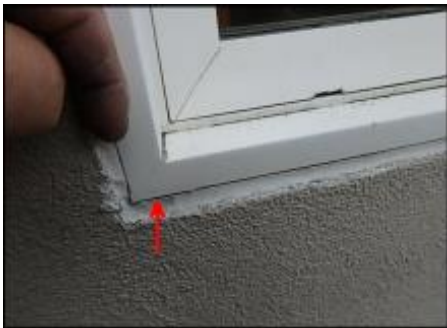
Sealant failure observed at window jambs and sill (C4-C7)

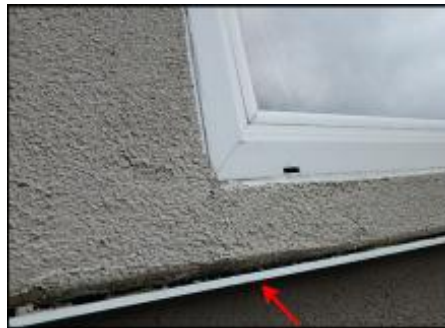
Floor line flashing not adequately extended over EIFS needs sealant joint application (B5-G5)

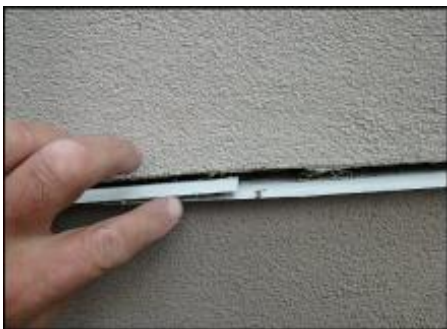
Floor line flashing not adequately extended over EIFS needs sealant joint application (B5-G5)

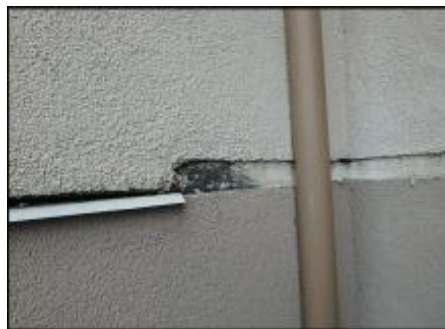
Floor line flashing lap needs to be sealed; typical

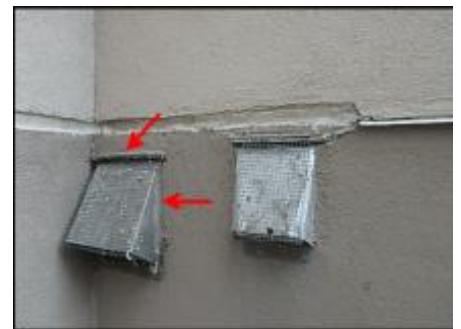
Sealant at floor line expansion joint needs to be removed and EIFS removed at base of joint prior to base coat, mesh and silicone sealant joint application; typical
