# Moisture Survey Inspection

January 1, 2019

123 Pleasant Lane  
Pleasantville, WA 98000

Sound Exterior Inspections, LLC performed a moisture survey inspection on January 1, 2019 of the EIFS Sprint Barrier System installed on the building located at 123 Pleasantville Lane, Pleasantville, Washington at the request of John Doe, LLC.

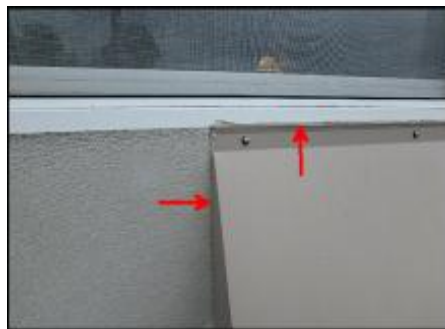
PTAC shroud terminations need remediation to accommodate 1/2" sealant joint application; typical

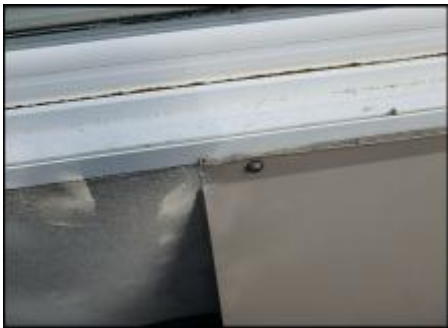
PTAC shroud terminations need remediation to accommodate 1/2" sealant joint application; typical

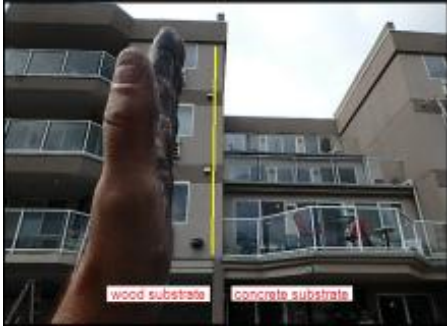
Wood substrate to concrete substrate needs expansion joint installation (H2-H6)

There are locations indicated in this report at dissimilar substrates (wood/concrete) that need expansion joint installation to accommodate movement to protect against cracking.

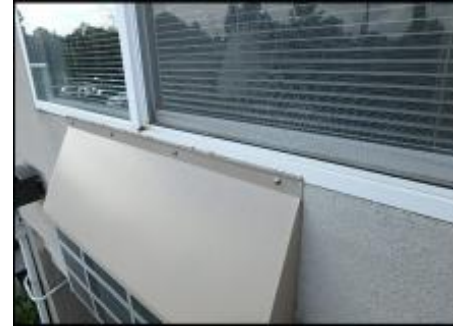
PTAC shroud terminations need remediation to accommodate 1/2" sealant joint application; typical

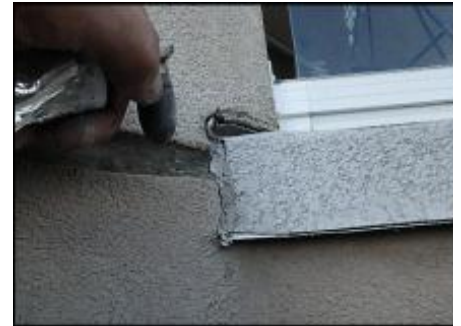
Deck termination needs end dam flashing installation; typical

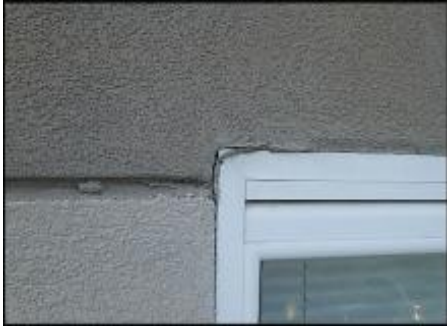
7/8" EIFS needs to be removed at window perimeter prior to base coat and mesh application to accommodate 3/4" silicone sealant joint application; typical

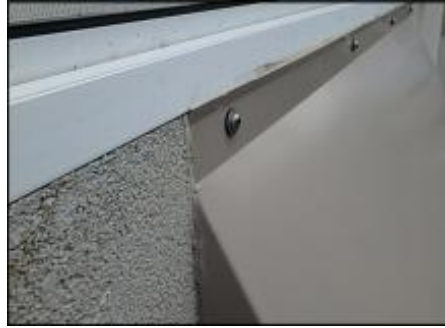
PTAC shroud terminations need remediation to accommodate 1/2" sealant joint application; typical

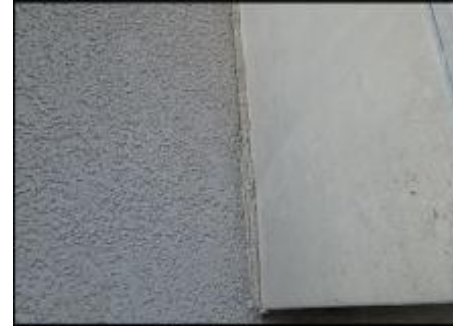
7/8" EIFS needs to be removed at PTAC perimeter prior to base coat and mesh application to accommodate 3/4" silicone sealant joint application; typical

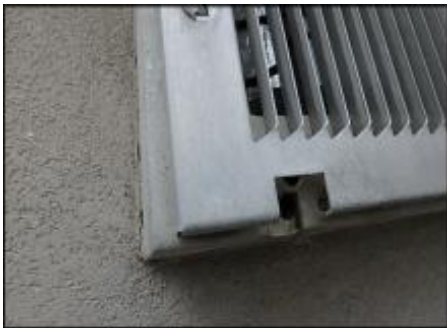
PTAC needs factory drip tubes installed to divert water away from system; typical

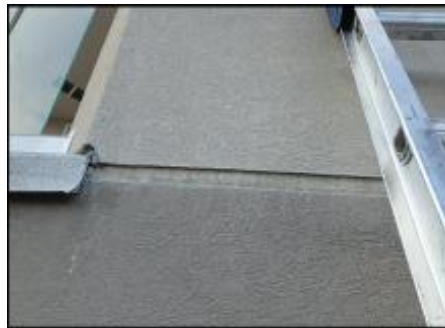
Sealant at floor line expansion joint needs to be removed and EIFS removed at base of joint prior to base coat, mesh and silicone sealant joint application; typical

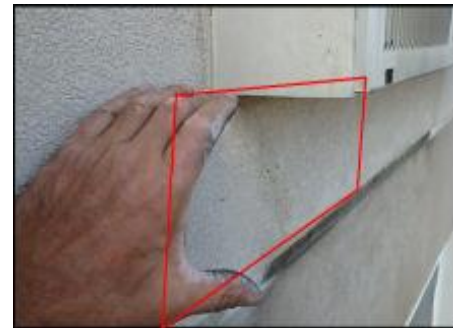
Approximate area of soft substrate needs to be removed and replaced (A5)

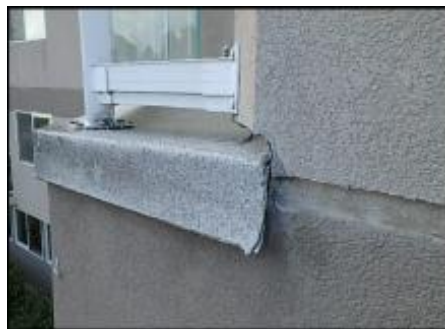
Deck termination needs end dam flashing installation; typical

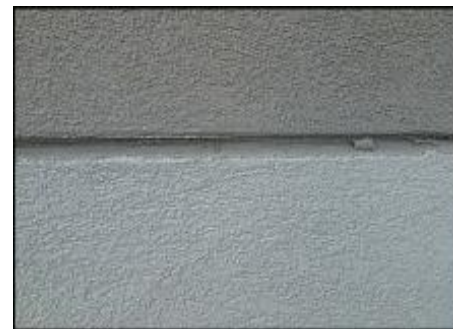
7/8" Sprint board application does not allow for minimum 3/4" foam at base of v-groove; hairline cracks observed; detail needs bond breaker tape and silicone sealant joint application; typical

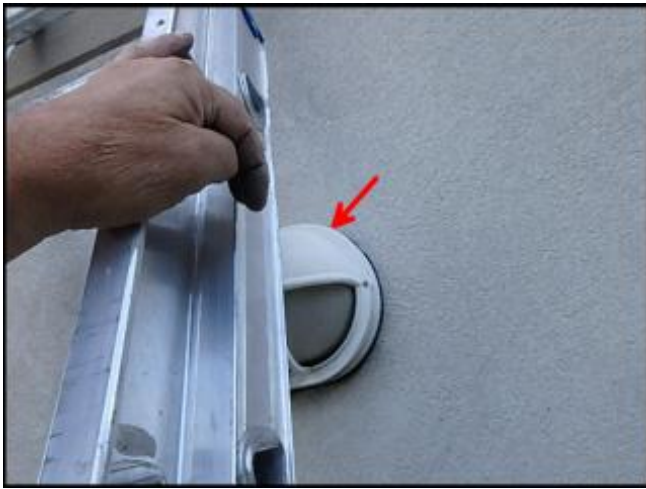
Light penetration needs 3/4" sealant joint application subsequent system remediation; typical

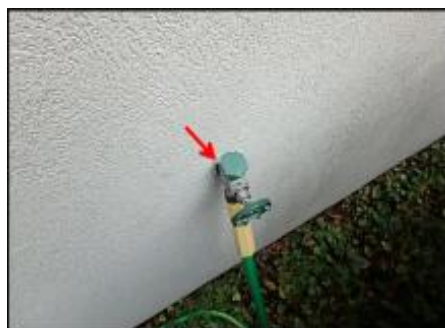
Penetration needs sealant joint application; typical

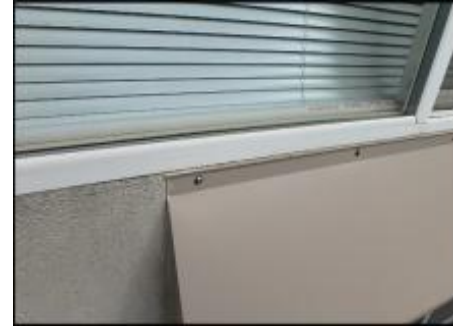
PTAC shroud terminations need remediation to accommodate 1/2" sealant joint application; typical

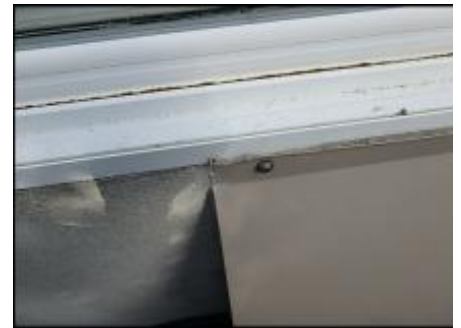
PTAC shroud terminations need remediation to accommodate 1/2" sealant joint application; typical

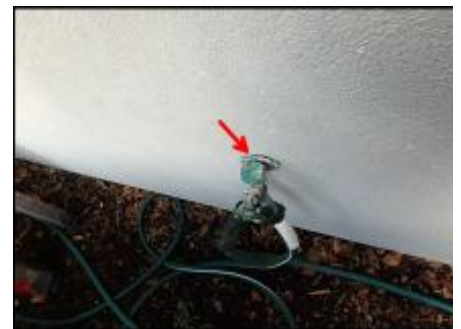
Penetration needs sealant joint application; typical

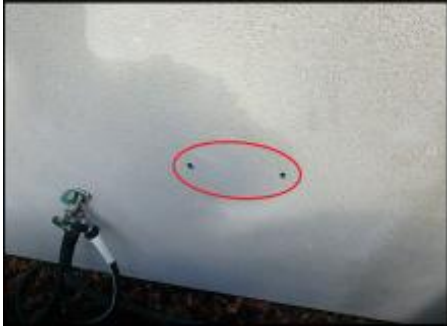
Penetrations will be remediated with application of base coat, mesh and finish coat application over entire system; typical

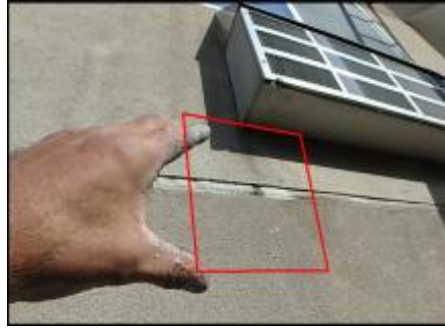
Approximate area of soft substrate needs to be removed and replaced (D5)

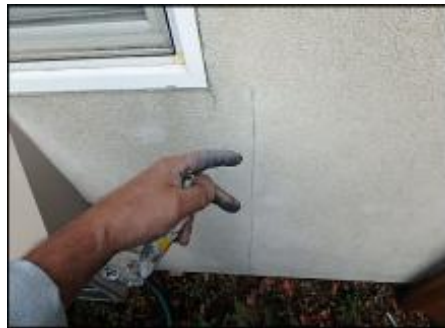
Crack needs to be gouged and slivered with EPS prior to base coat, mesh and finish coat application; typical

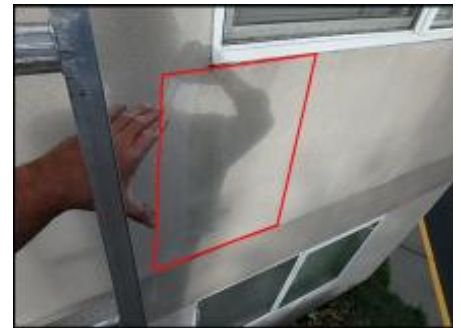
Approximate area of soft substrate needs to be removed and replaced (H4-H5)

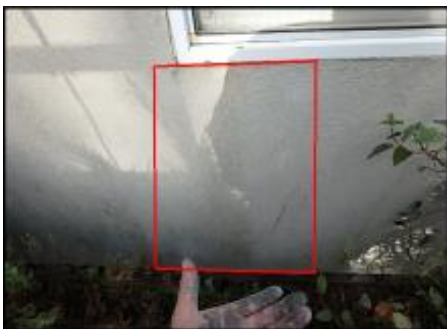
Approximate area of soft substrate needs to be removed and replaced (H6-H7)

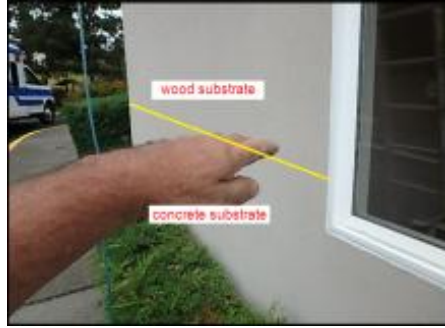
Wood substrate to concrete substrate needs expansion joint installation (B7)

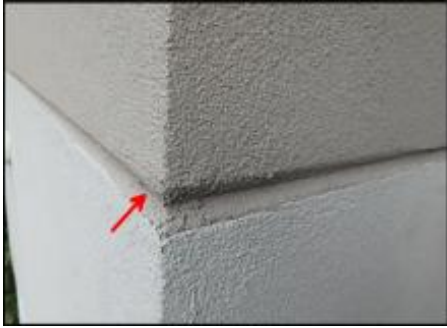
7/8" EIFS needs to be removed at vents prior to base coat and mesh application to accommodate 3/4" silicone sealant joint application; recommend replacing vents upon system remediation; typical

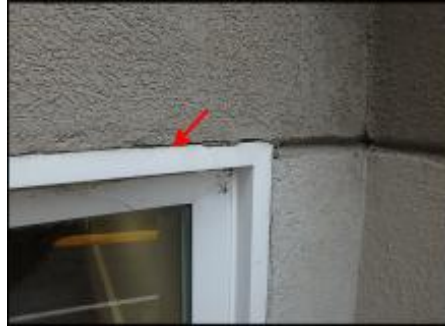
7/8" Sprint board application does not allow for minimum 3/4" foam at base of v-groove; hairline cracks observed; detail needs bond breaker tape and silicone sealant joint application; typical

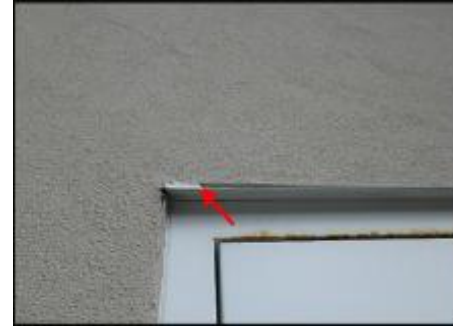
7/8" EIFS needs to be removed at window perimeter prior to base coat and mesh application to accommodate 3/4" silicone sealant joint application (D3-I6)

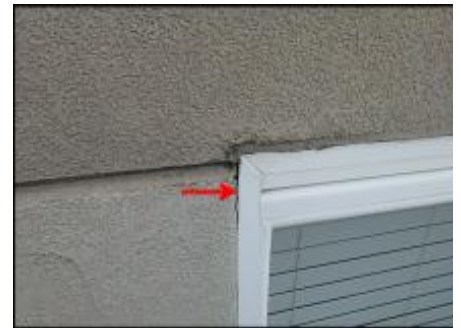
Floor line expansion joint lacks sealant joint application (G5-I5)

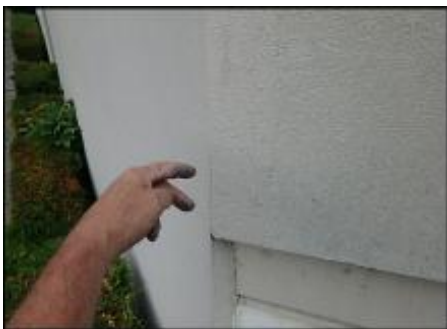
7/8" EIFS needs to be removed at window perimeter prior to base coat and mesh application to accommodate 3/4" silicone sealant joint application; typical

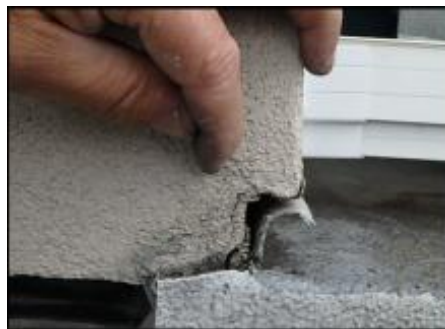
Crack needs to be gouged and slivered with EPS prior to base coat, mesh and finish coat application; typical

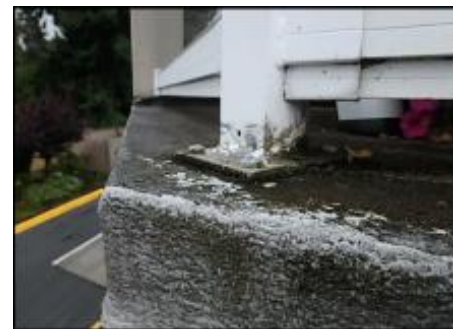
Recommend replacement of deck membrane due to installation defects and failure observed; deck termination needs end dam flashing installation; typical
